# Clearing the Fog on the Aging I-77 Rock Slopes

**Ryan Tinsley, PG**  
HDR Engineering, Inc.

**David Lee, PE**  
VDOT Materials Division  
Salem District

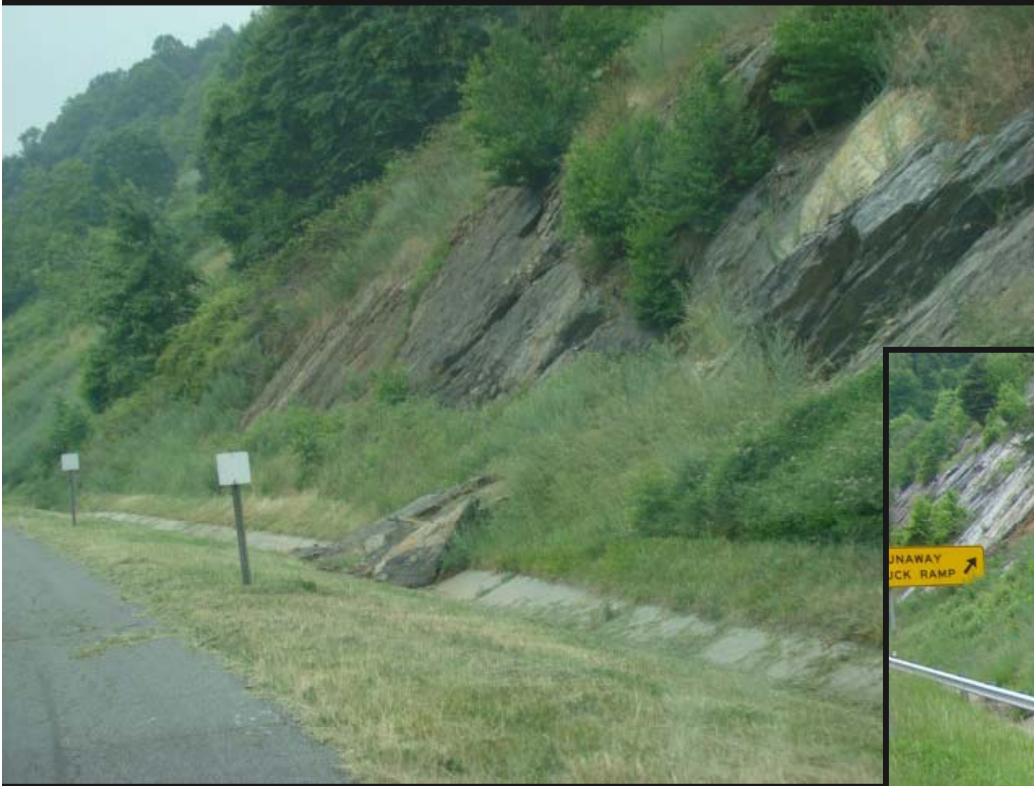
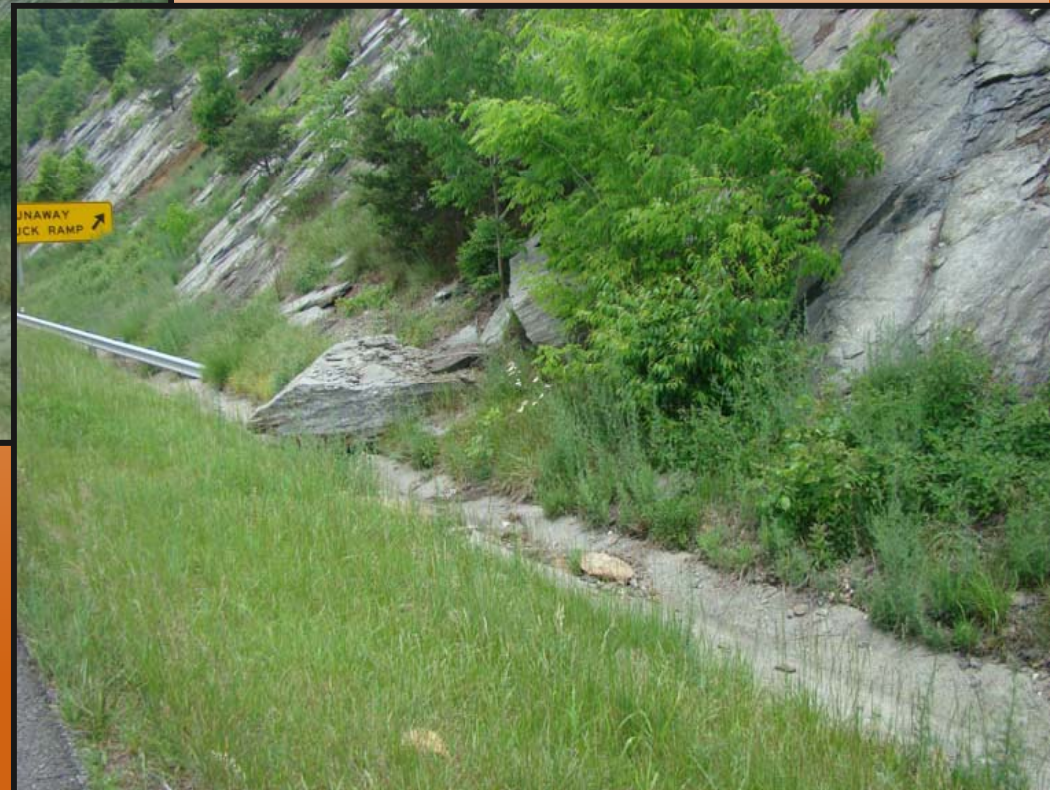
# I-77 Corridor Challenges: Rockfalls

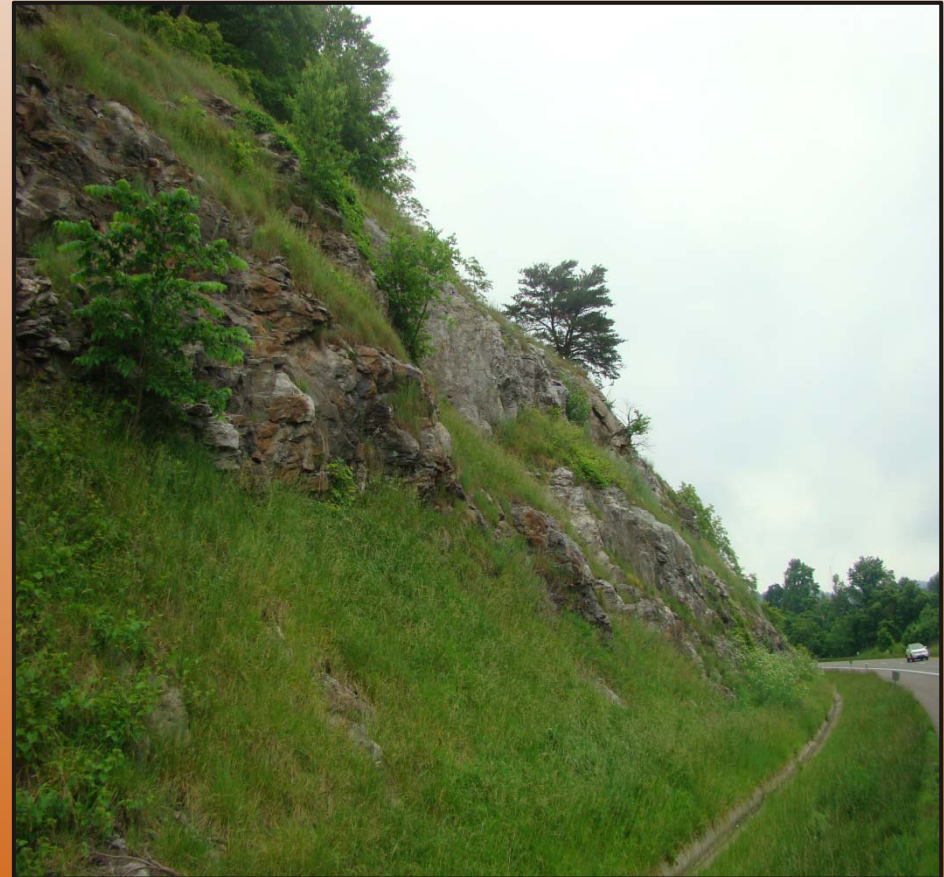
**Sight Distance:  
Worst Case: 420 ft  
Percent DSD Score = 81**

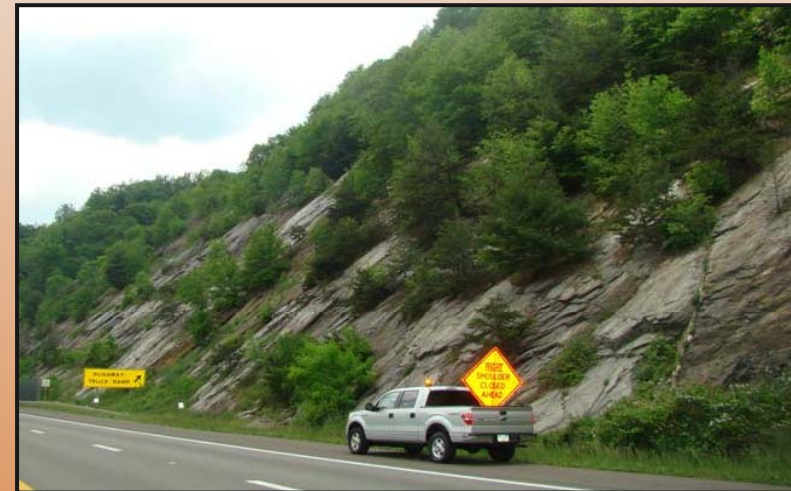
Continuous and Adverse Orientation

Slopes Showing Their Age

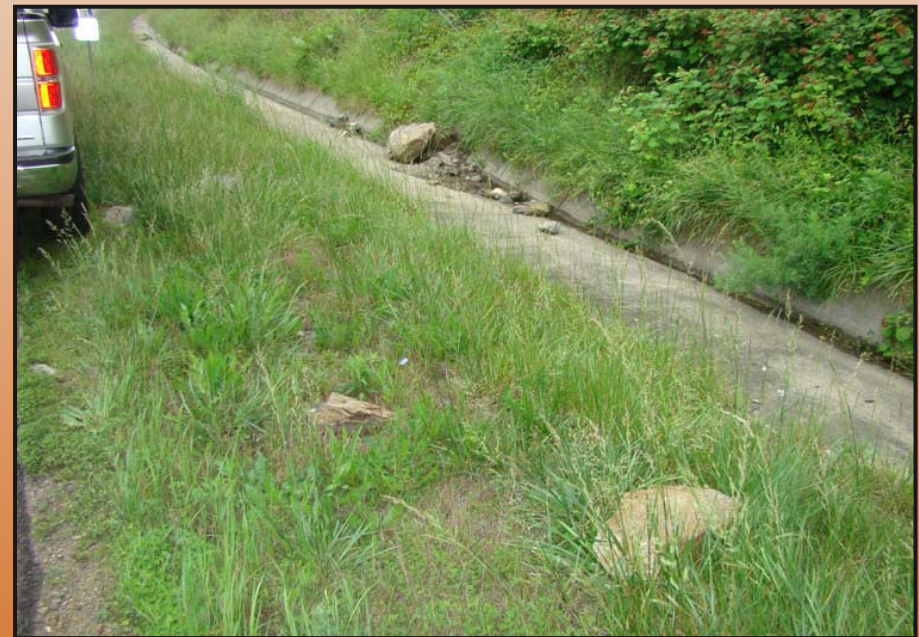
**Rockfall History :  
Constant Shedding of Rock**

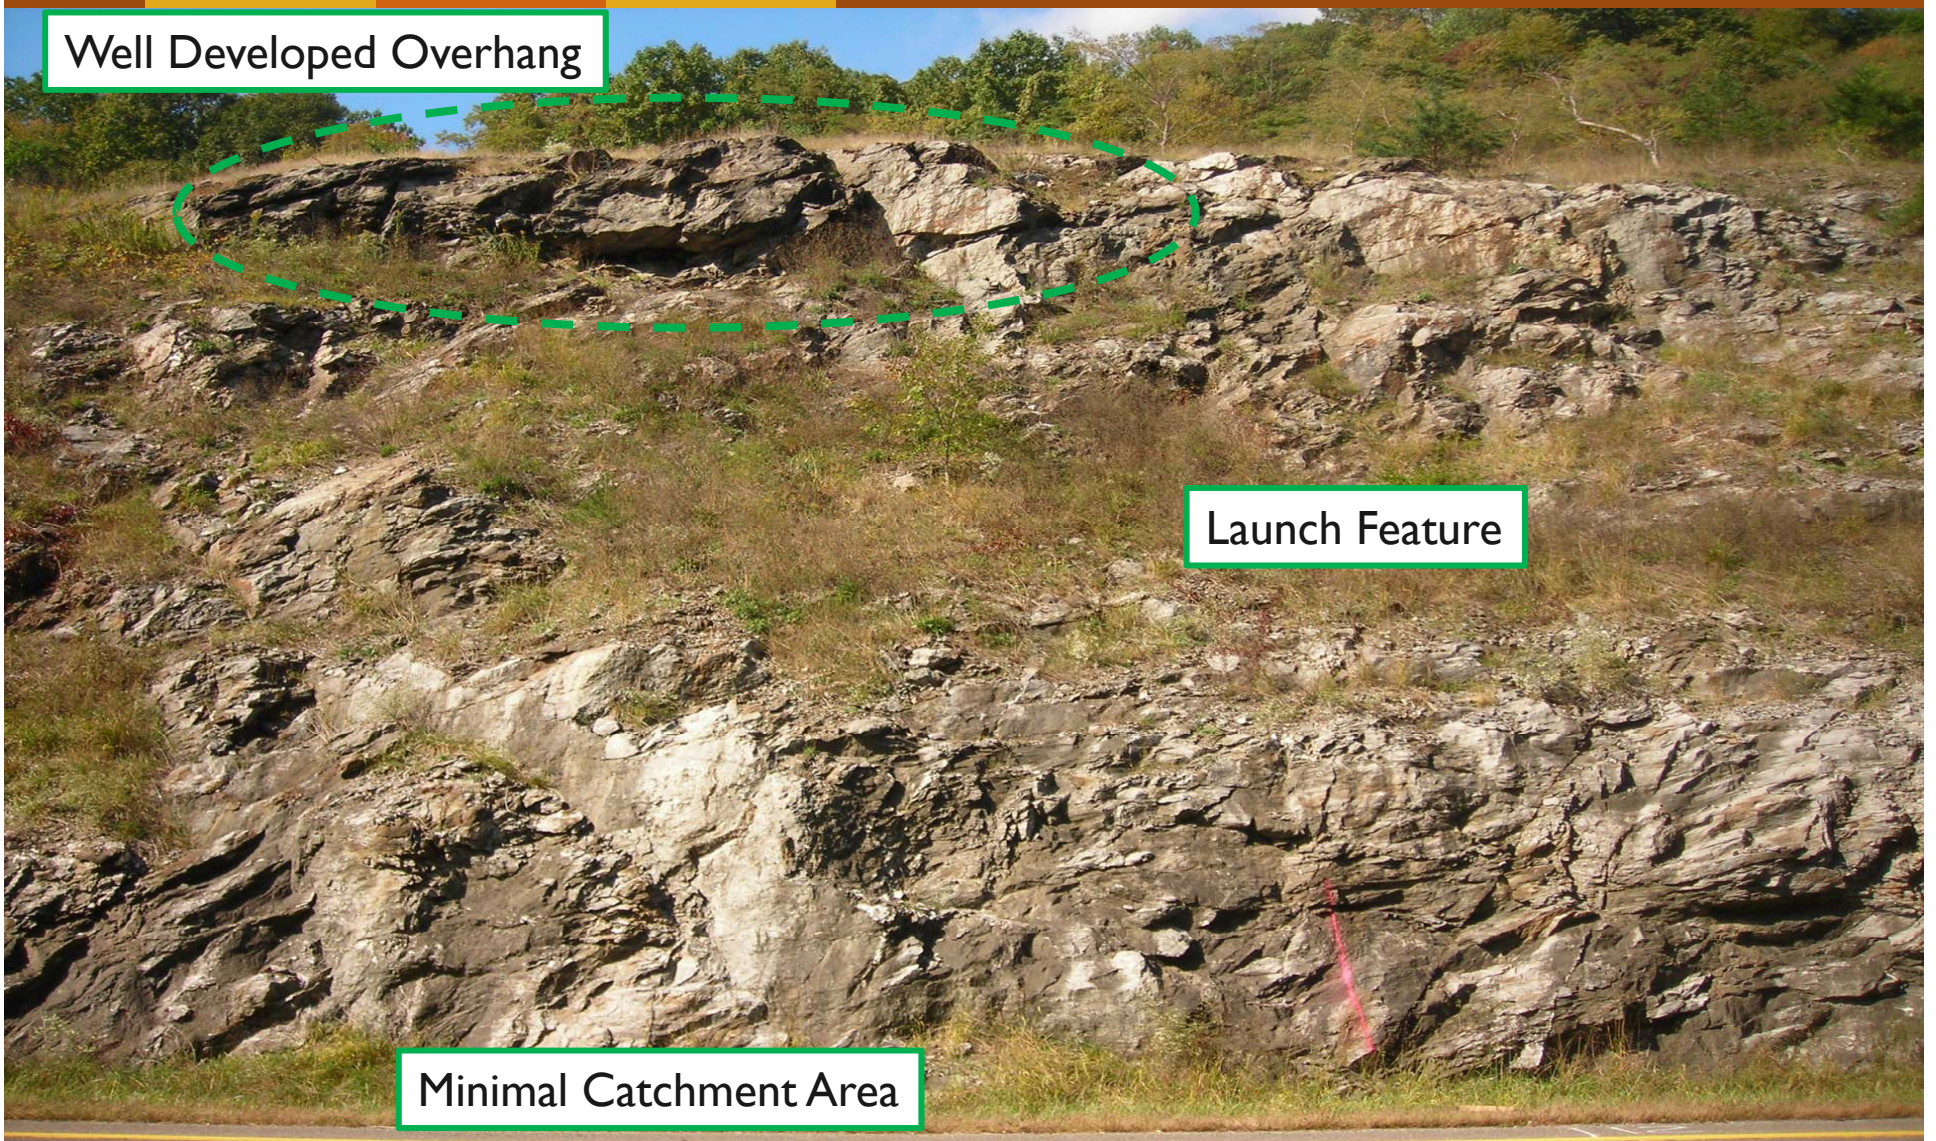
# Geologic Evaluation: I-77 NB Median MP 3.6 to 3.9

Well Developed Overhang

Launch Feature

Minimal Catchment Area

- Scale approximately 1200 LF of Slope
- Remove Well Developed Overhangs
- Remove Well Developed Wedges
- Estimated Schedule : 30 to 90 days
- Construction Started on 5/29/2012

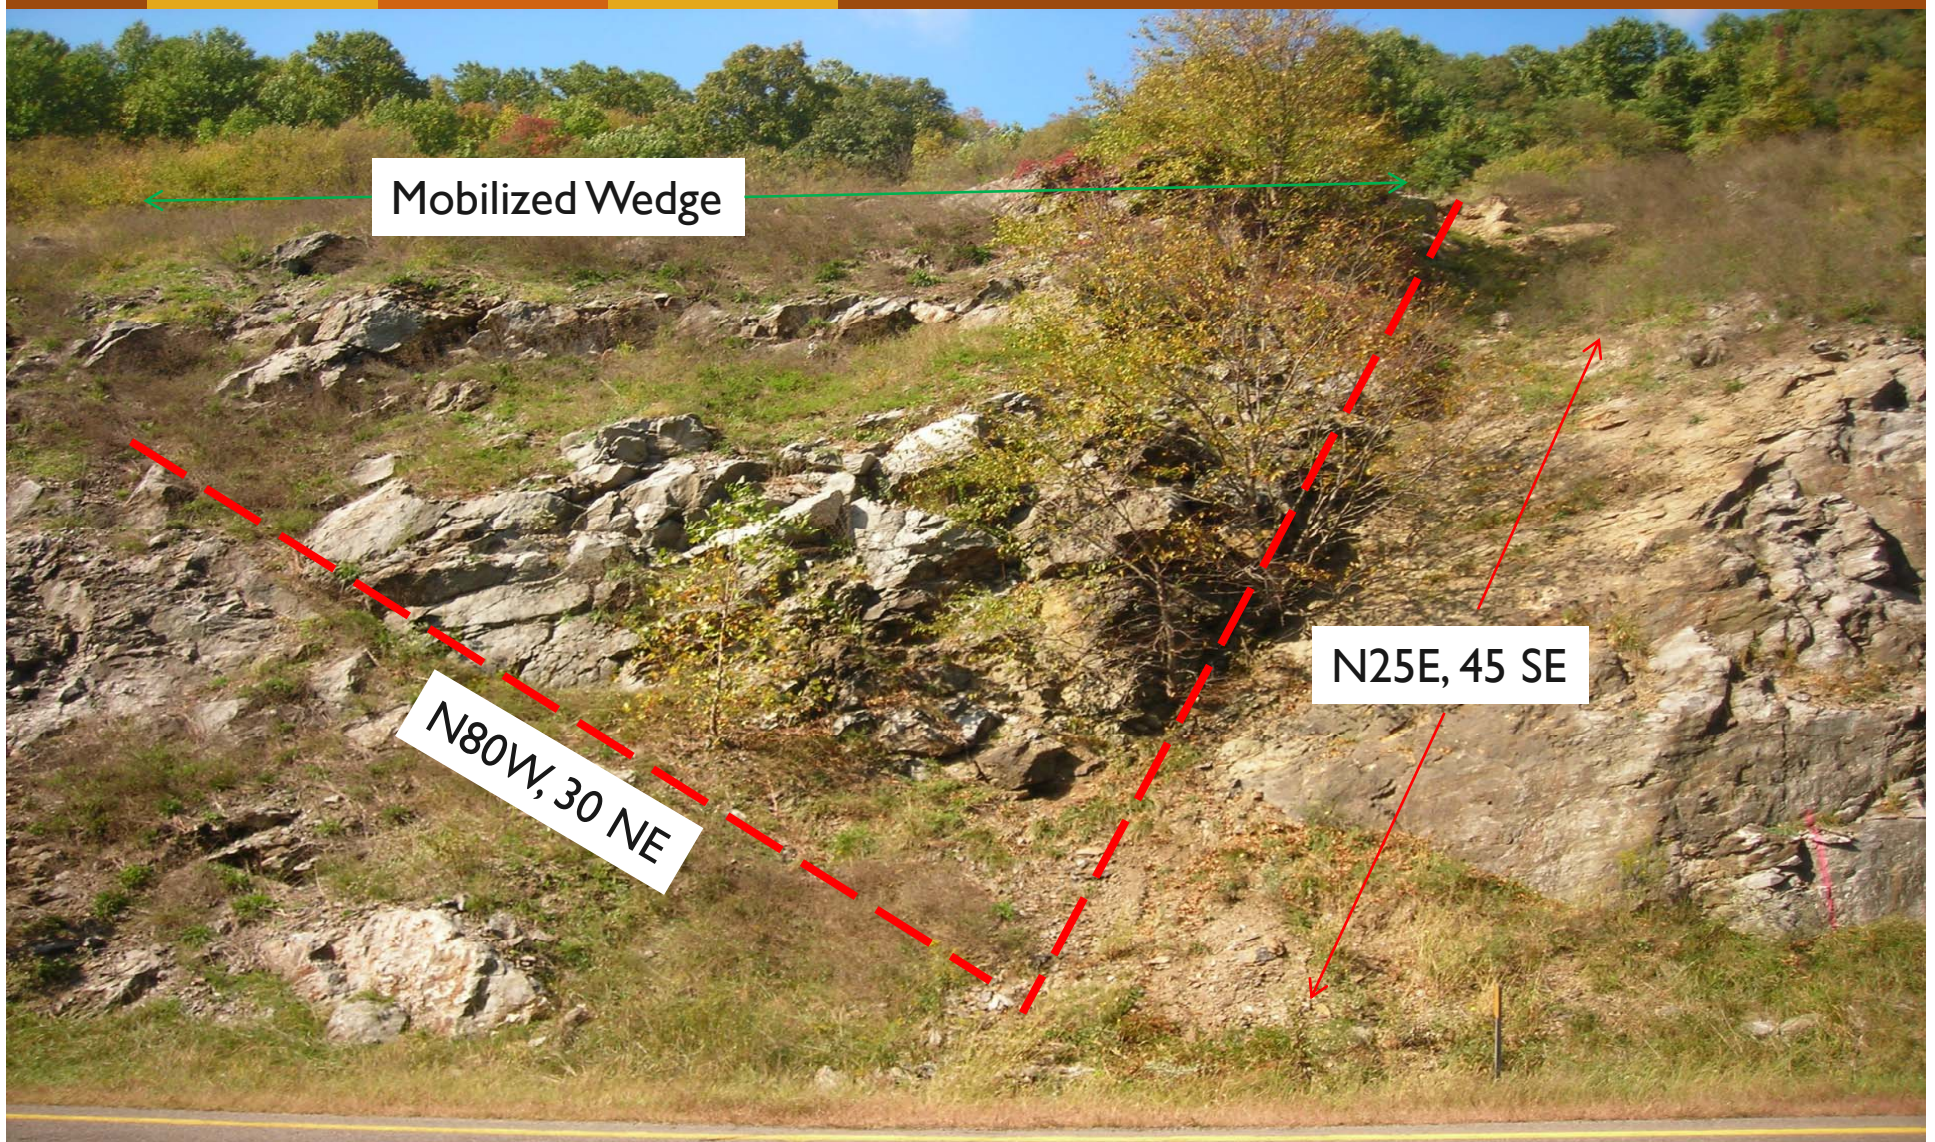
# Geologic Evaluation: I-77 NB Median MP 3.6 to 3.9

Mobilized Wedge

N80W, 30 NE

N25E, 45 SE
