MINIMIZING GEOTECHNICAL SURPRISES

James K. Mitchell

43rd Southeast Transportation
Geotechnical Engineers Conference

Will examine two case histories involving geotechnical failures or special problems and evaluate each in terms of whether it should be considered unexpected (an act of God) or could/should have been anticipated.

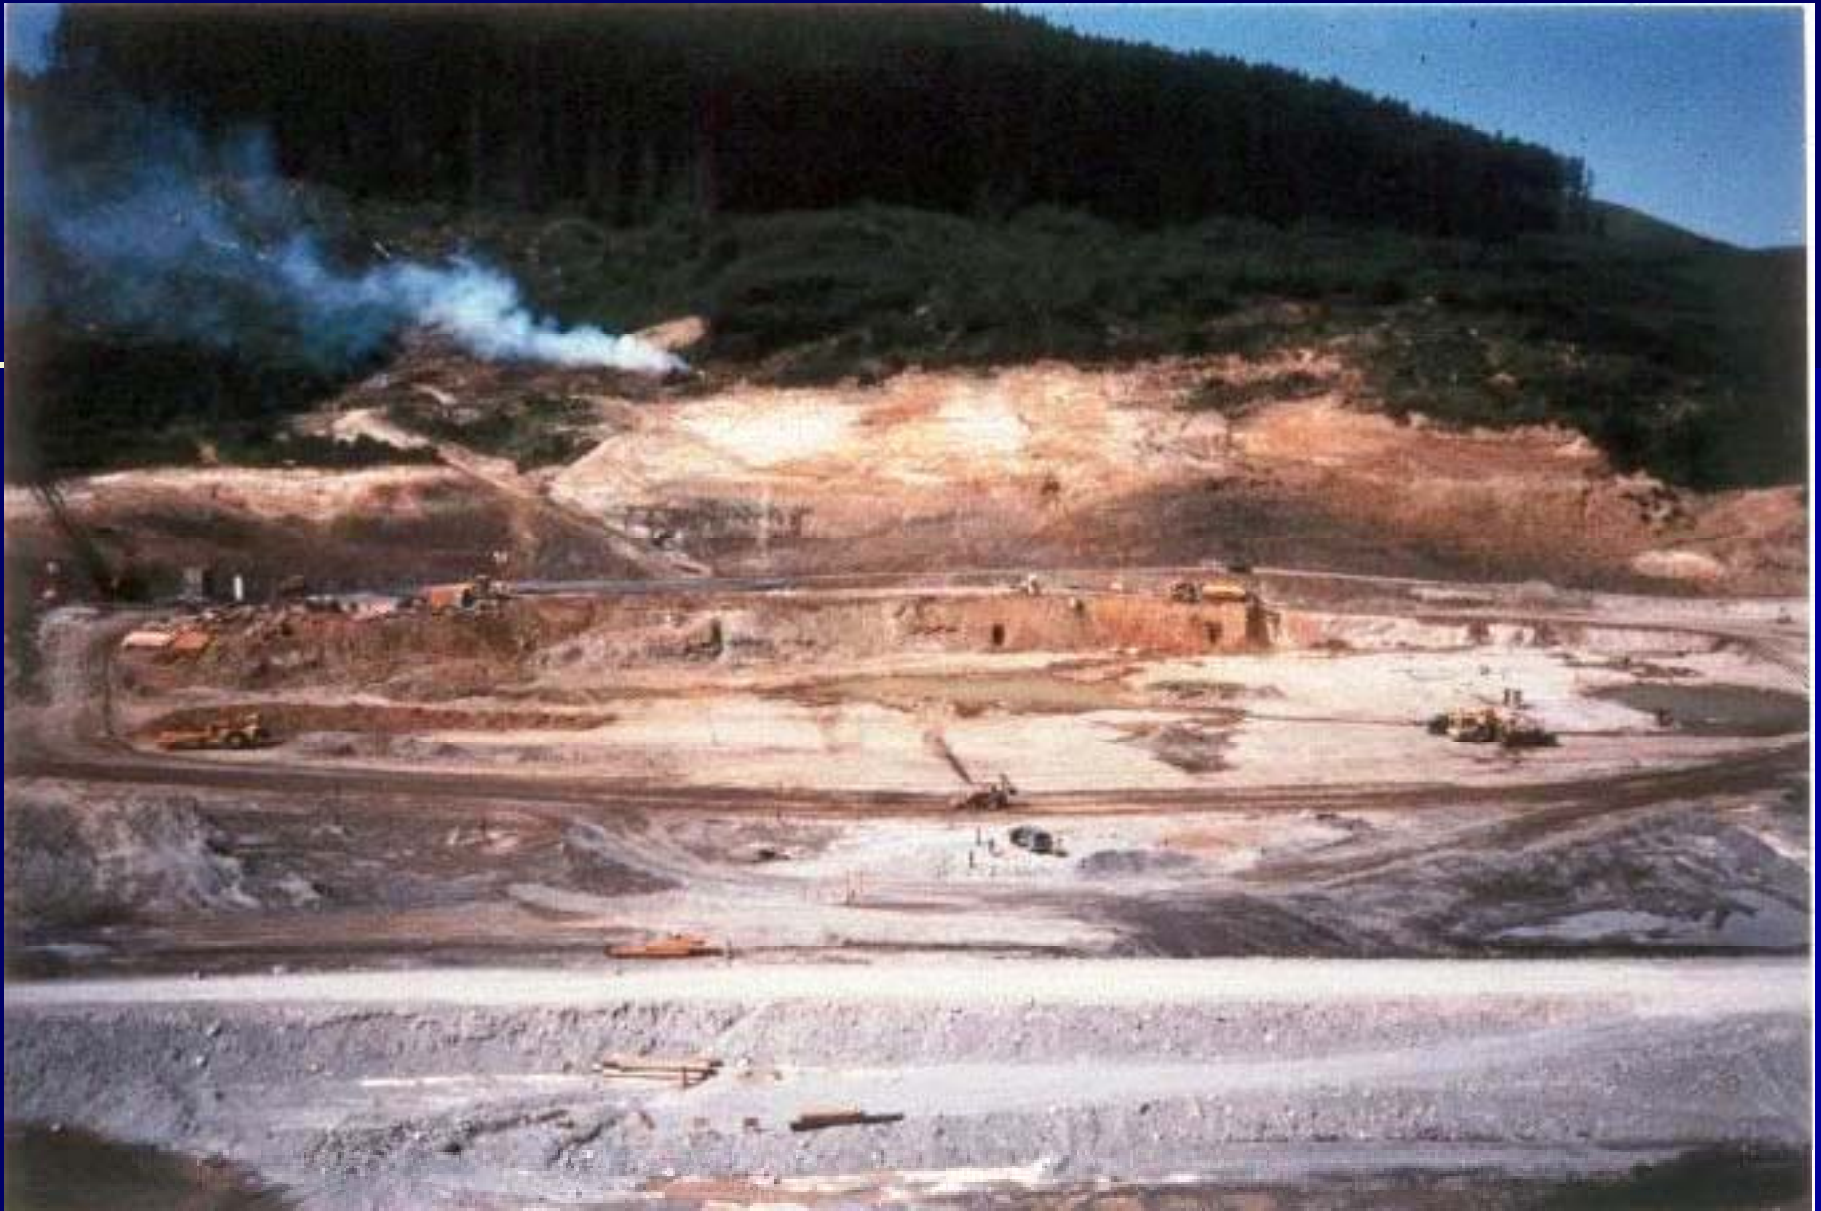
Left abutment area on June 30, 1987. Gravels and overlying fine-grained materials on cut slopes were source of handling and stockpiling problems during initial excavation.

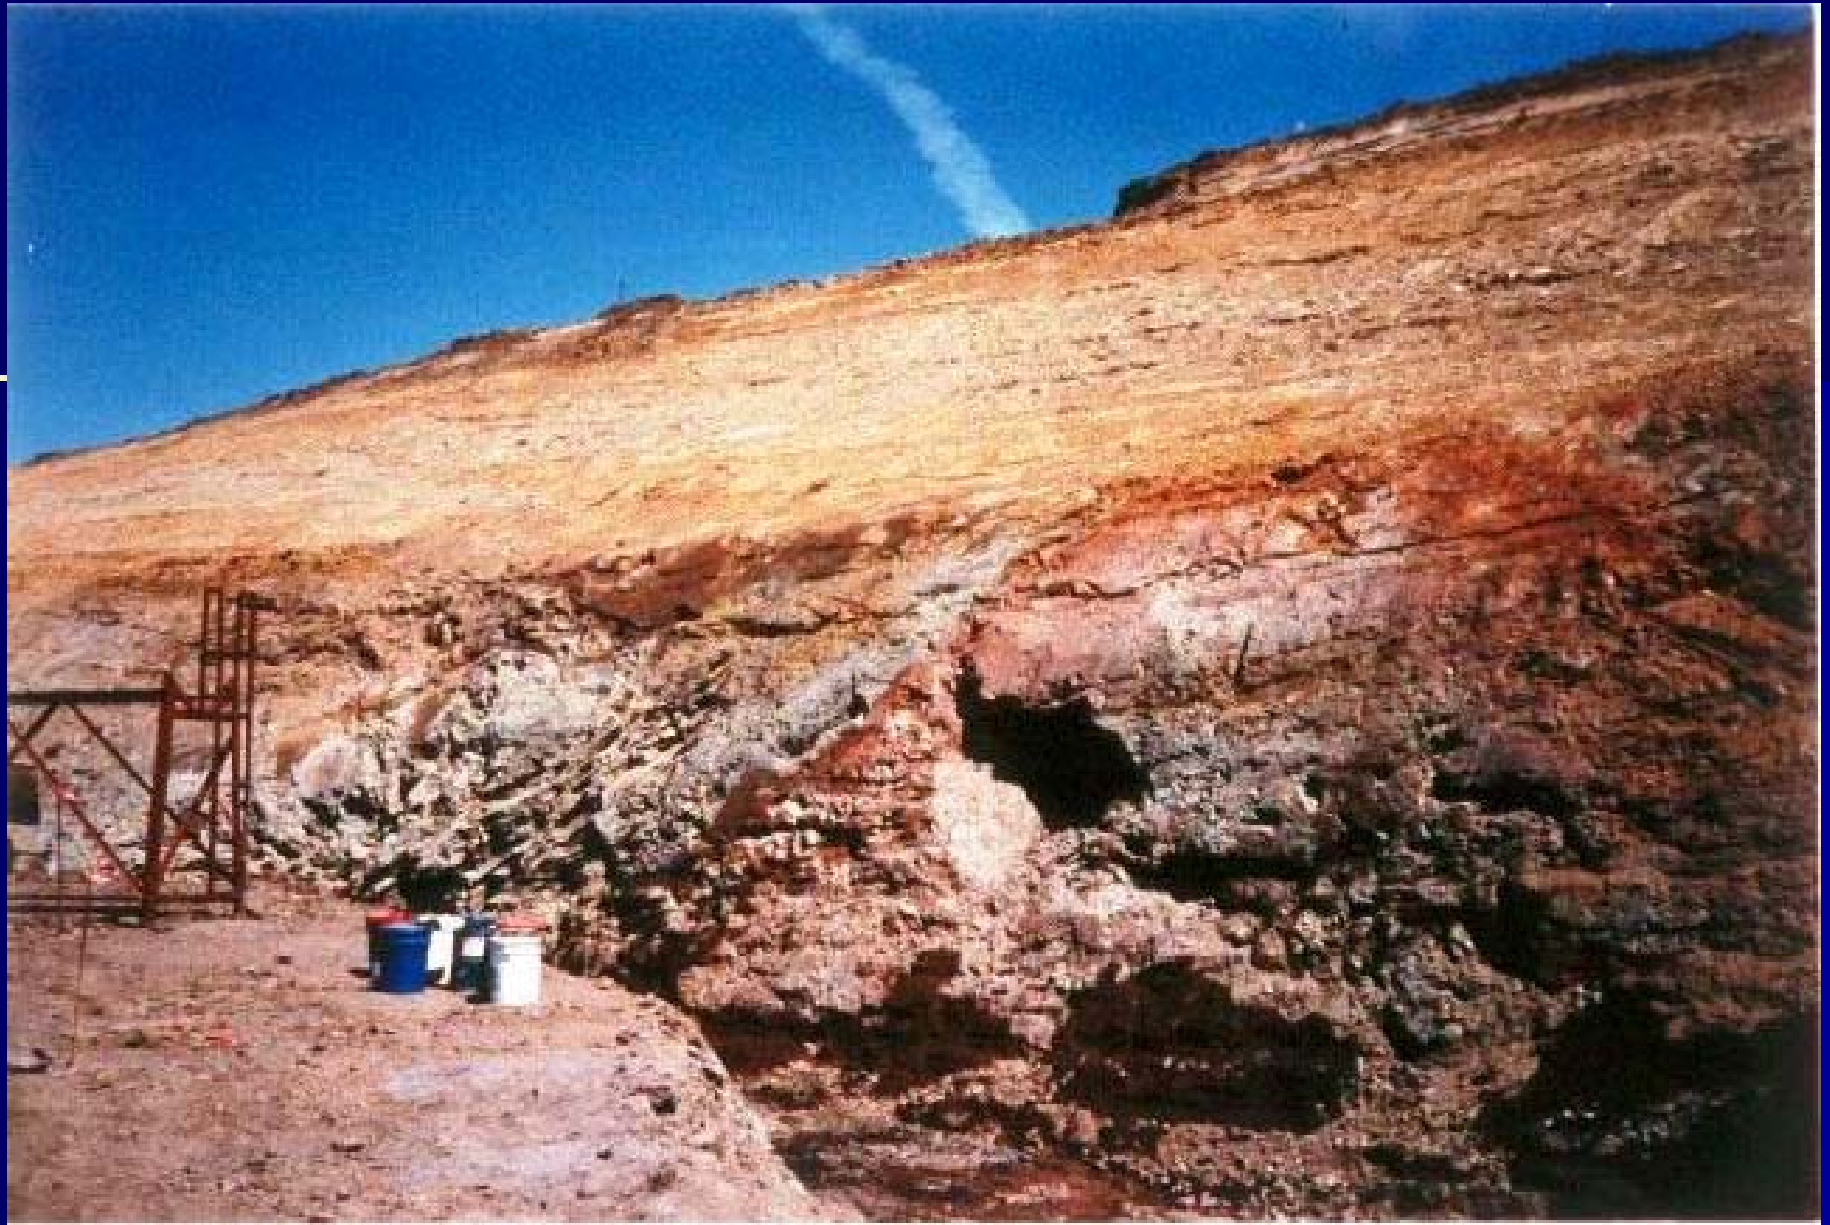
Right abutment area on June 30, 1987. Dark material at top is the "slimes", lighter material beneath is the impervious borrow, and the lower dark zone is the flow breccia.

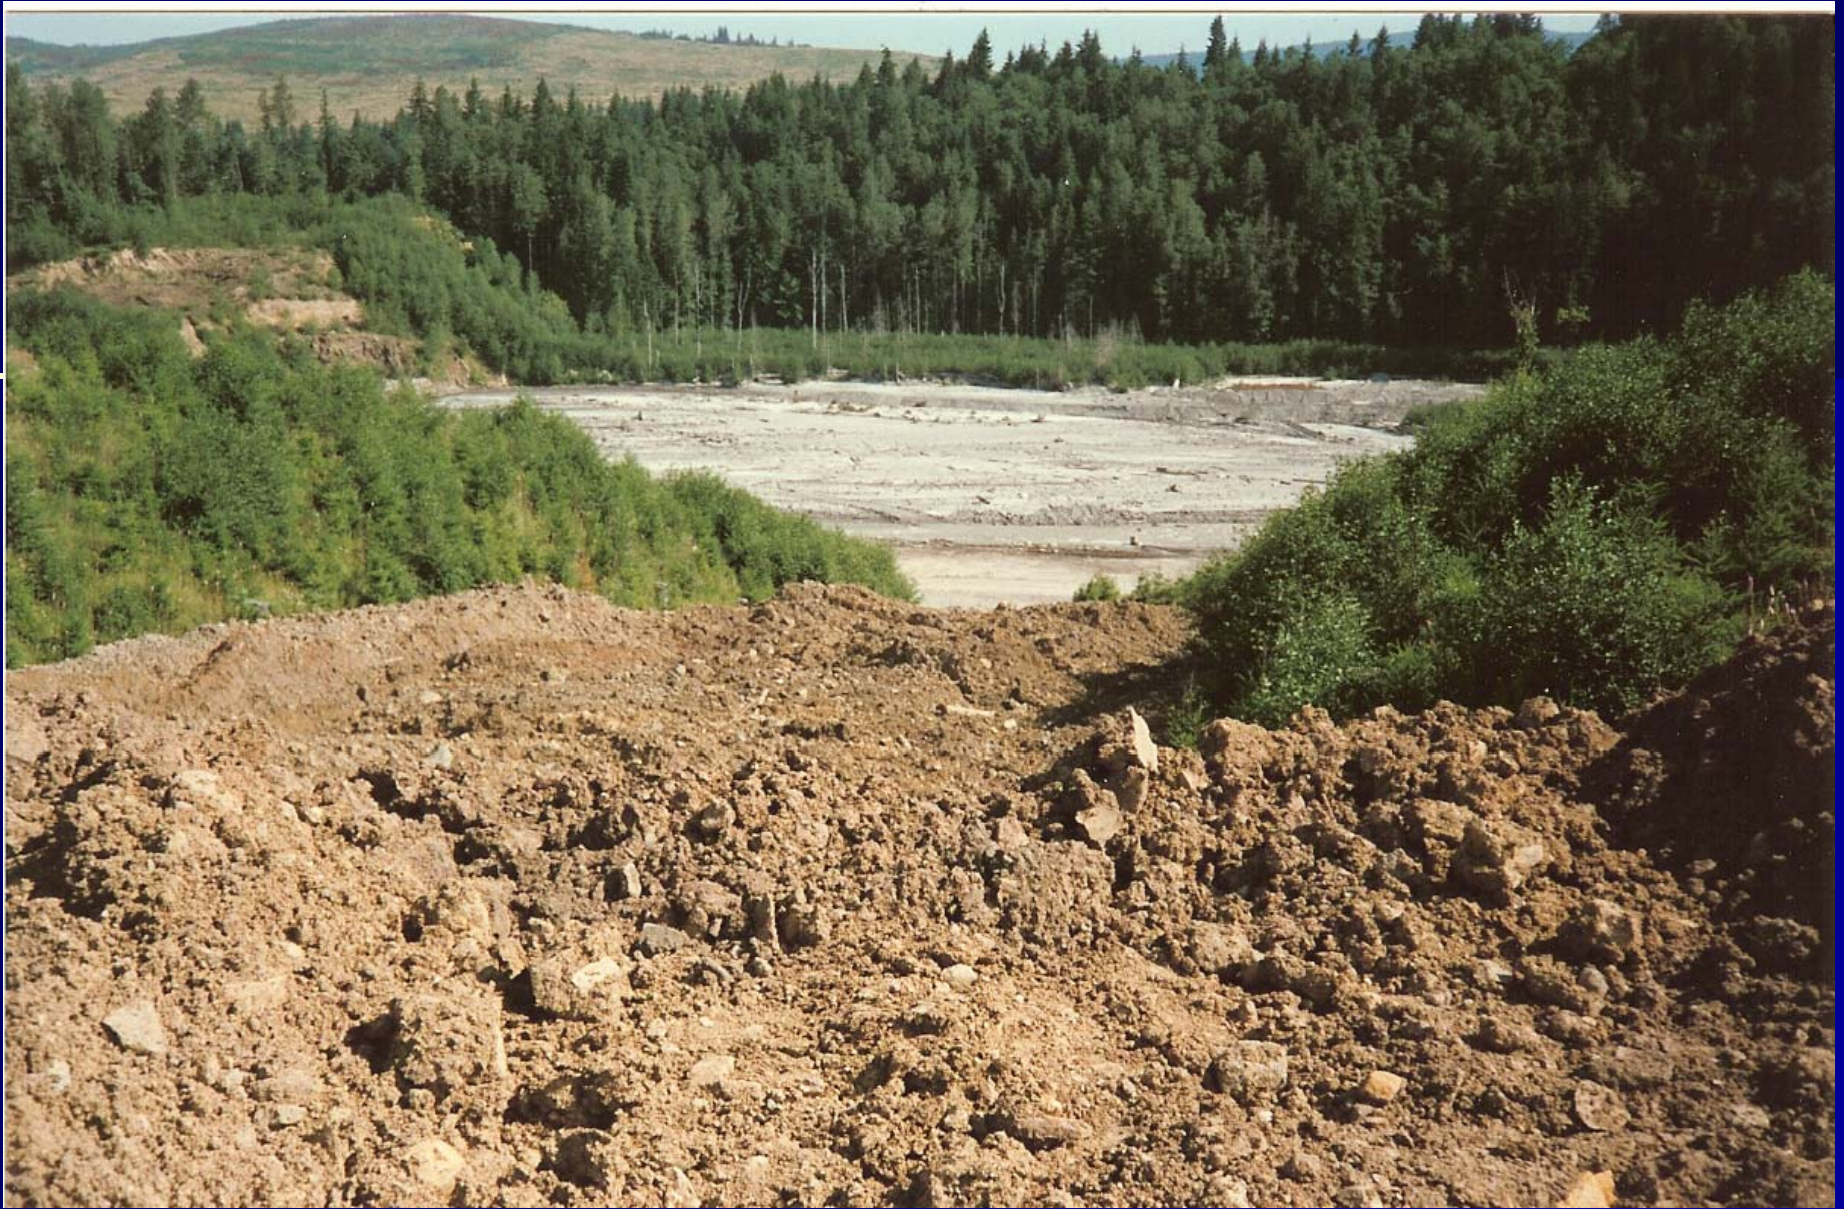
- Glacial drift gravel was soft and unstable during excavation and wet weather (had hoped to use it as a stable base) - would not support construction equipment.
- Stockpiled excavated material was unstable - flowed up to 500 ft (152 m) until stable slope at 2 - 5 degrees.
- Fine-grained sediments above gravels were unstable.
- Slimes in right abutment area unable to support construction equipment.
- In-situ water contents well above optimum.
- Right abutment impervious overburden, designated for use in core, softened during compaction and appeared wettest in areas subjected to heaviest construction traffic.
- Flow breccia exhibited slaking.

Unstable stockpile slope of old glacial drift gravels excavated from the left abutment area of the Mt. St. Helens Sediment Retention Structure.

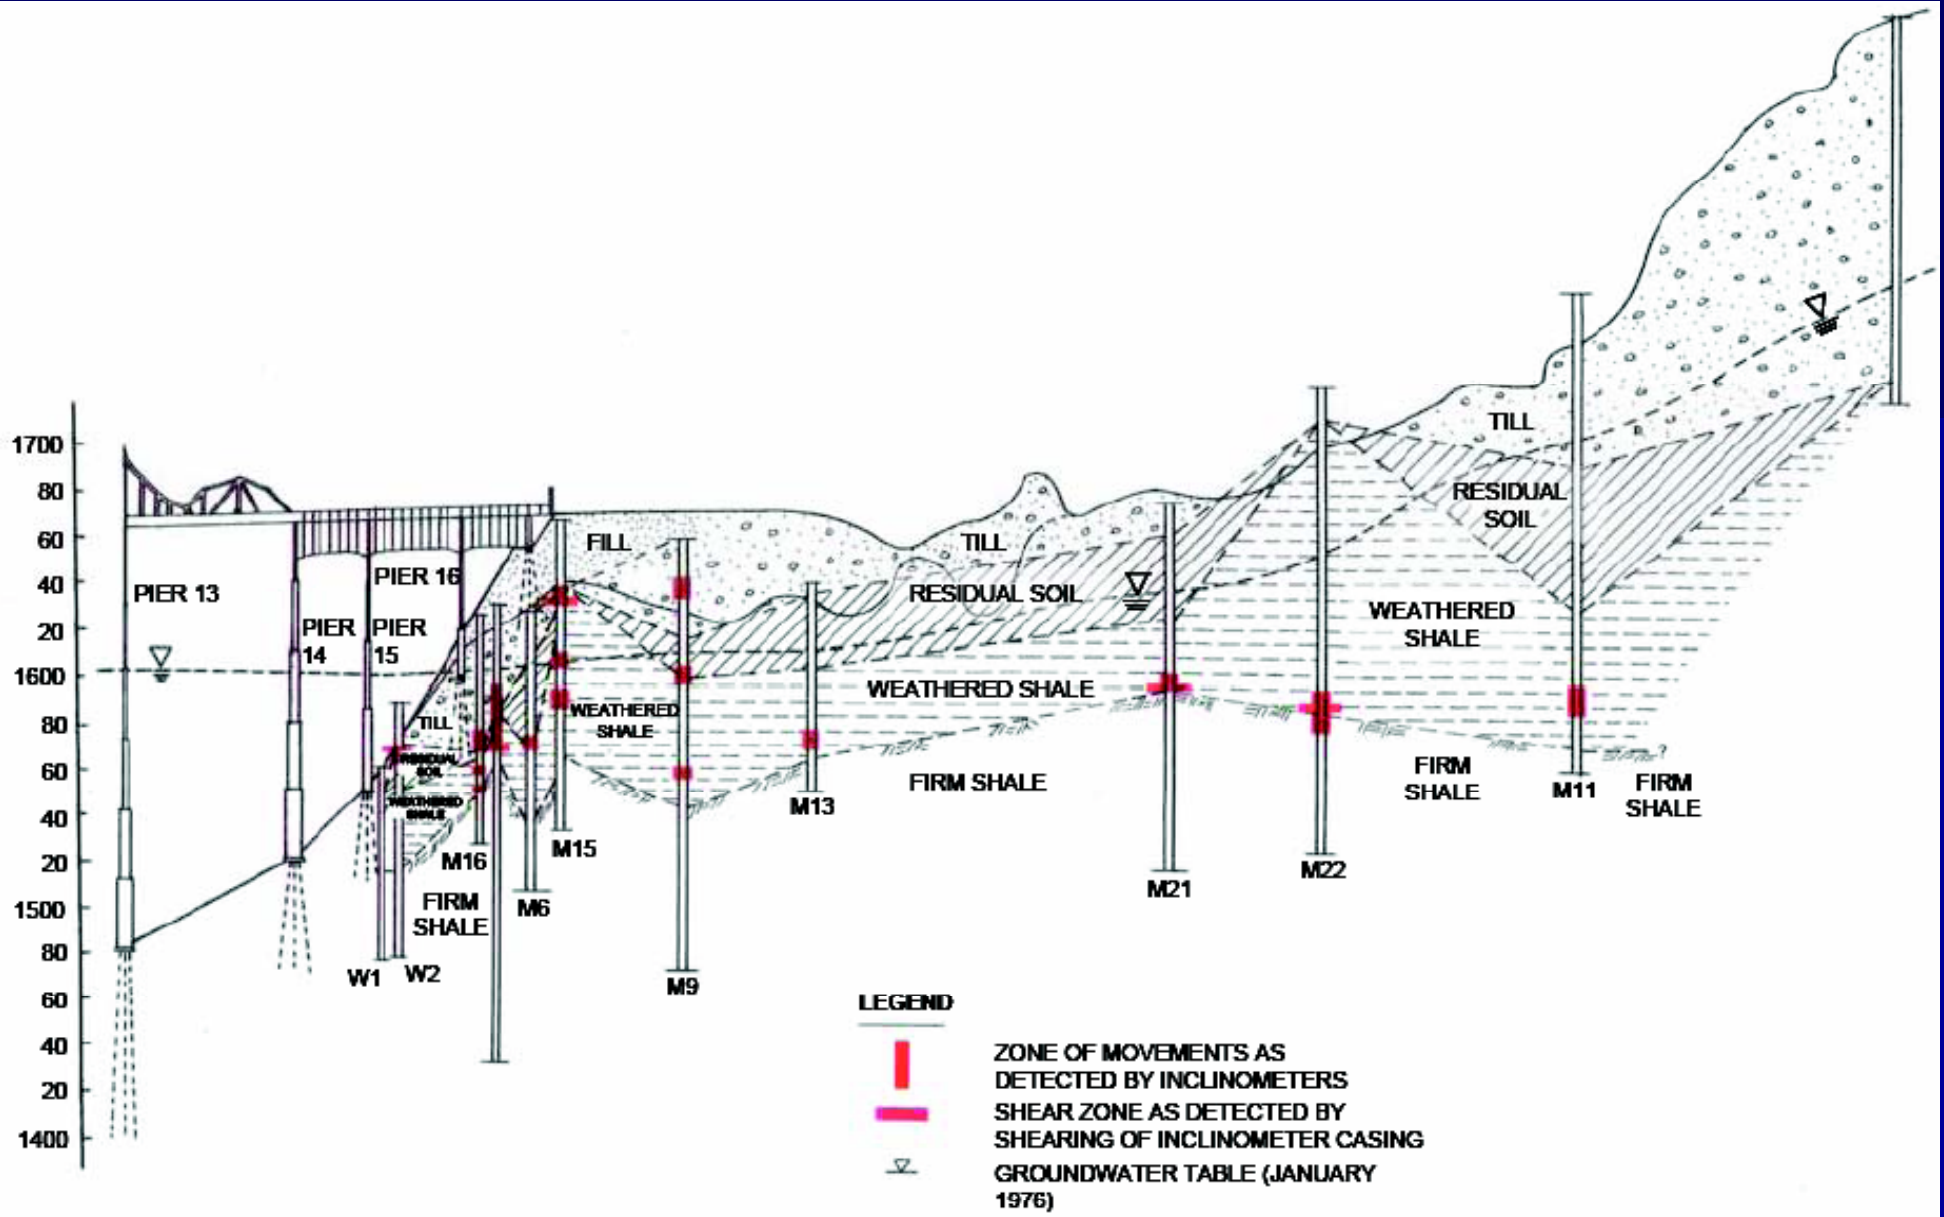
Materials and shear zones in vicinity of the south abutment

- Sliding occurred in the Pierre Shale.
- Pierre Shale in vicinity of the bridge is an overconsolidated smectite (montmorillonite/bentonite).
- Unloading and weathering led to internal fracturing, swelling, and strength loss.
- Progressive failures are common.
- Many slopes at F.S. near 1.0.
- Values of residual friction angle at Forest City are from 3.2 to 7 degrees.
- Bridge out to Pier 16, the south abutment, and approach road up to slide scarp were built on old slide initially at F.S. \approx 1.0.
- Rising water level reinitiated slide movements.

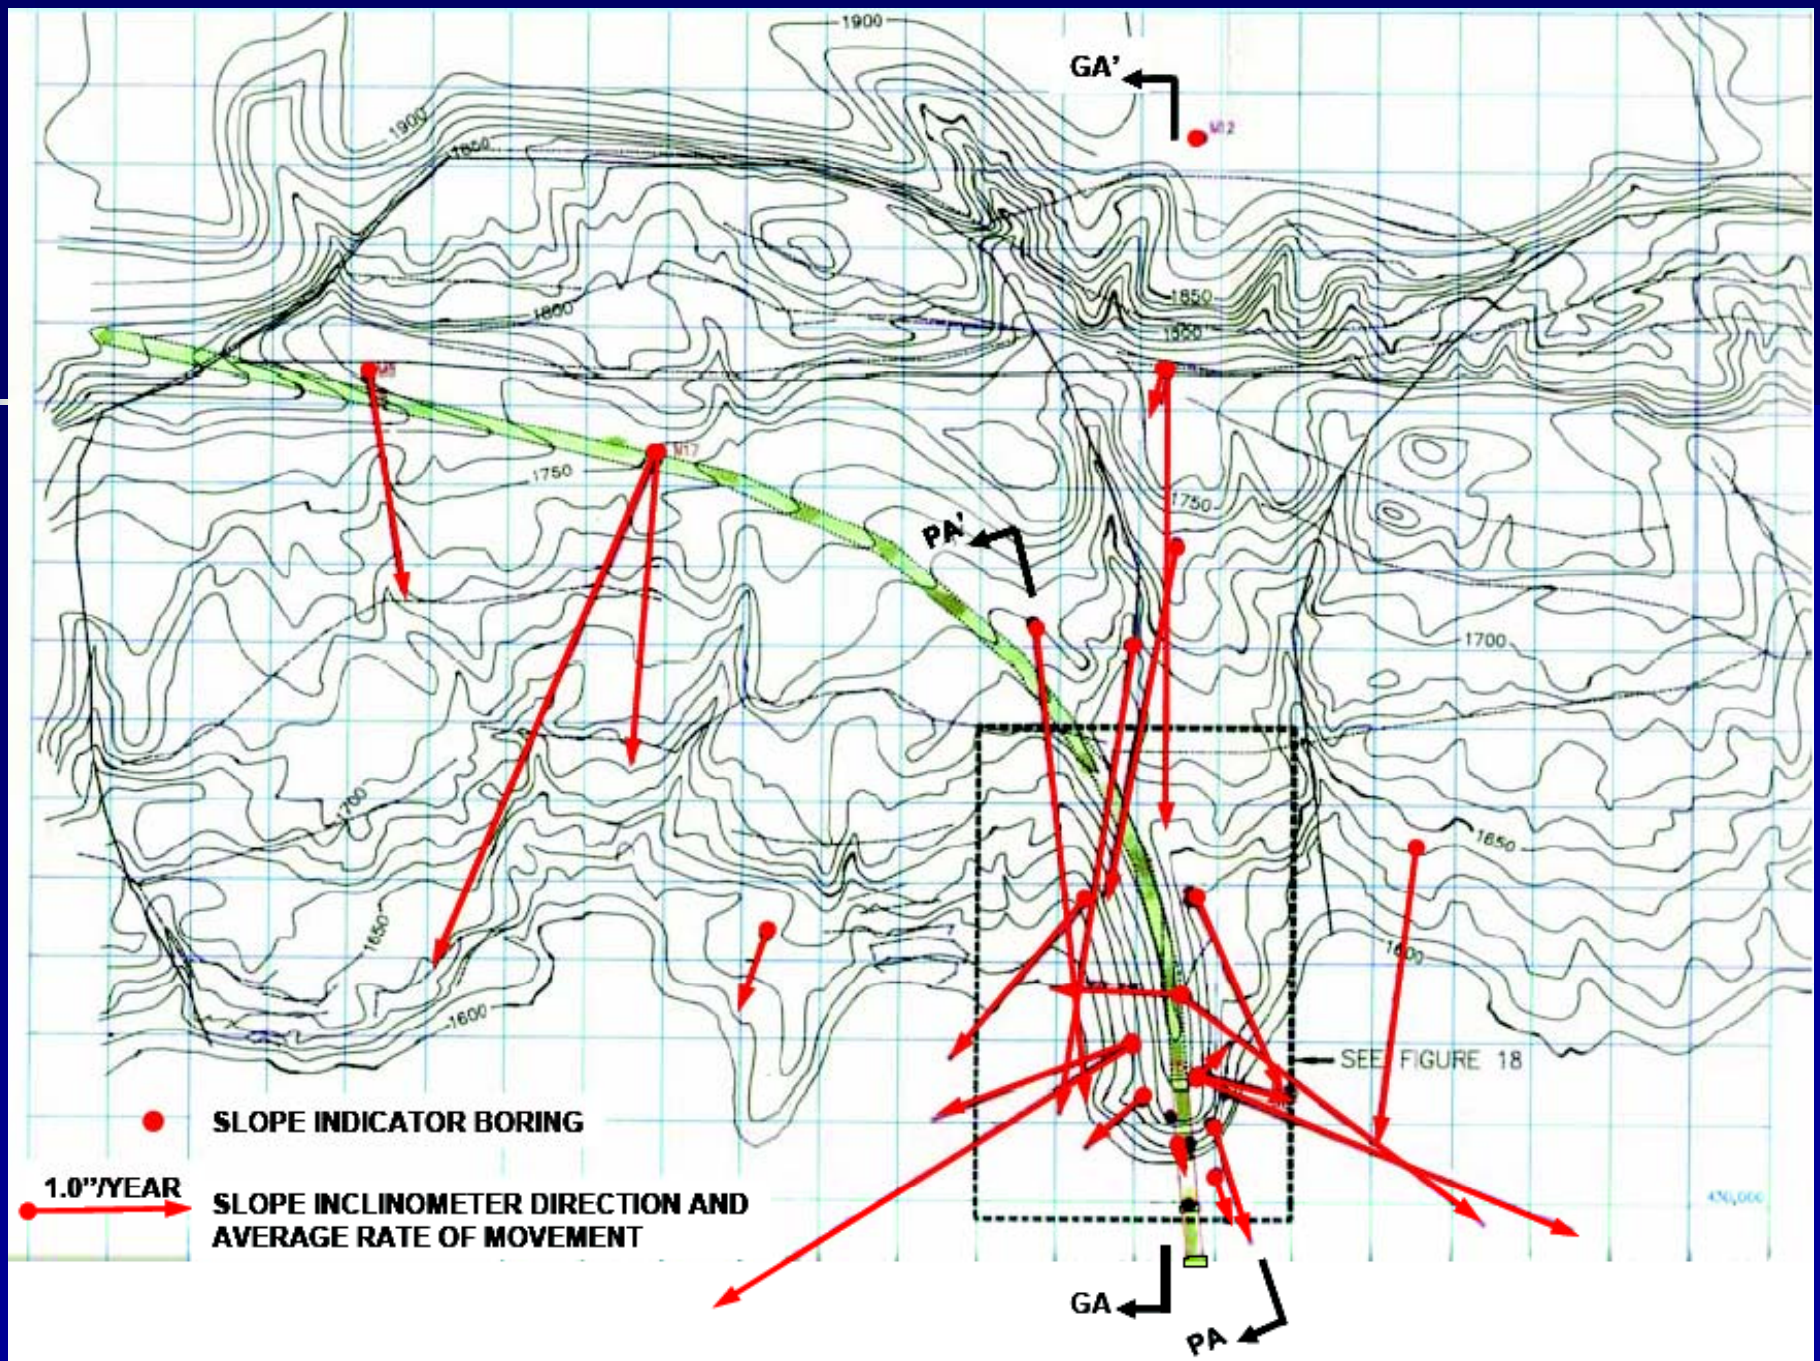
- Water level in slope rose when reservoir filling began.
- Local failures developed along shoreline and under approach embankment.
- Movement velocities up to a few inches per year were recorded.

Slide movement rates and directions during the mid-1980s

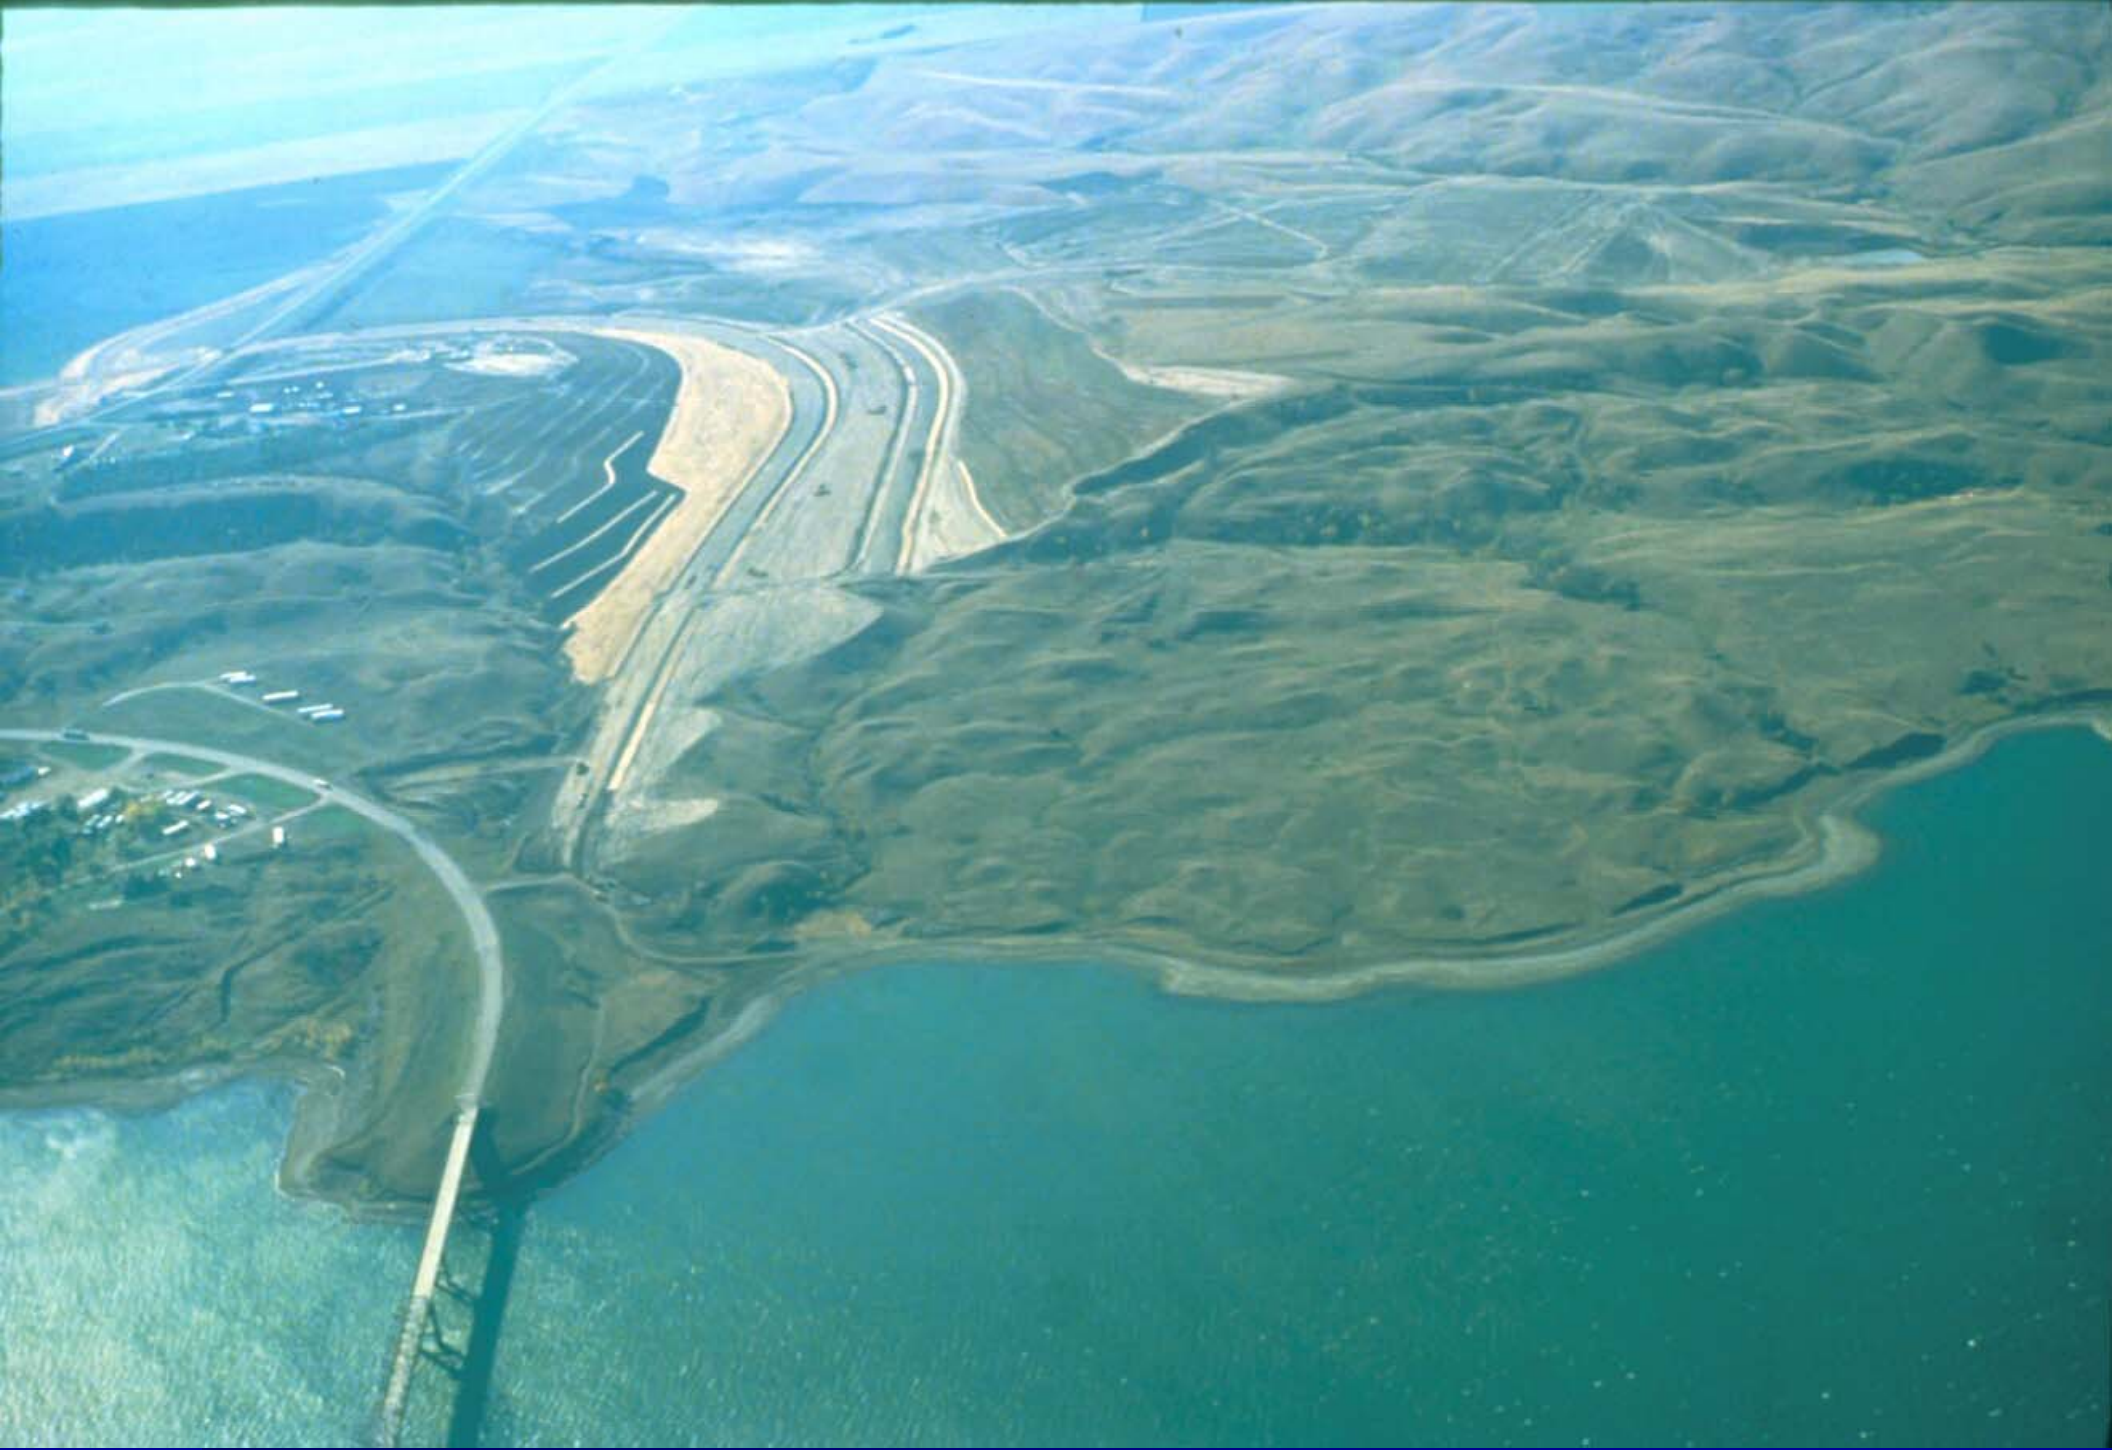
Excavation of slide near its head. (Slide courtesy of Vern Schaefer)

- In-situ reinforcement in 1993 to stabilize approach embankment in vicinity of south abutment.
 - Stone columns
 - RC dowels
 - Rip rap at toe to reduce erosion
- New corridor for the approach road excavated on 5 percent grade in 1994-1995.
- Stone column shear pins installed in 1998 around the approach embankment.
- Structural T's placed to reduce local approach embankment movements at bridge abutment.
