TROUBLESHOOTING PILE DRIVING PROBLEMS WITH A-GAME METHODS STGEC 2023

Jesse G Rauser, PE
Assistant Geotechnical Engineer Administrator
LADOTD

LA 75 - BAYOU BREAUX BRIDGE

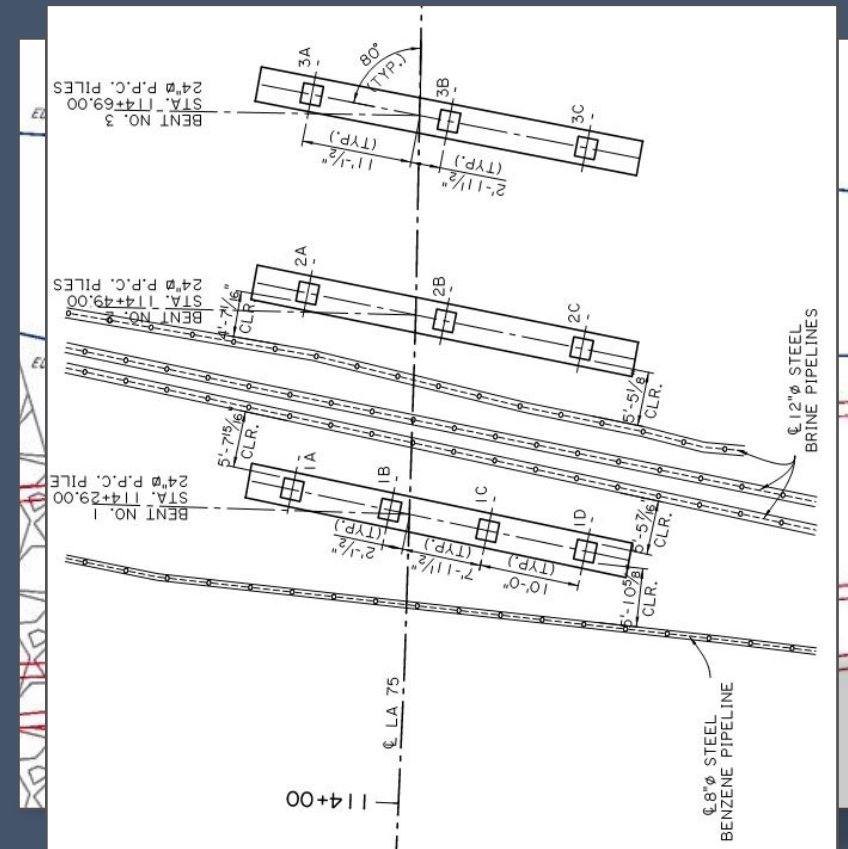
Pipeline Survey: Plan Set

- DOTD Geotech was asked to evaluate:
 - Relocating Bent 2 approx. 5' towards Bent 1
 - Feasibility of driving piles at Bent 1
- A second pipeline survey was ordered
 - Plan set survey shows:
 - 3 brine lines between Bents 1 & 2
 - 1 benzene line downstation of Bent 1
 - New survey shows:
 - 1 line between Bents 2 & 3
 - 2 lines between Bents 1 & 2
- Results do not match plans
 - More uncertainty!

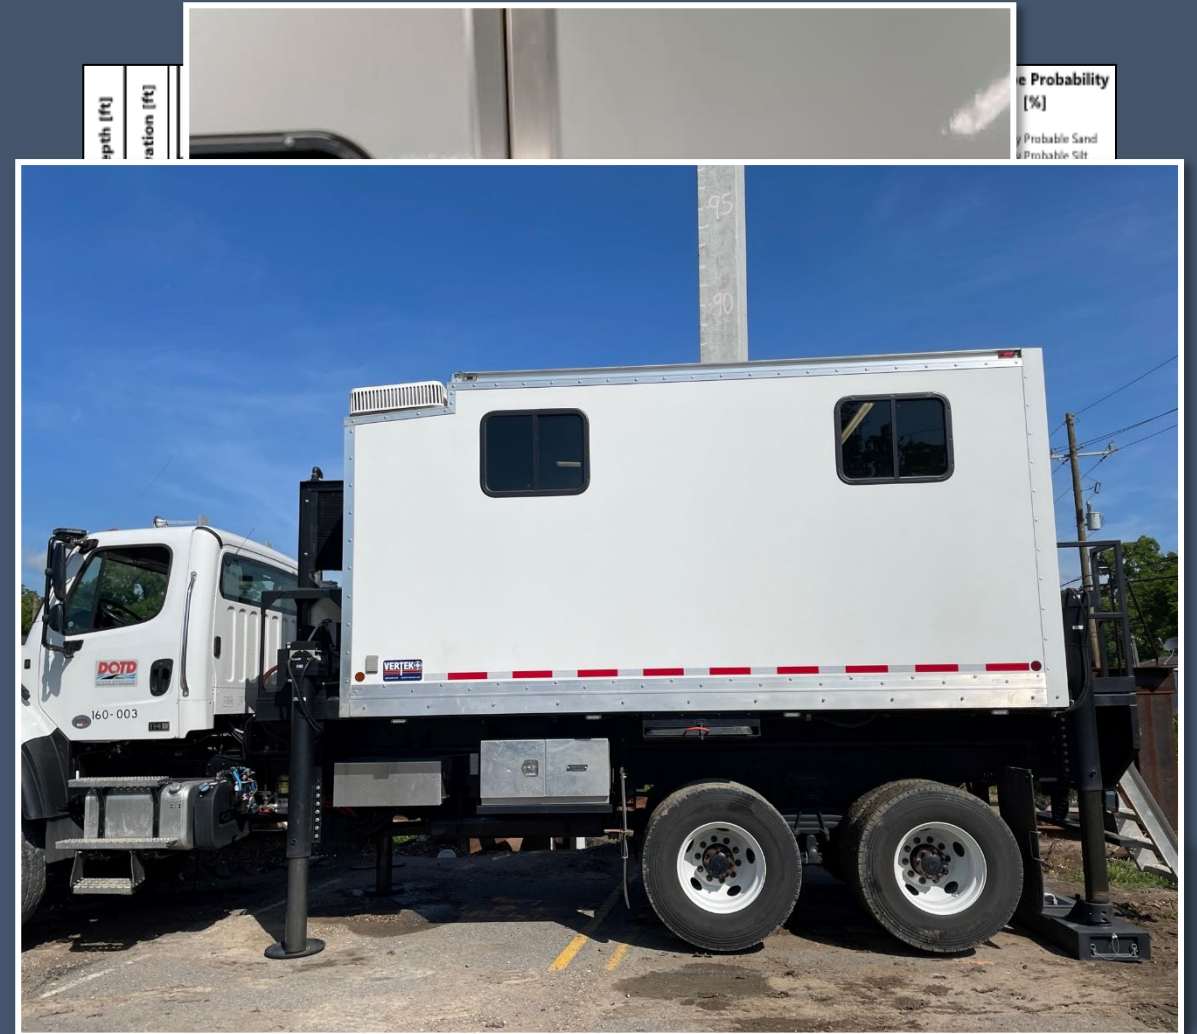
LADOTD CPT Rig
CPT Sounding Data
Cone with Dummy Tip

- Pushed 2 CPTs at Bent 1 (20' away)
- One with dummy tip for obstructions
 - No obstruction found with dummy tip
- One CPTu sounding to confirm stratigraphy
 - No obstruction found with the CPT probe
- CPT rig could not get close to Bent 2
 - Still uncertainty regarding offset option

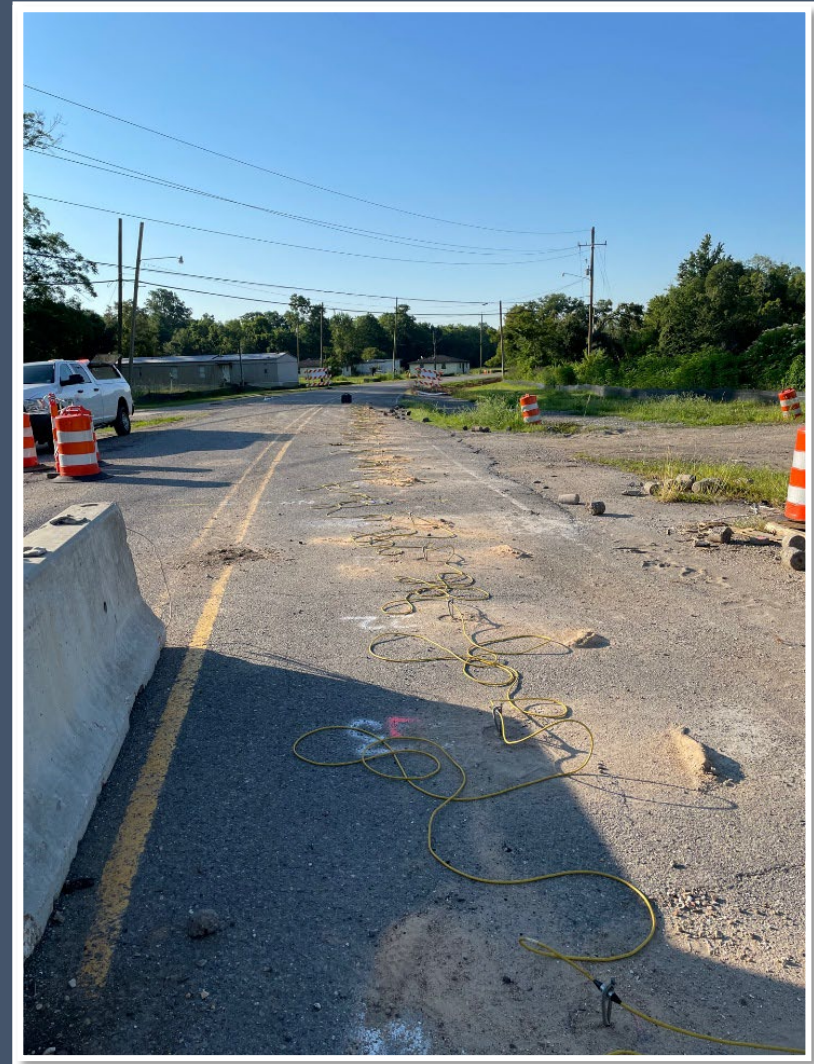
Survey of South Ave (for on bridge)

- Hired a consultant to perform ER survey
- Laid out two lines at ~270' each
 - Try to pass on 2 sides of cracked pile
- Max. depth approx. 70'
- LADOTD drill crew cored roadway & backfilled holes with sand
- Sand was wetted prior to ER testing

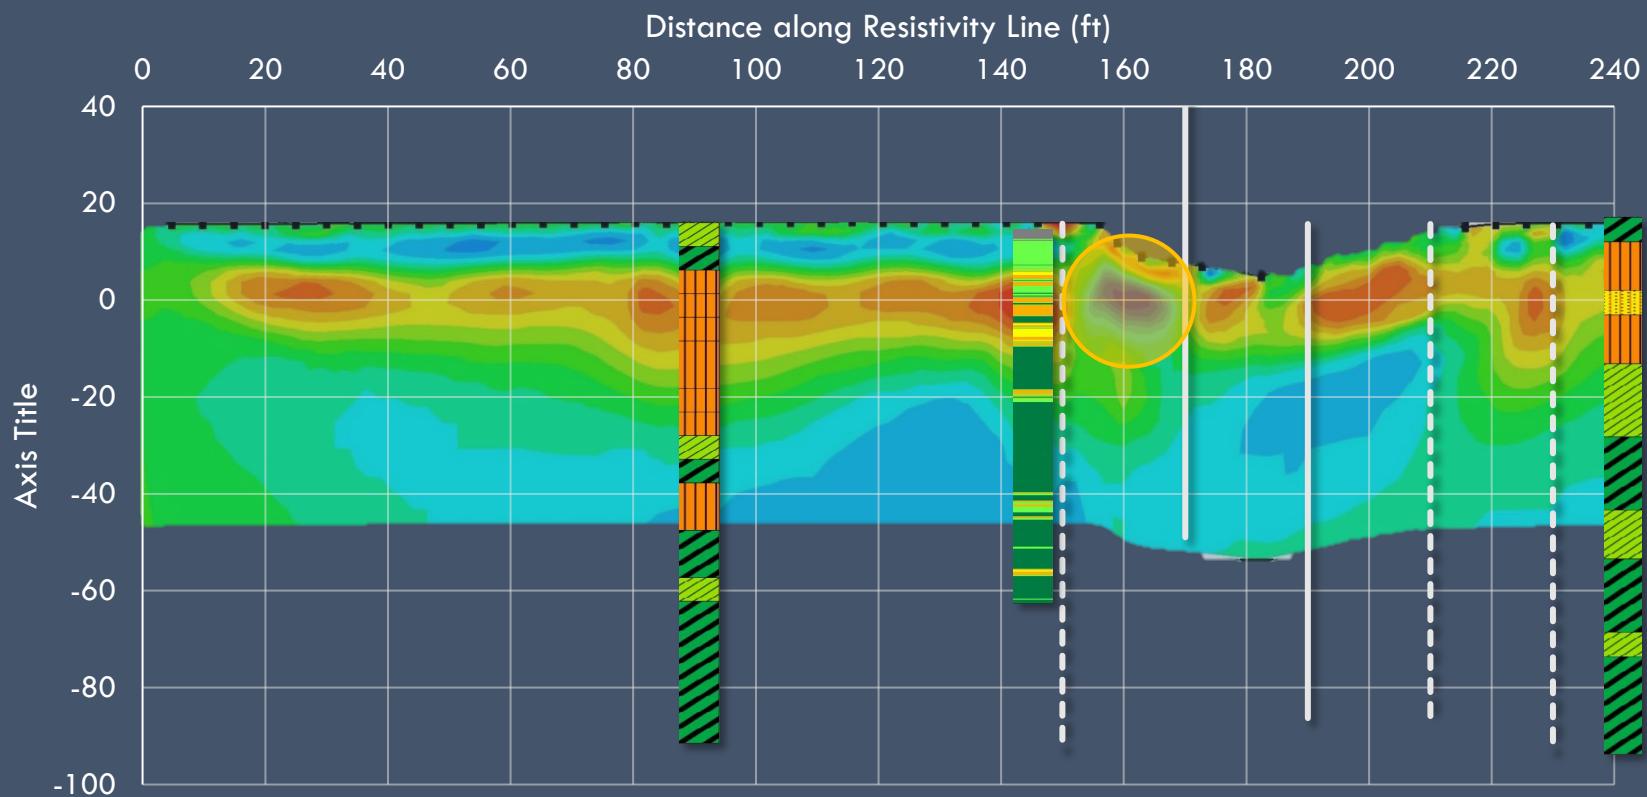
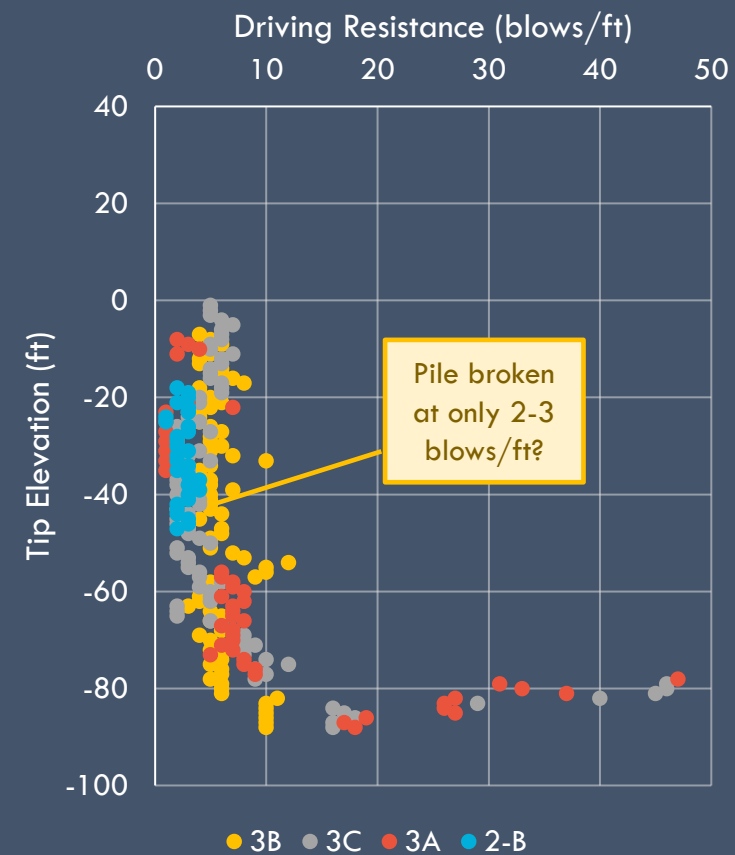
ER SURVEY RESULTS

- Piles in Bent 1 can be driven
- Do not relocate Bent 2
 - ER survey shows discontinuity in the sand stratum
 - Could be leaking pipe or clay backfill?
- Attempt to redrive damaged pile another ~10 feet, then cut off
 - Surveys confirm no lines at this location
 - No evidence of dense layer or obstruction in the pile driving logs
 - Should be soft clays – can we remobilize it before completely breaking it?
- Redesign Bent 2 to accommodate additional piles
 - No evidence of dense layer or pipeline in ER survey
 - Inspector later told us pile driving crew argued about breaking the pile before it happened!
 - Did the Contractor use pipeline concerns as an excuse to buy time?

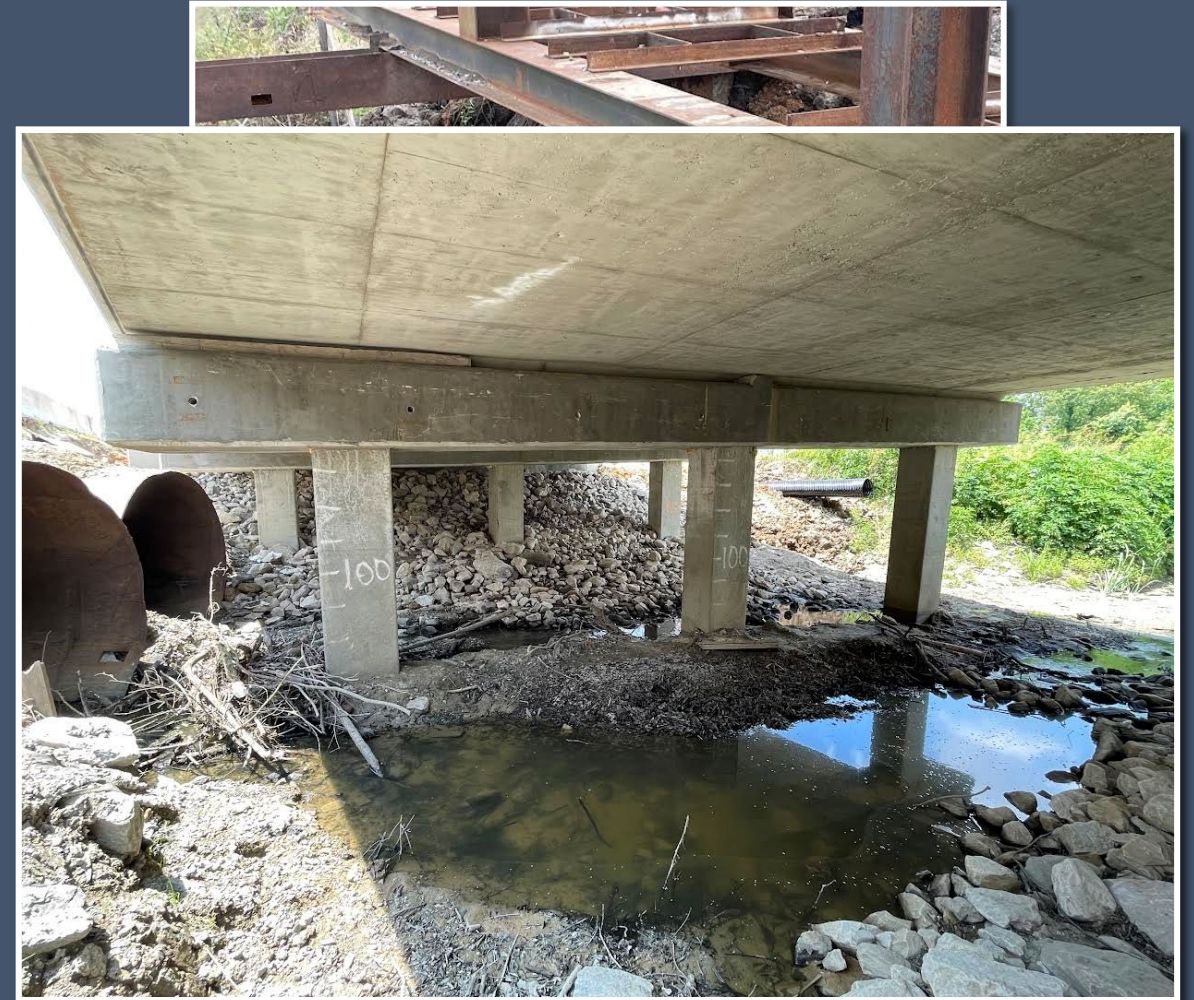
Underneath of Concrete Bridge

Abandoned Broken Pile

- Pile Driving Analyzer (PDA) was added to monitor the stresses on the piles
- Bent 2 was redesigned from a three-pile bent to a four-pile bent
 - The piles were all driven to grade at Bent 2 without hitting any “obstructions” or damaging the piles
- The damaged pile was cut-off at the ground surface, re-driving the pile was deemed unsafe
