Date & Time: Tue May 19 16:25 47 EDT 2020 Position: 036°53'59,3"N &083°20'27.3"W Altitude: 2028ft Datum: WGS-84 Azimuth/Bearing: 261° S81W 4640mils (Trué) Zoom: 1X US 421 MP 22.88 Slide Repair

- Slope failed following a February 2019 storm event for which Kentucky received a Presidential Disaster Declaration.
- The Kentucky Transportation Cabinet (KYTC) worked with the Federal Highway Administration (FHWA) to use a repair eligible for FHWA Emergency Relief (ER) Funding.
- KYTC and FHWA agreed that a permanent rock-anchored tieback wall with soldier piles embedded into bedrock was acceptable for ER funding.

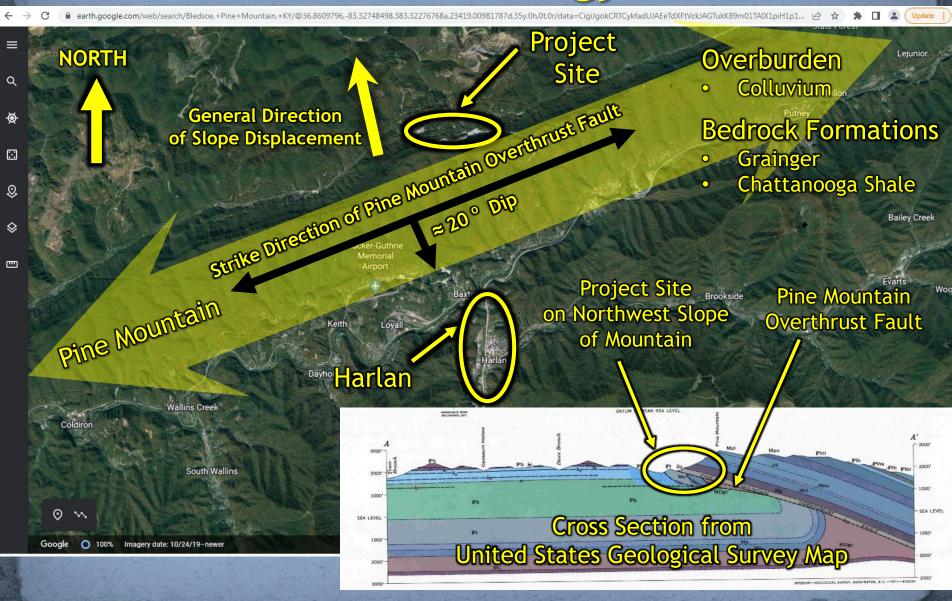
## Site Geology

Overburden generally described as brown and gray moist clay with rock fragments, cobbles; floaters and boulders

- Bedrock Consists of Chattanooga & Grainger Shale Formations
  - Compressive Strength 50 to 6000 psi (Avg ≈ 2000 psi)
  - KY Modified Rock Quality Designation 0 to 94 (Avg ≈ 12)
  - Slake Durability Index 7 to 100 (Avg ≈ 74)

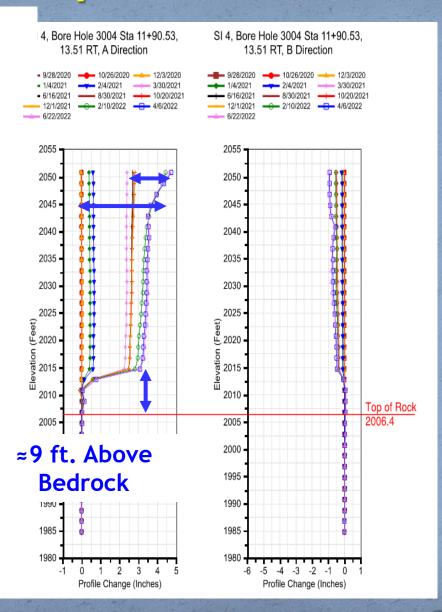
## Typical Slope Inclinometer Plot

6/16/2021 To 6/22/2022

≈2 in. Displacement

≈5 in. Displacement Total

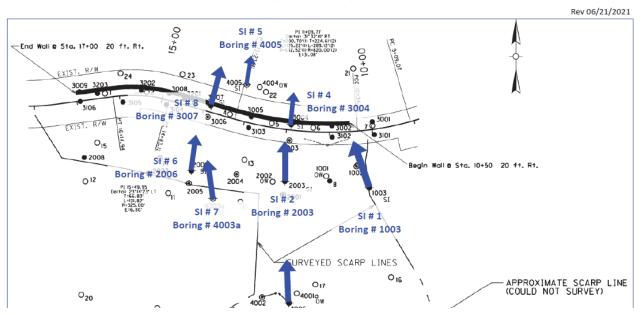
## Measured Slope Displacements

#### Displacements Along Apparent Failure Surface

Arrow Sizes are Approximately Proportional to Displacement Magnitudes
Arrows Indicate Approximate Displacement Directions

- Measured Displacements (before letting)
  - ≈ 2 to 4 inches
  - Varied from ≈ 4 to 15 ft. above bedrock
- Size of arrows approximately proportional to displacement magnitude
- Direction of arrows approximately in resultant direction of movement

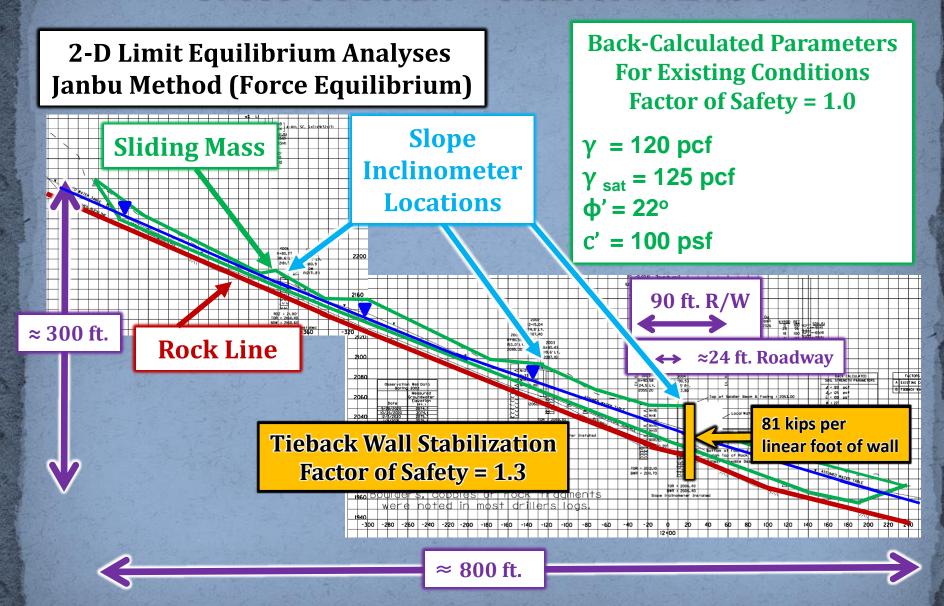
#### **Cross Section - Station 12+00**

## **Approximate Extents of Sliding Mass**

earth.google.com/web/@36.89965918,-83.34068607,627.65378821a,614.42286181d,35y,128.73118552h,60t,0r **NORTH Rock Quarry** 800 ft. Lateral Distance ≈ 300 ft. Elevation Change **US 421** ≈ 700 ft. Longitudinal Distance

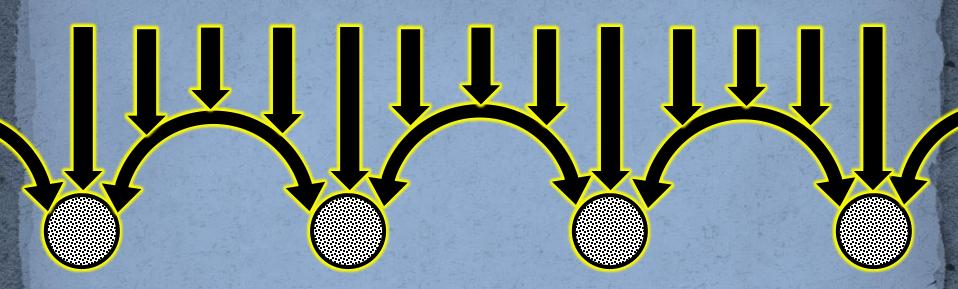
### Soil Arching below wall facing down to sliding surface

#### Maximum Soldier Pile Spacing Constraints:

#### Max. Allowable Center-to-Center Spacing:

B = diameter of soldier pile concrete backfill from the bottom of lagging to top of rock (ft.)

$S_{max} = 3.5 B$ Station 10+50 to 14+50:

S<sub>max</sub> = maximum center-to-center spacing between

Station 14+50 to 16+00:  $S_{max} = 3.0 B$

soldier pile concrete backfill (ft.)

Station 16+00 to 17+00:  $S_{max} = 3.5 B$
