US-701 Bridge Damage due to Landslide Emergency Response, Movement Monitoring, and Stabilization

US 701 BRIDGE OVER CAPE RIVER

- Geotechnical Investigation and Emergency Response
- Bridge Repair vs Replacement

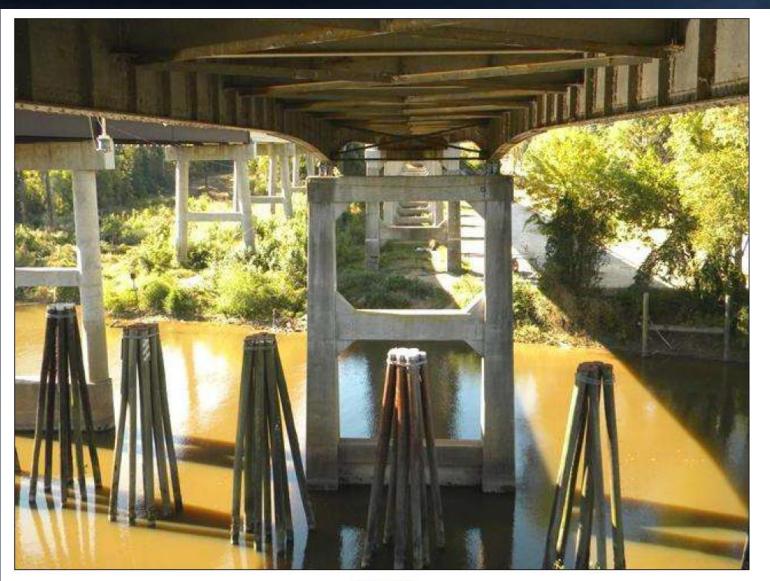
Original 1930's Span

Non redundant fracture critical

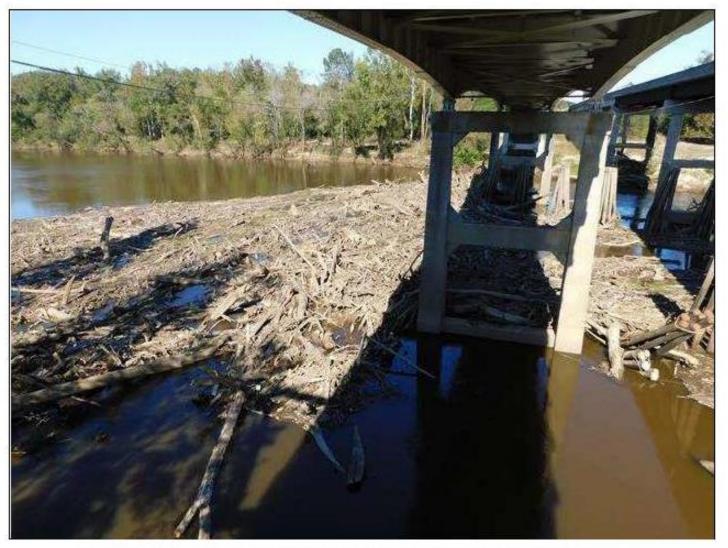
DRIFT DEBRIS PROBLEM

250' x 250' x 20' deep dirt and debris on upstream end of Spans 9-11 (PM)

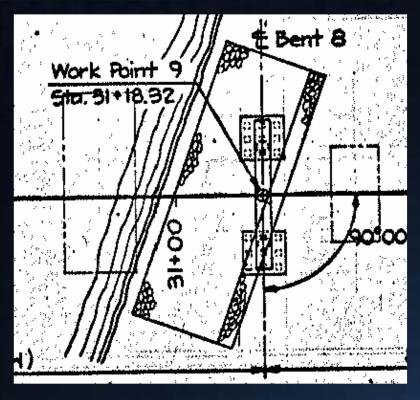
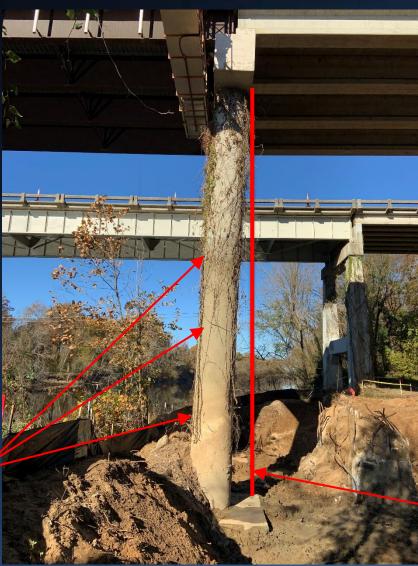
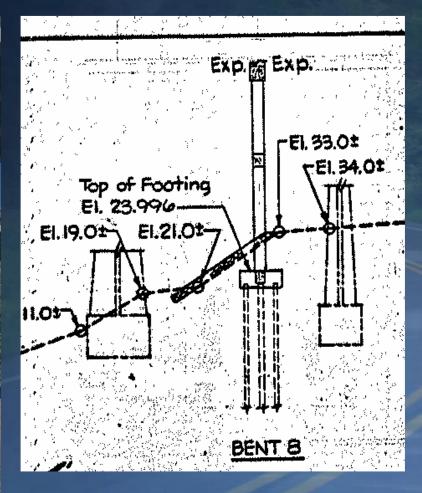
DAMAGED BENT

21" Displacement

Tension Cracks
on Both Columns

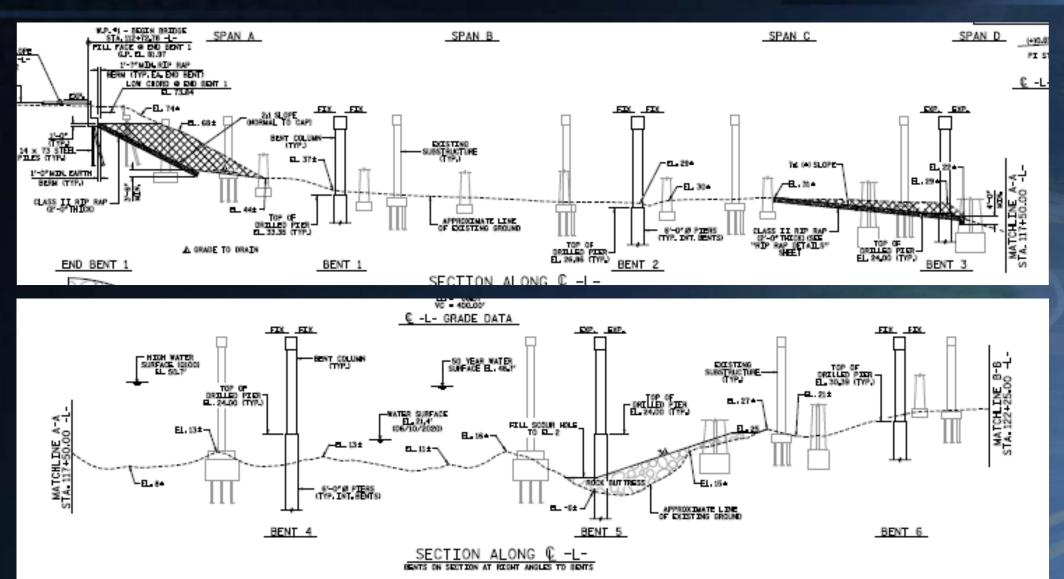
COMPLETE REPLACEMENT

TOTAL BRIDGE LENGTH = 1218 FT

7 INTERIOR BENTS

4 DRILLED PIERS PER BENT
