**Landslide Stabilization  
Blue Ridge Parkway MP 400.8**

**Brian K. Banks, PG  
Pamela Patrick, PE**

**STGEC  
October 5, 2010**

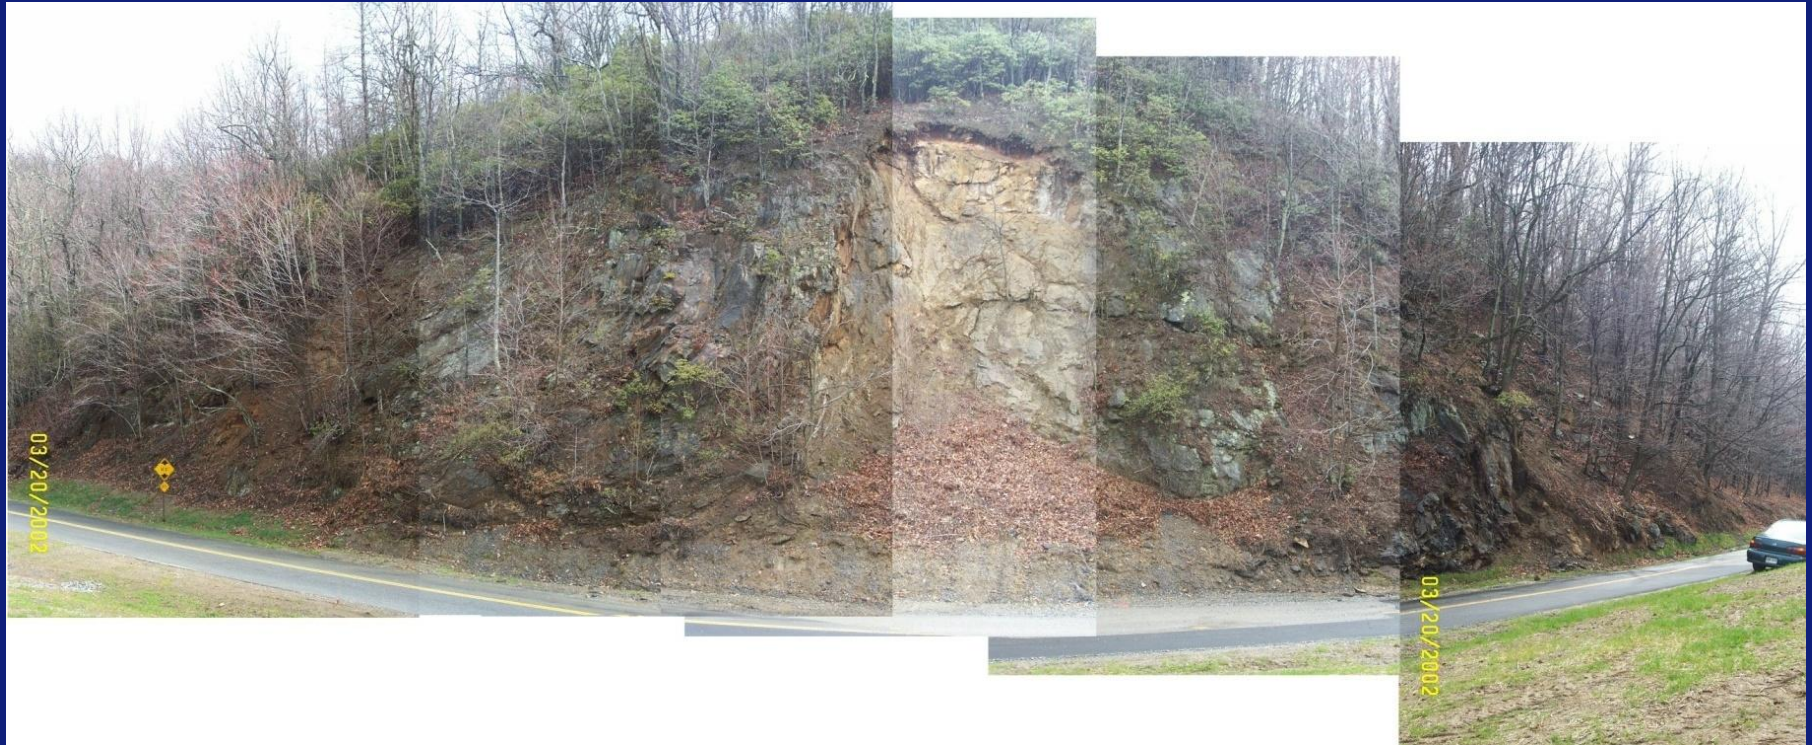
# Landslide History

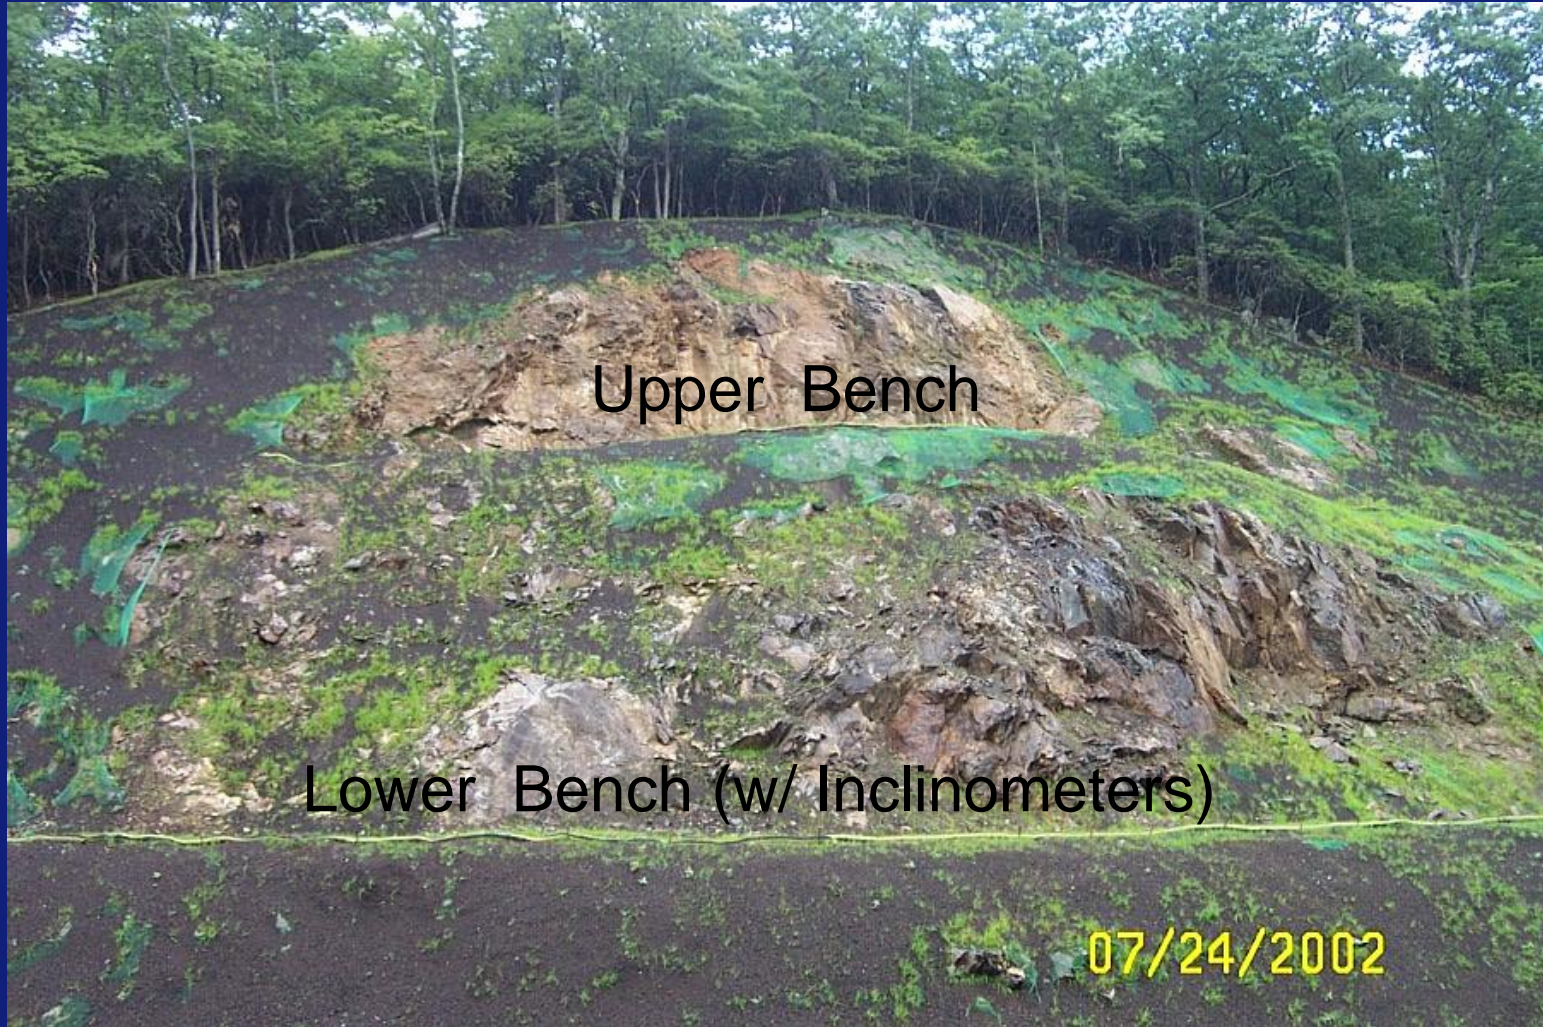
# Initial Slope Repair

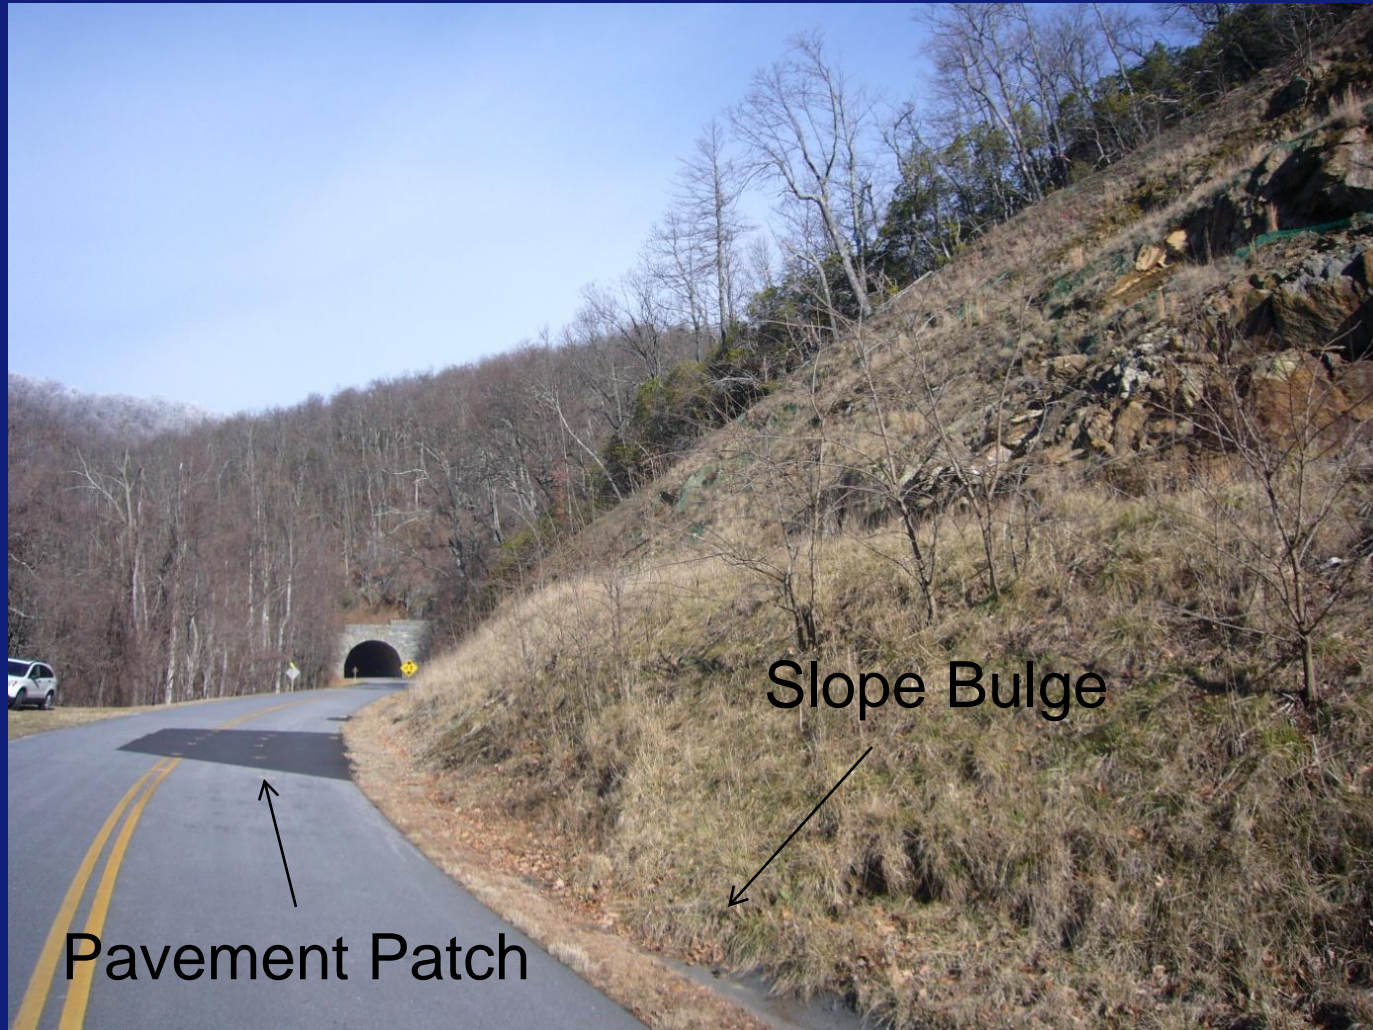
# Continued Movement

Pavement Patch

Slope Bulge

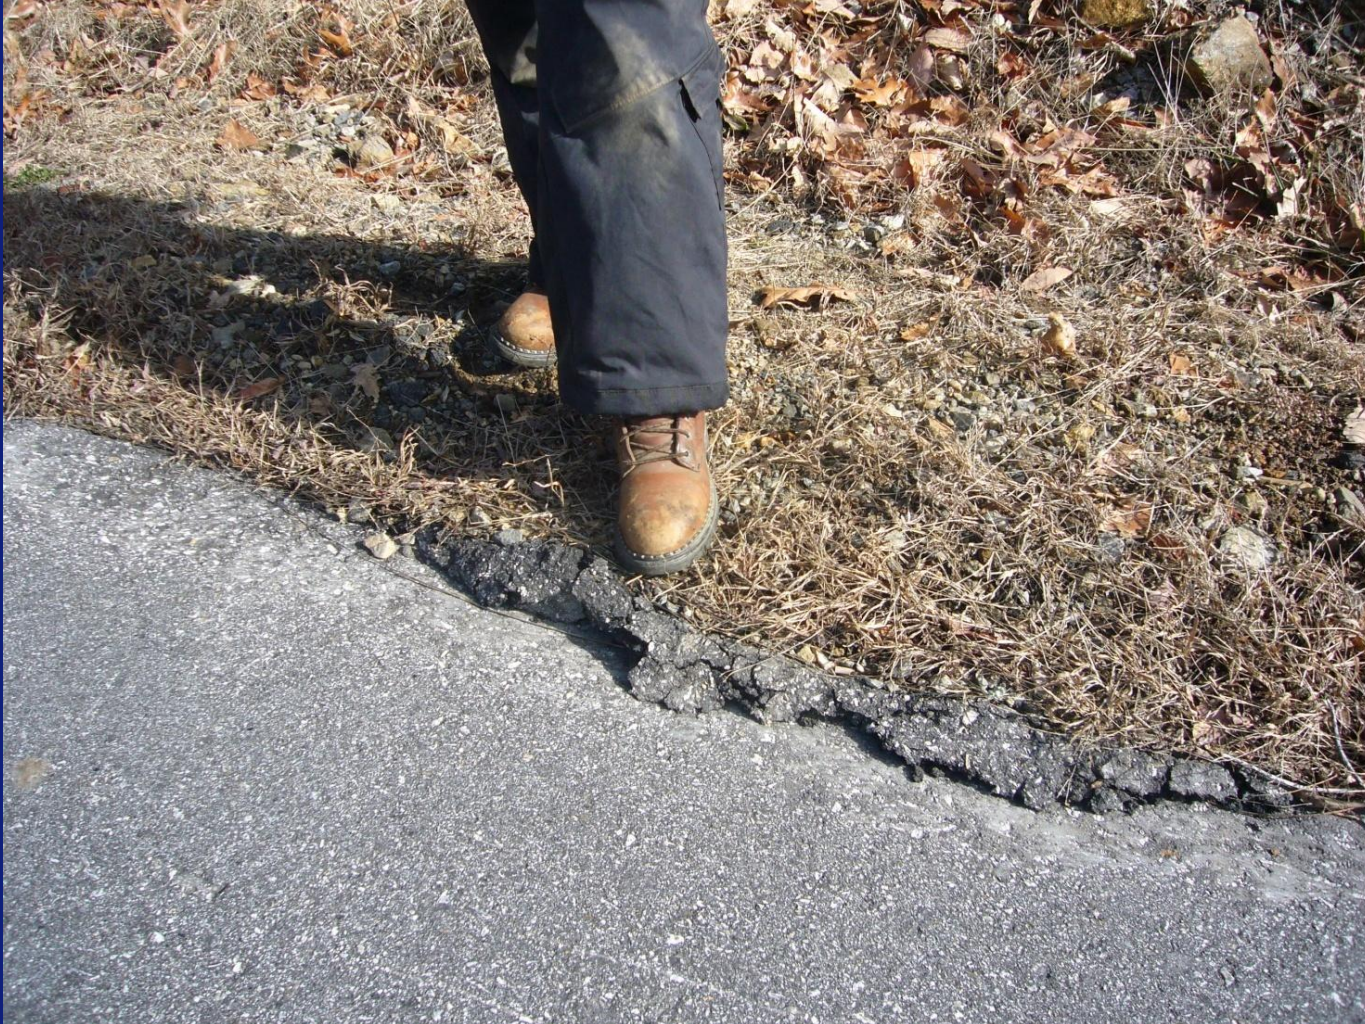
# Bulging Pavement

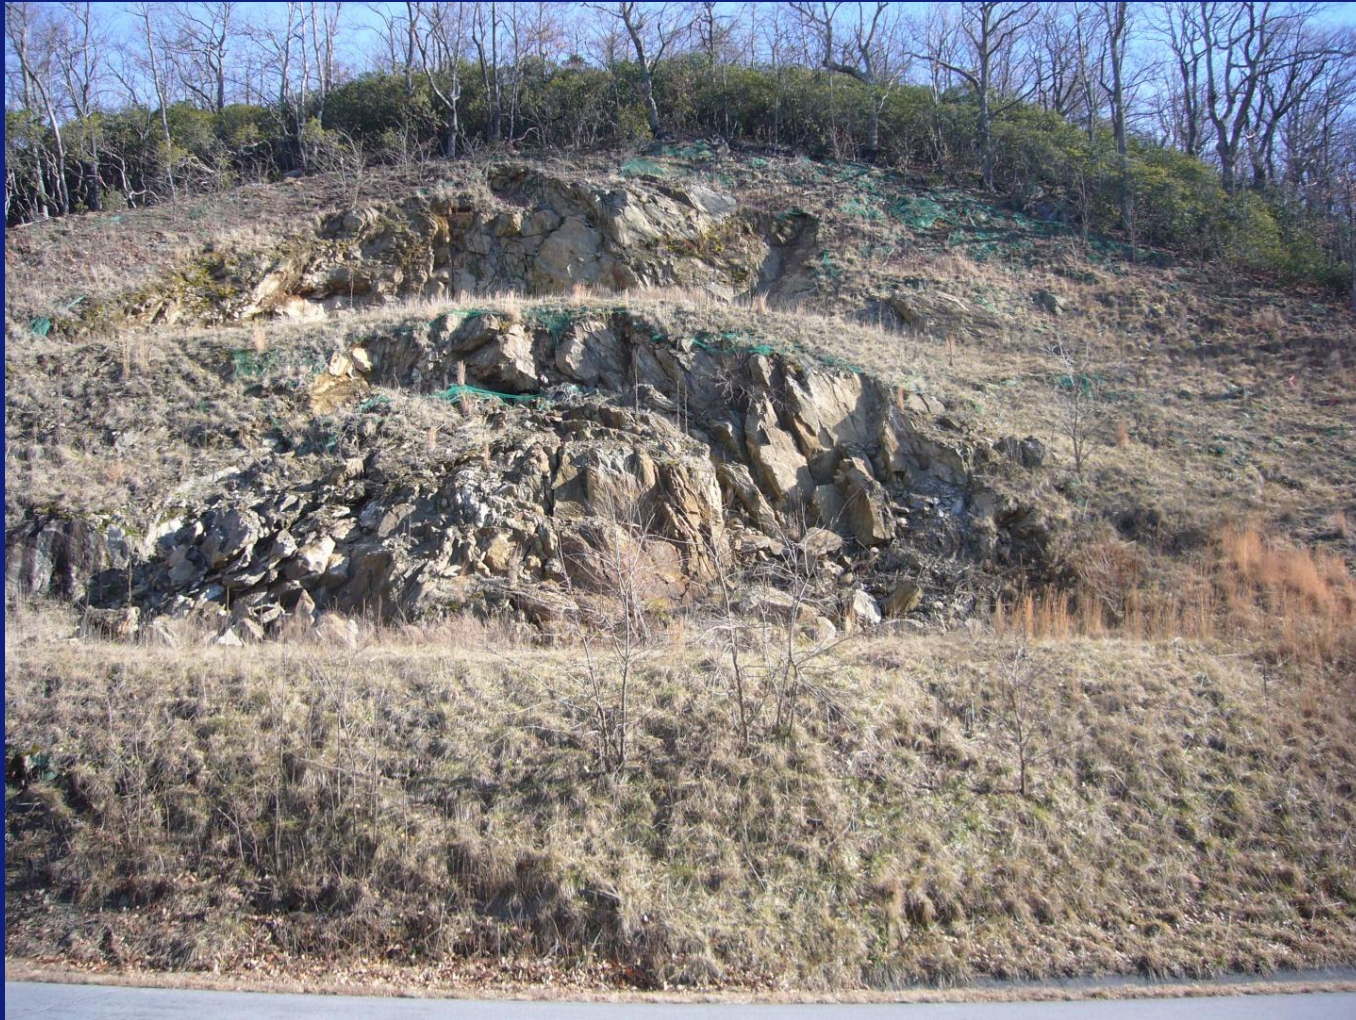
# Localized Rockfall

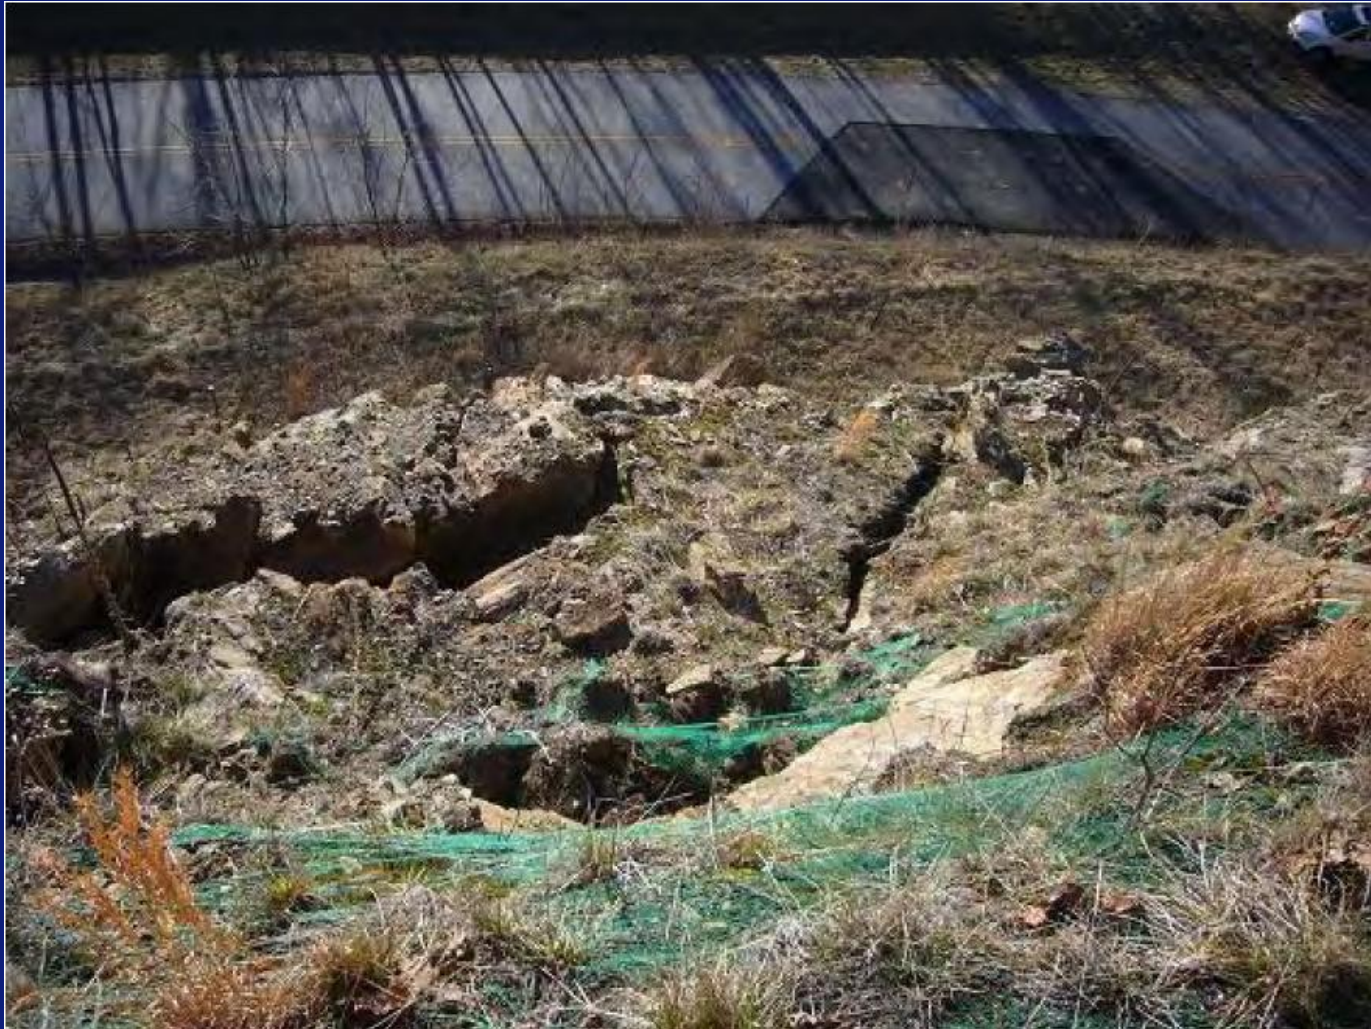
# Tension Cracks

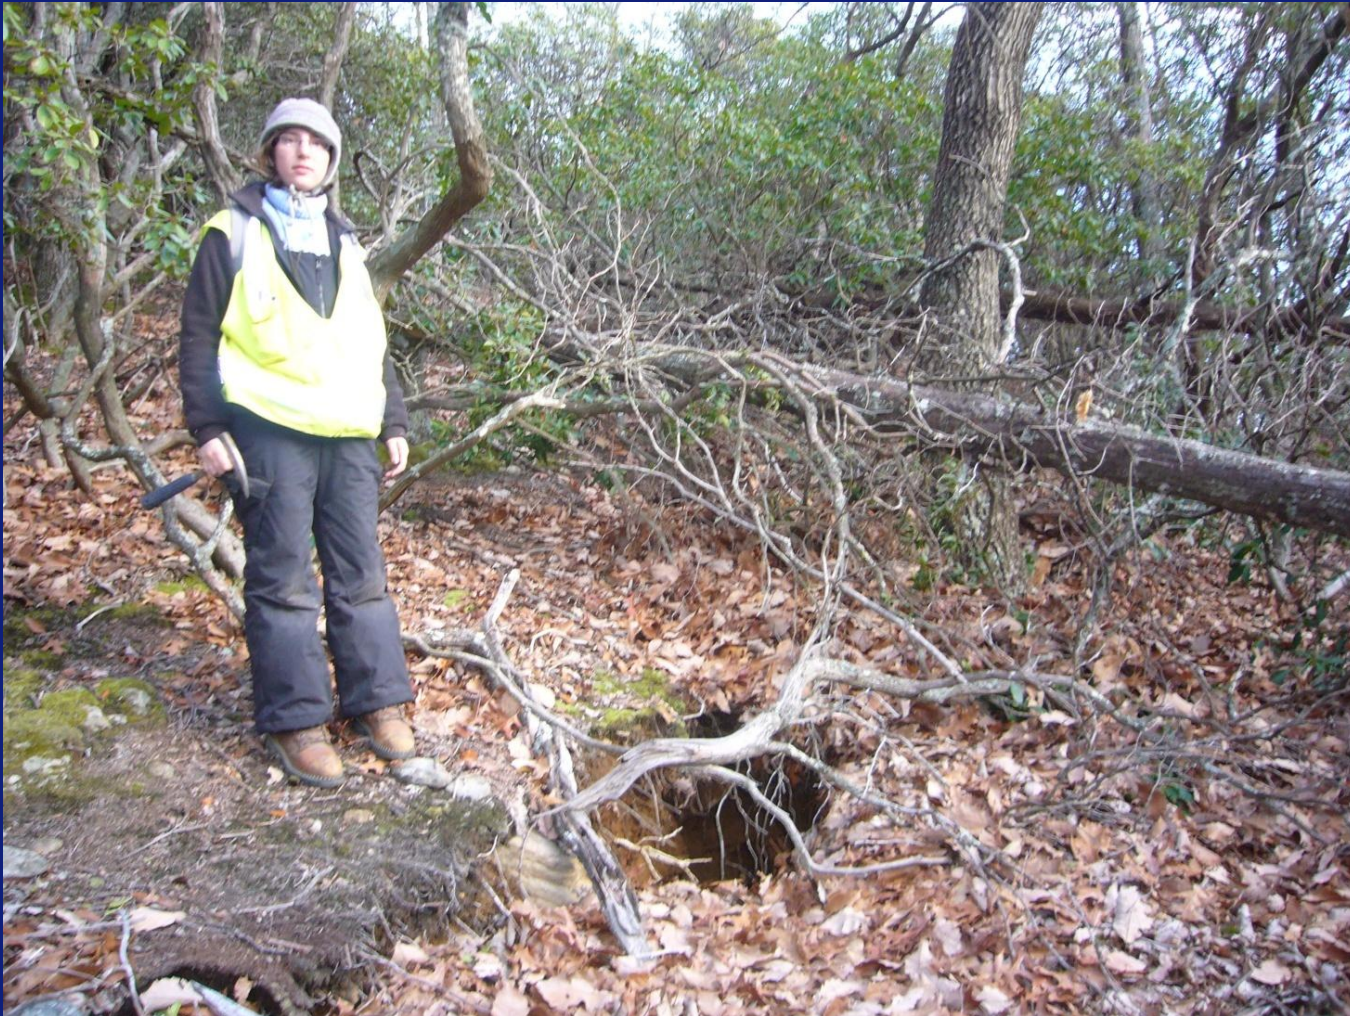
# Tension Cracks

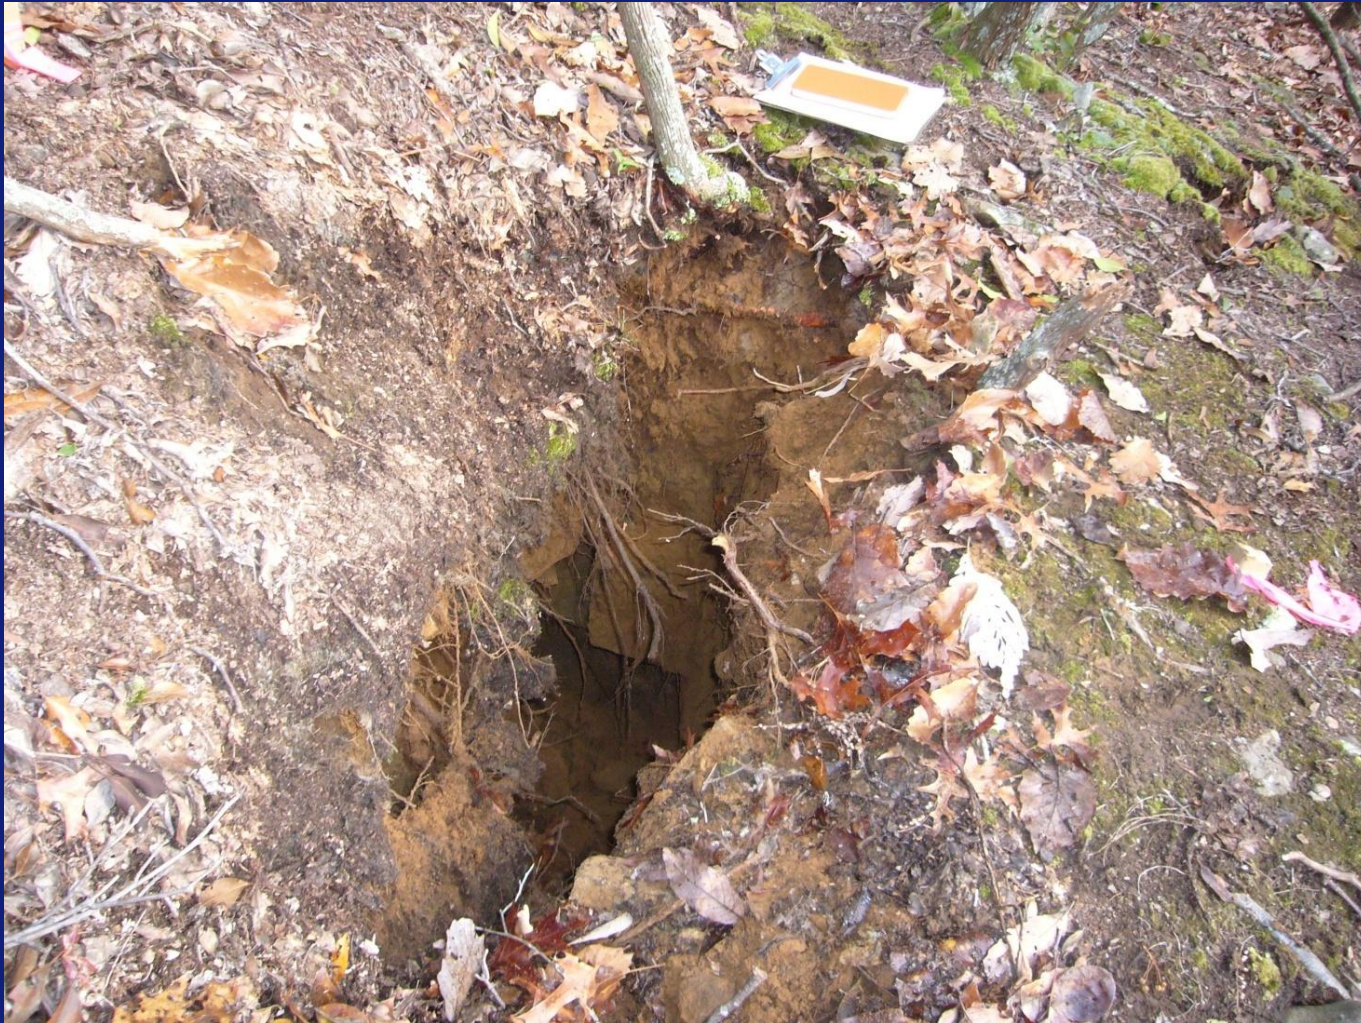
# Tension Cracks

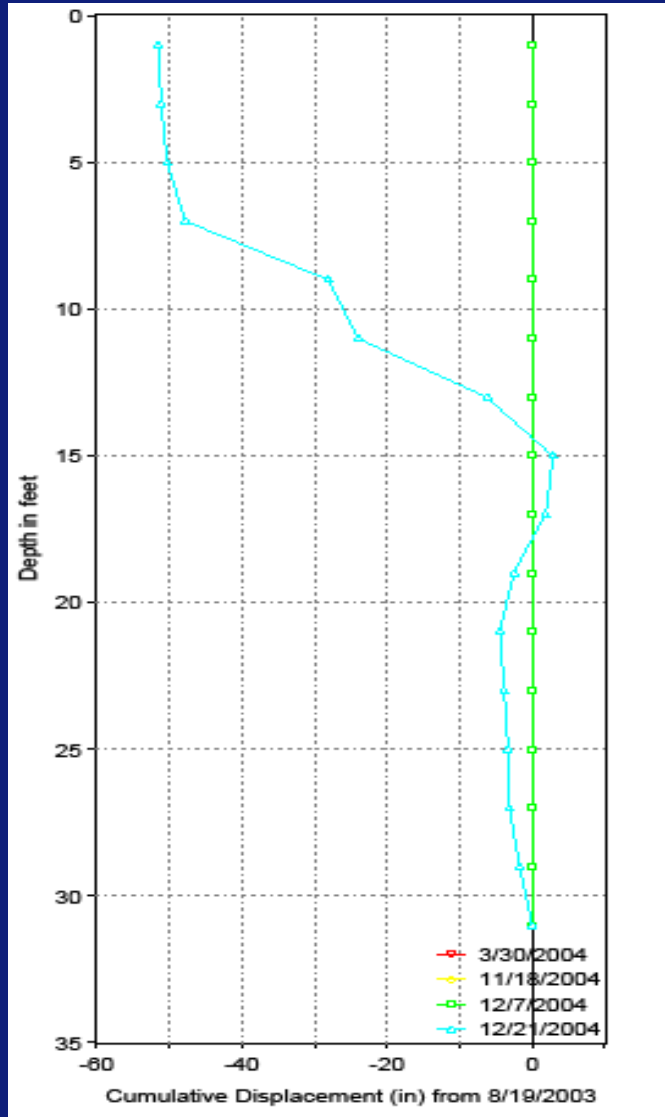
# Inclinometer Data

15 ft →

Weathered  
Rock

Competent  
Rock

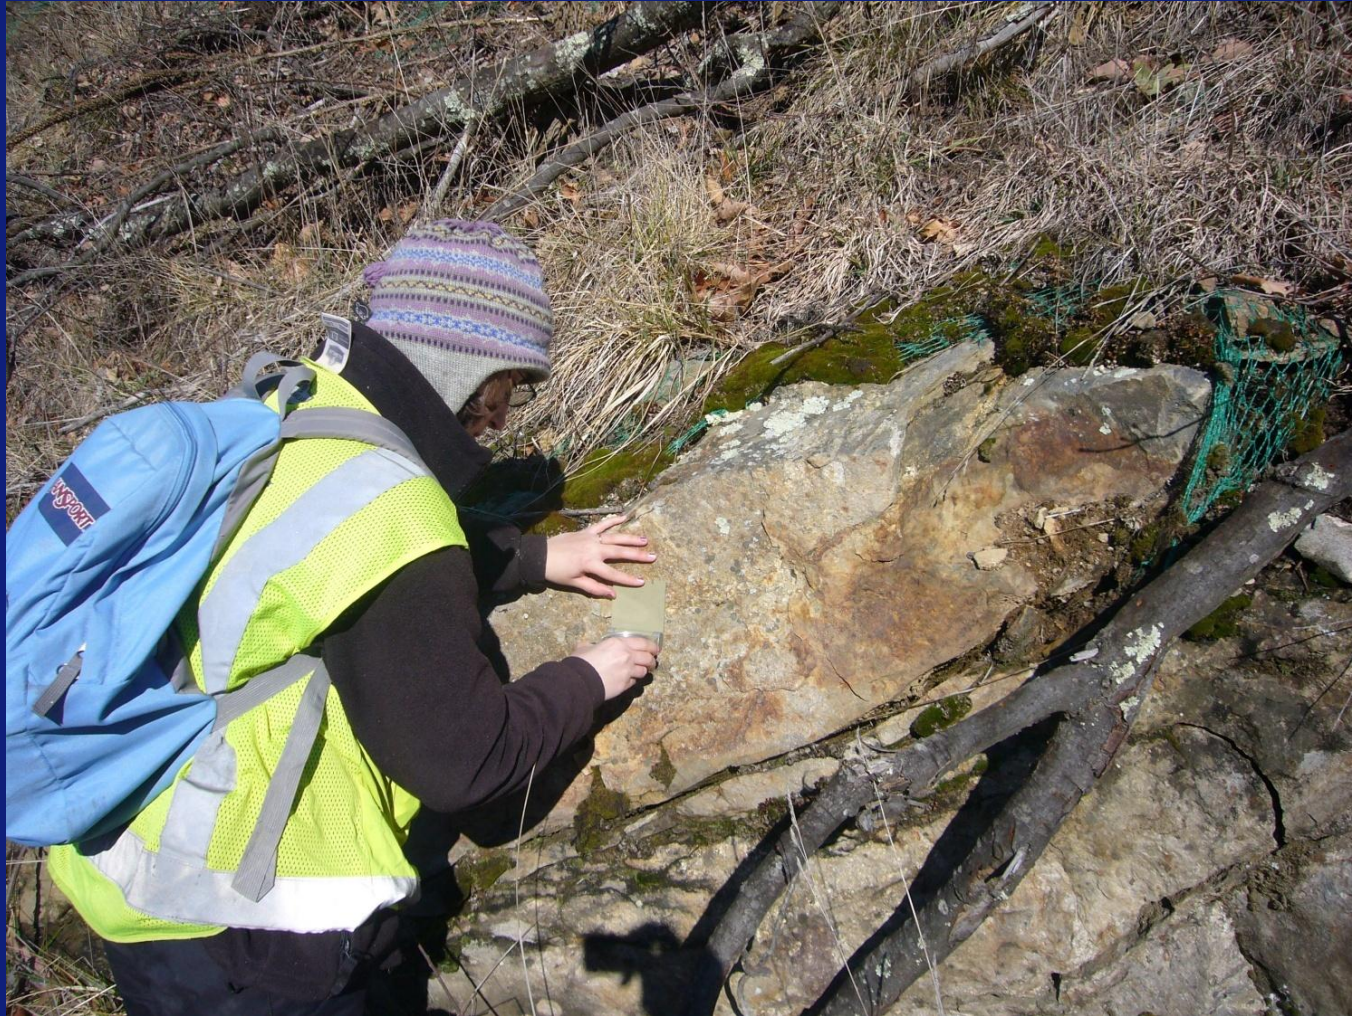
# Rock Structure Mapping

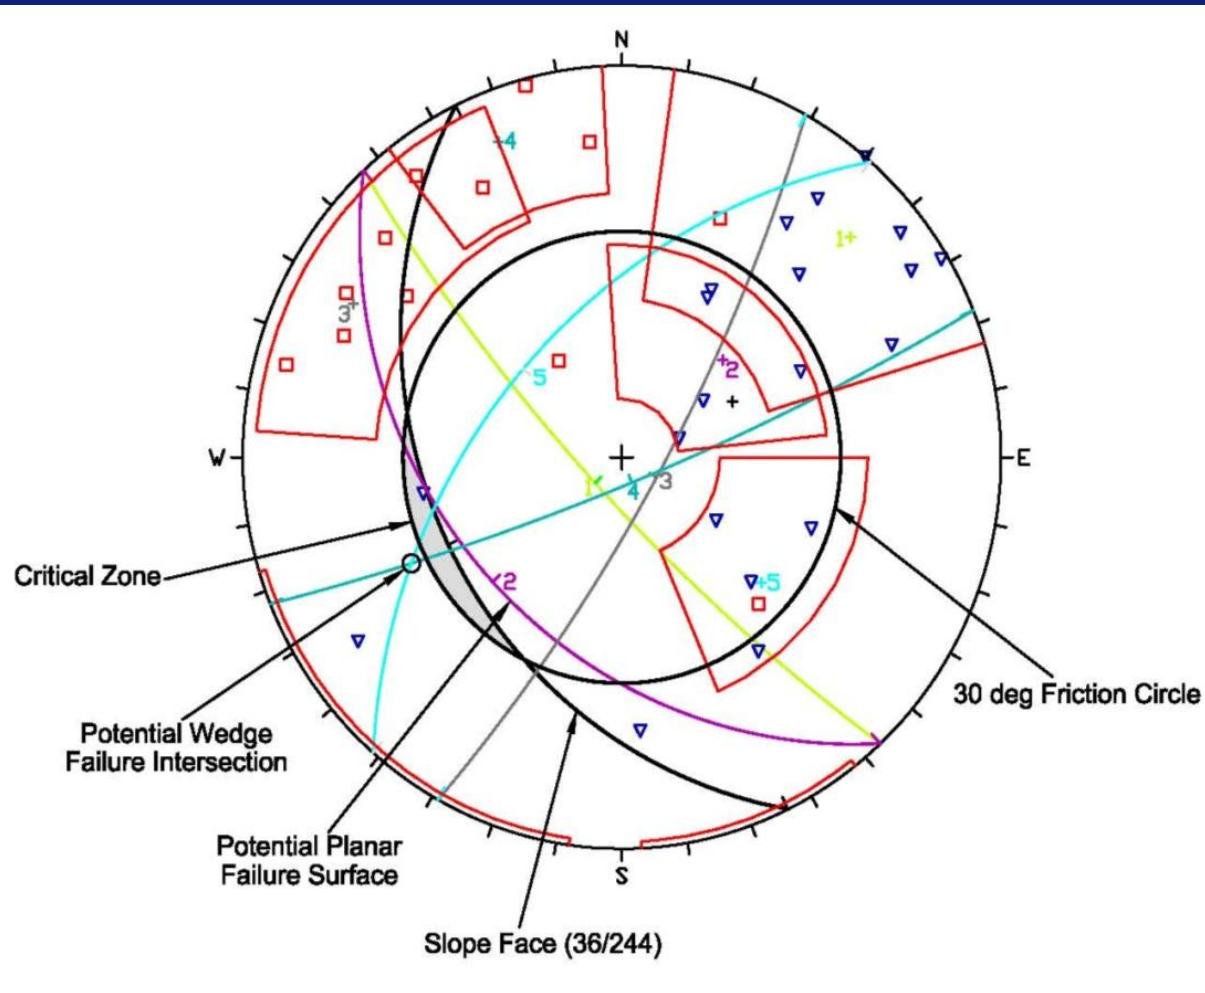
# Stereonet

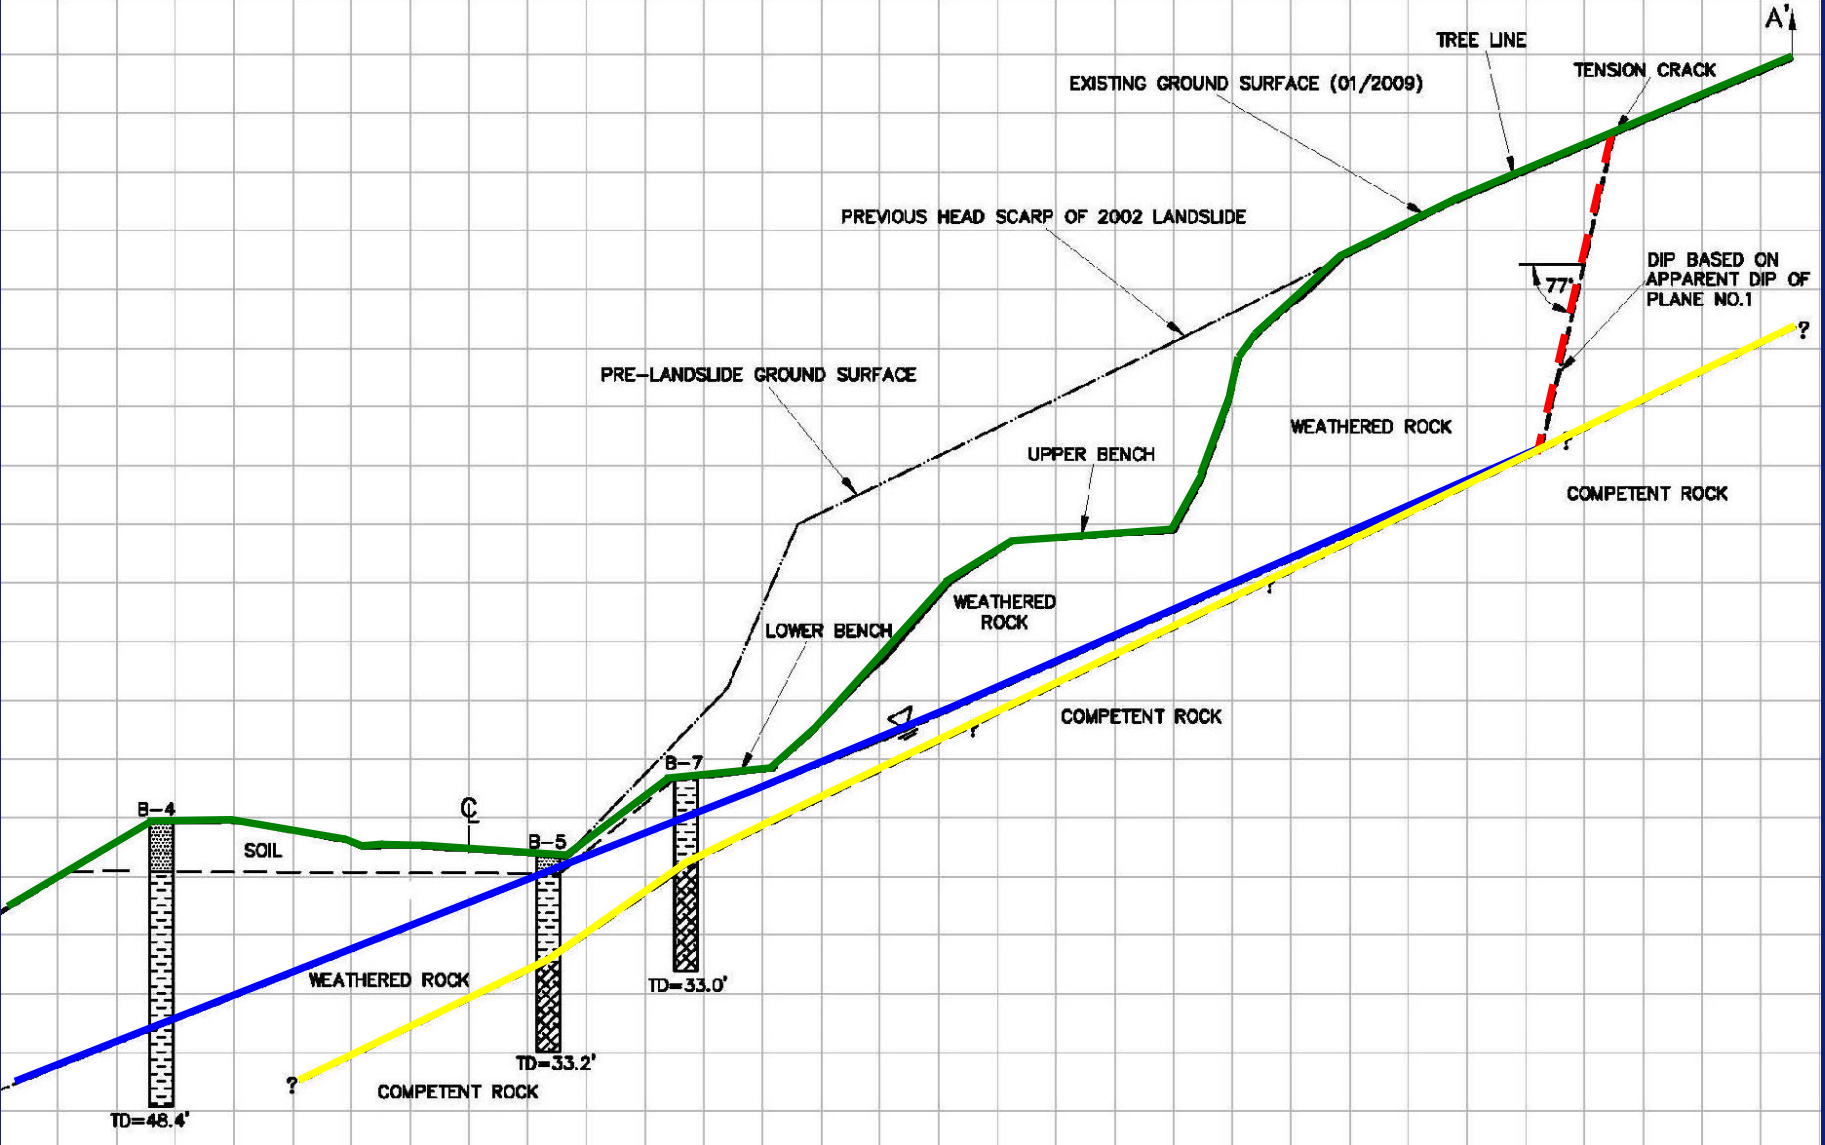
# Failure Model

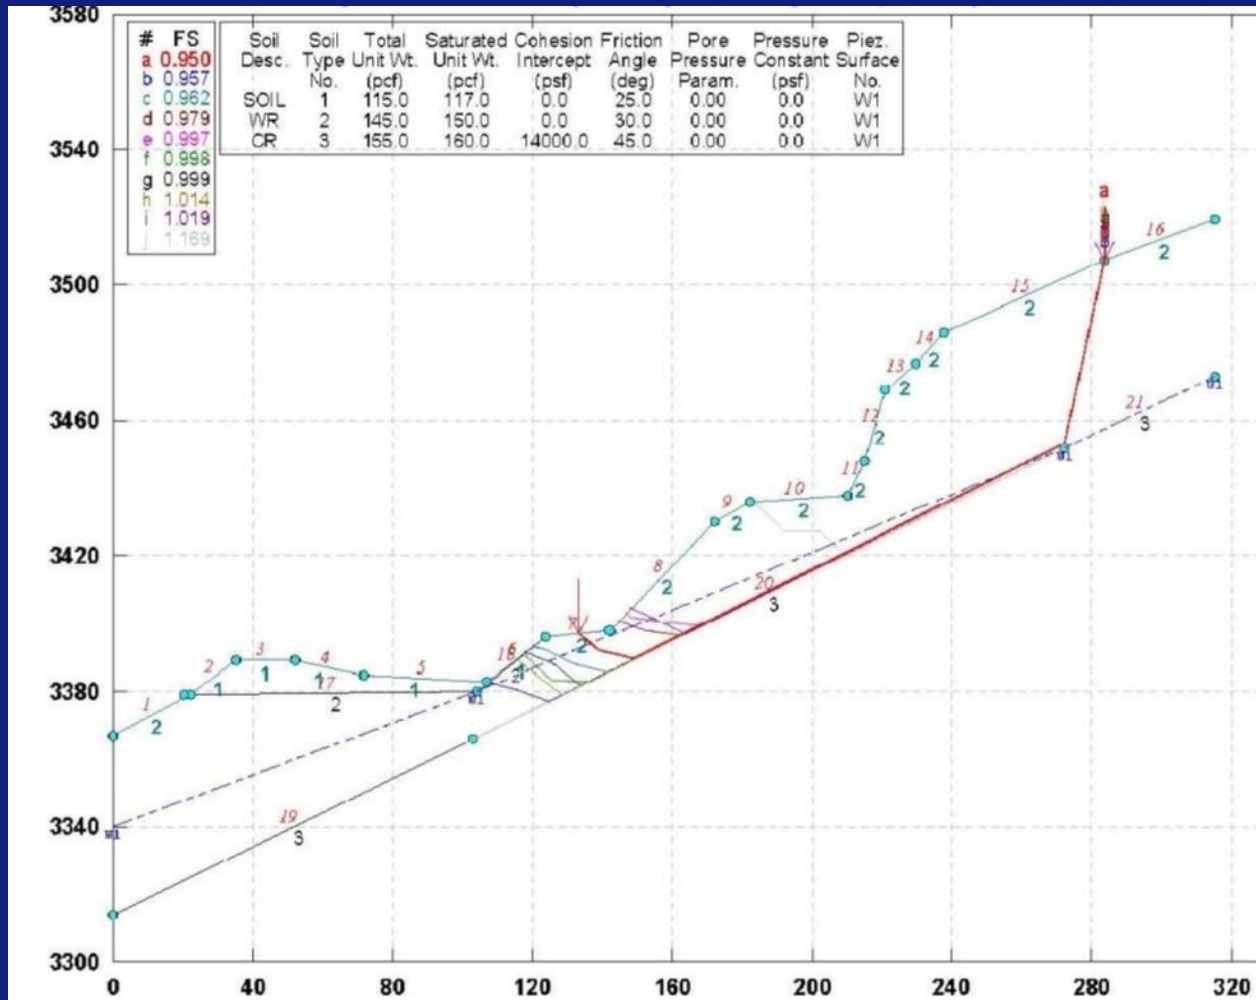
# GSTABL7 Stability Analysis

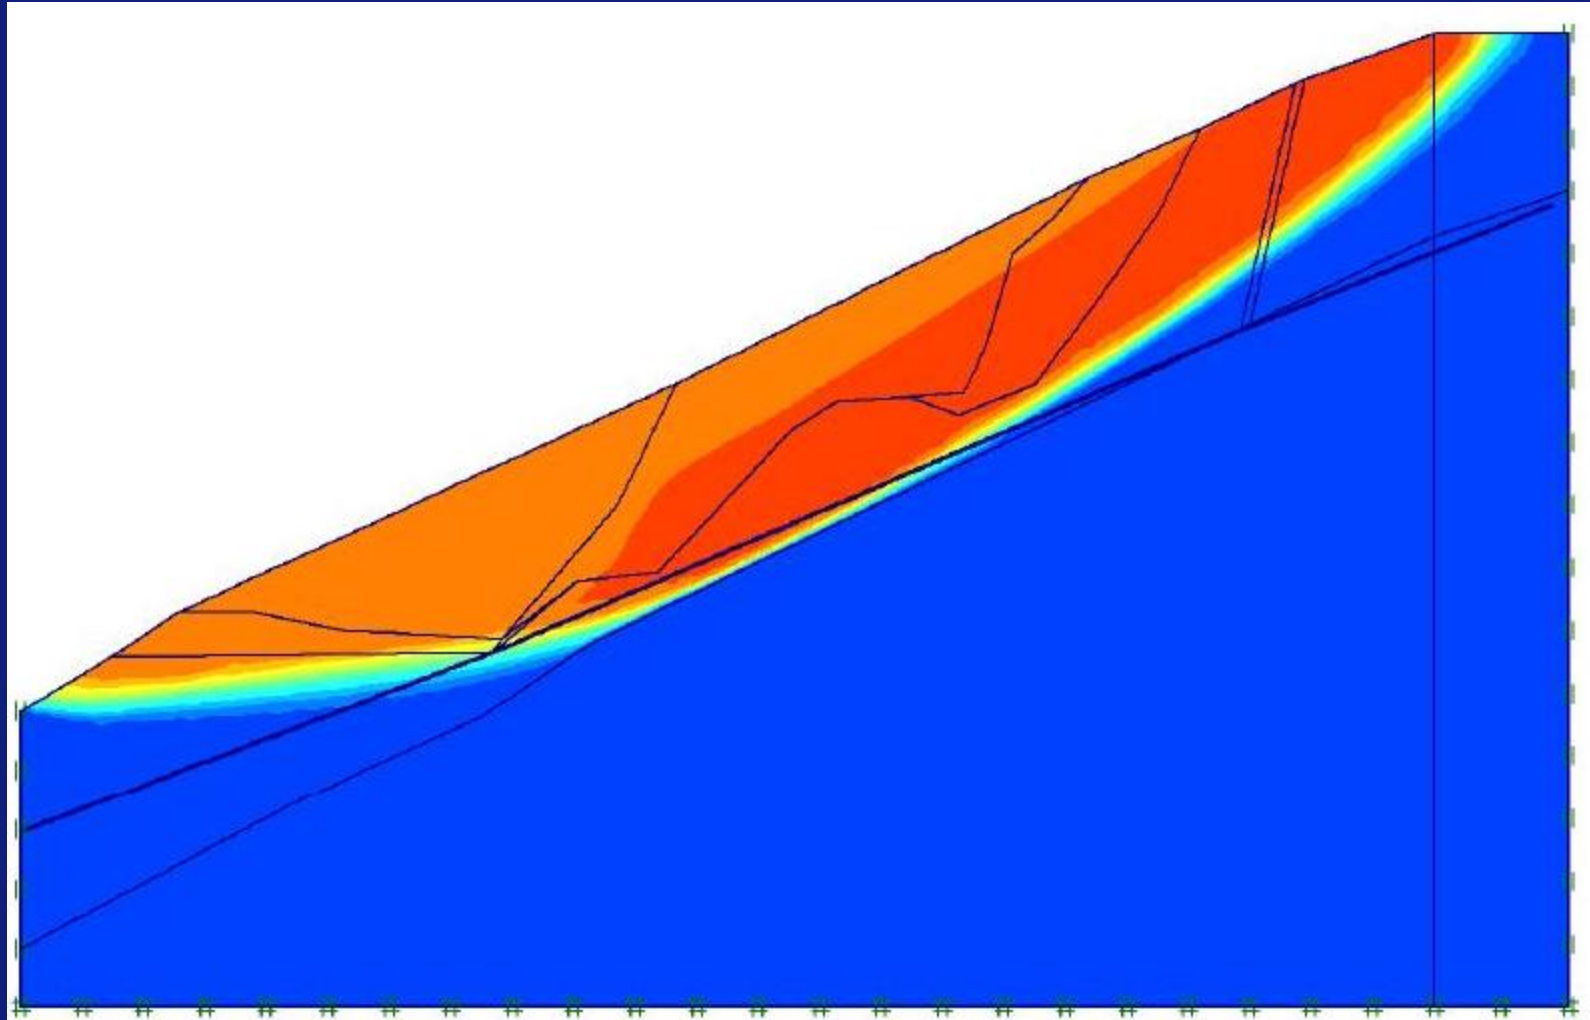
# PLAXIS Stability Analysis

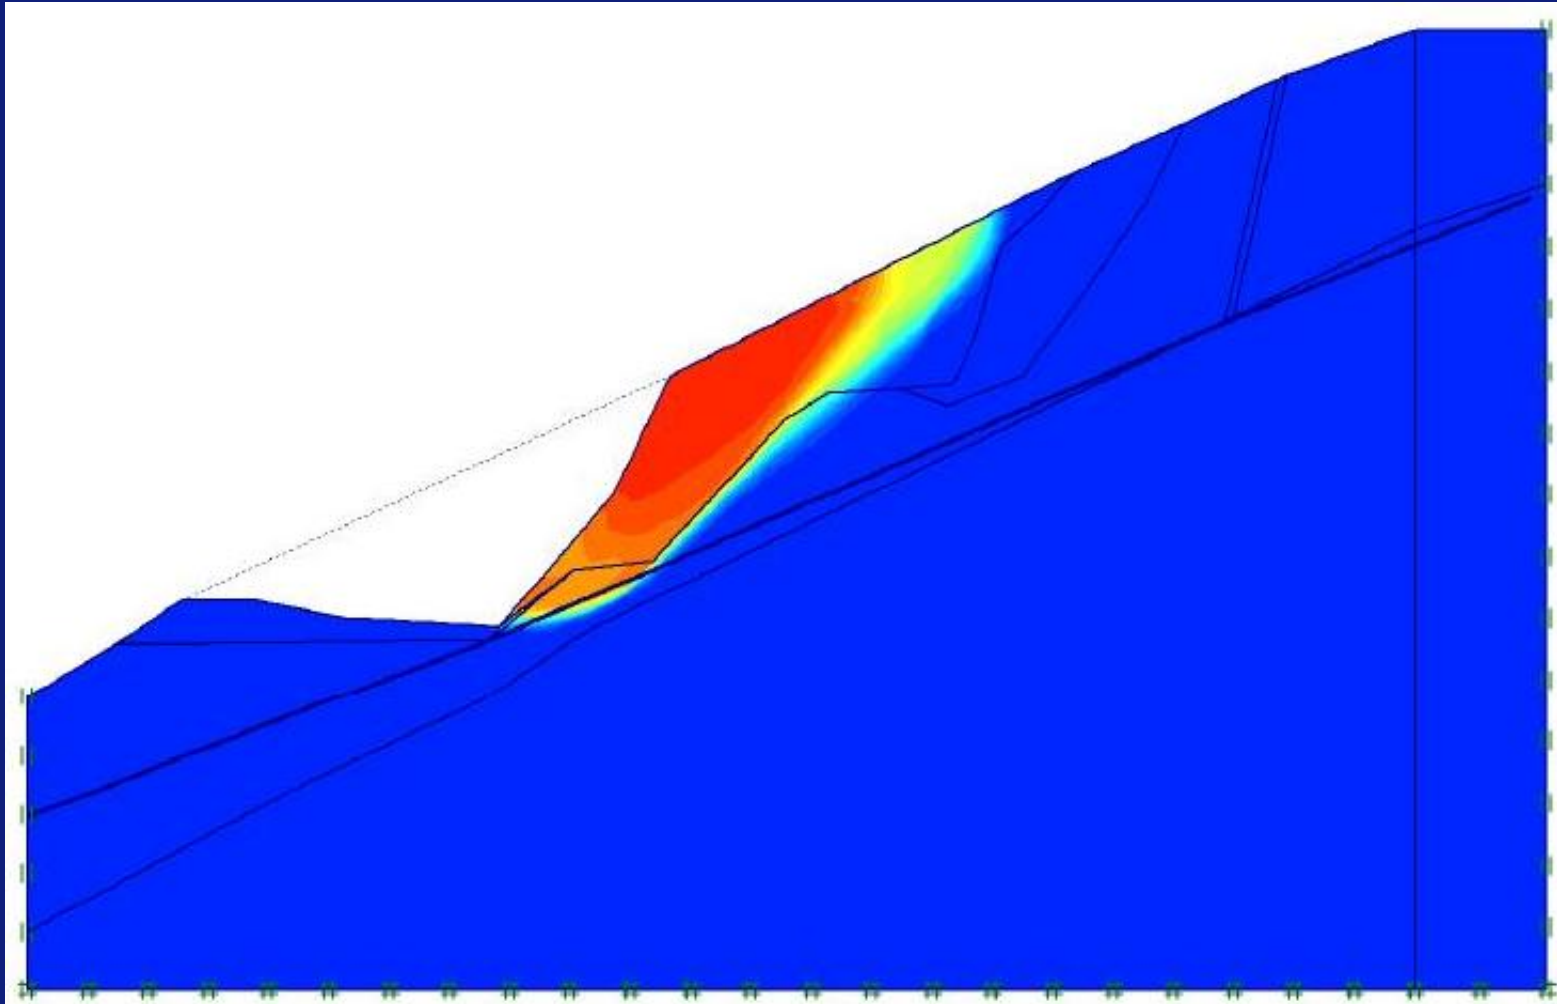
# Stability of Initial Cut Slope

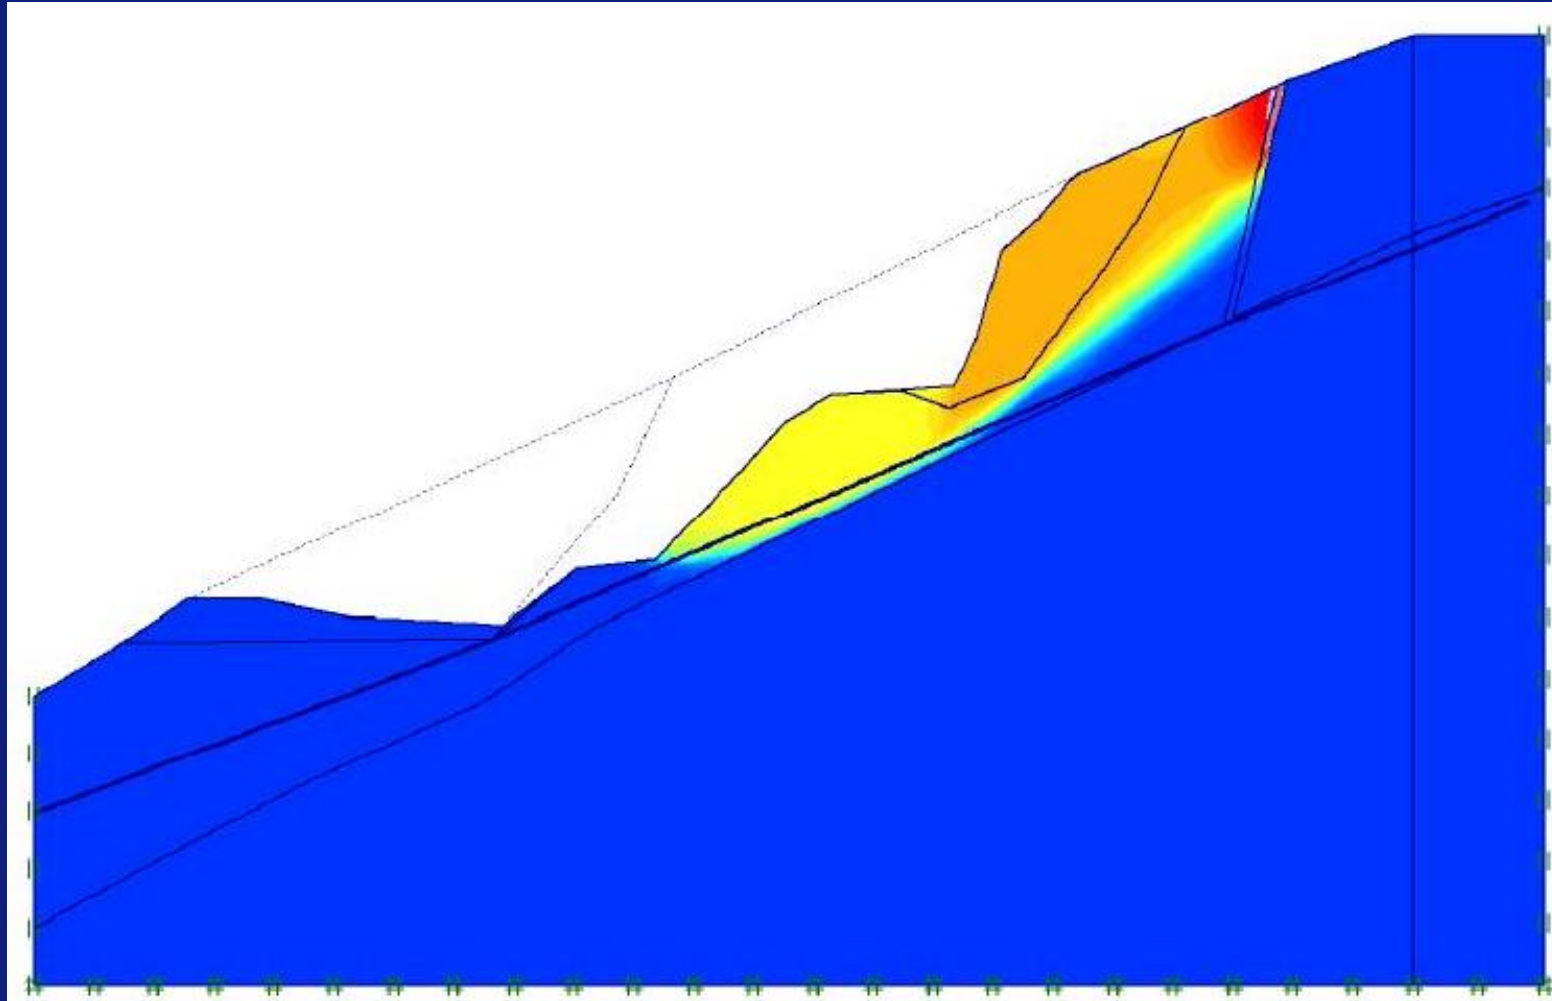
# Stability of Benched Configuration
