**Landslide Stabilization  
Blue Ridge Parkway MP 400.8**

**Brian K. Banks, PG  
Pamela Patrick, PE**

**STGEC  
October 5, 2010**

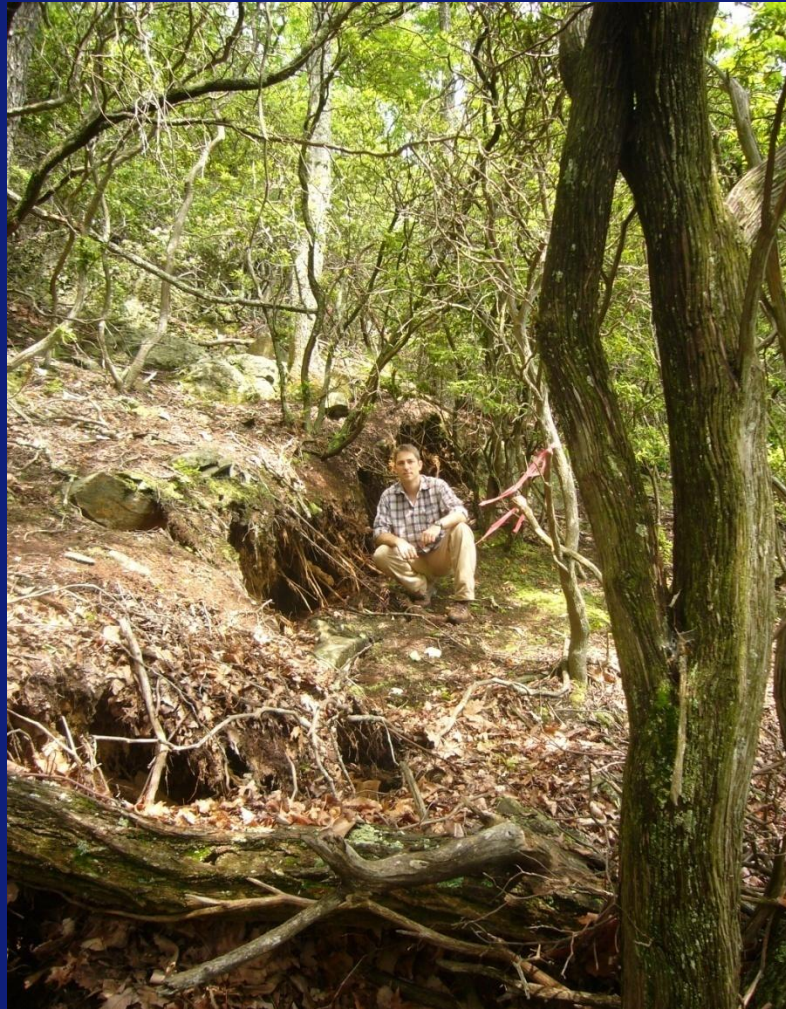
# Ongoing Movement

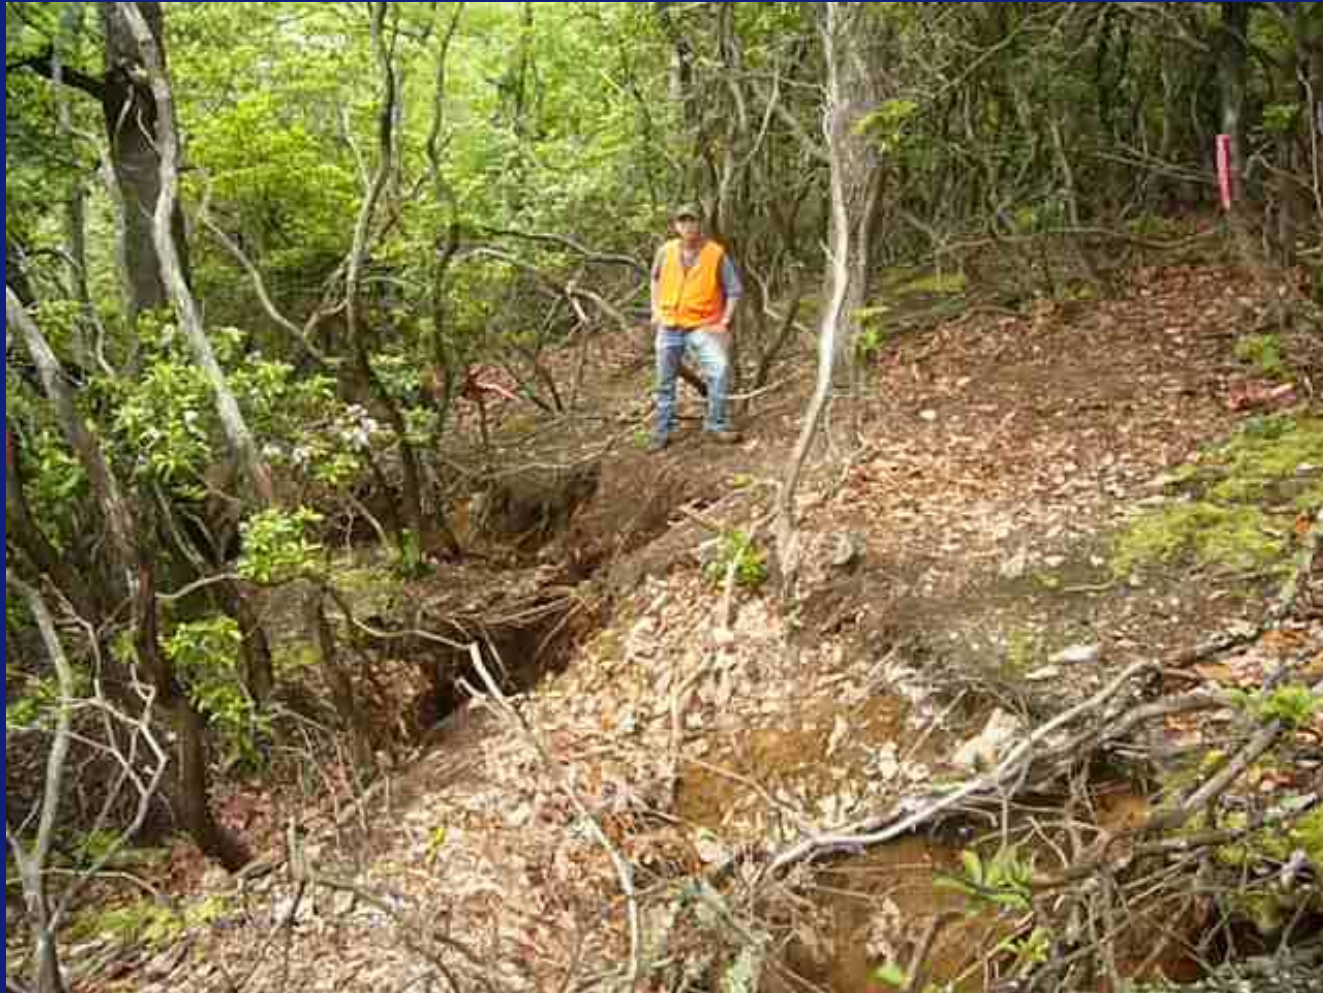
# Ongoing Movement

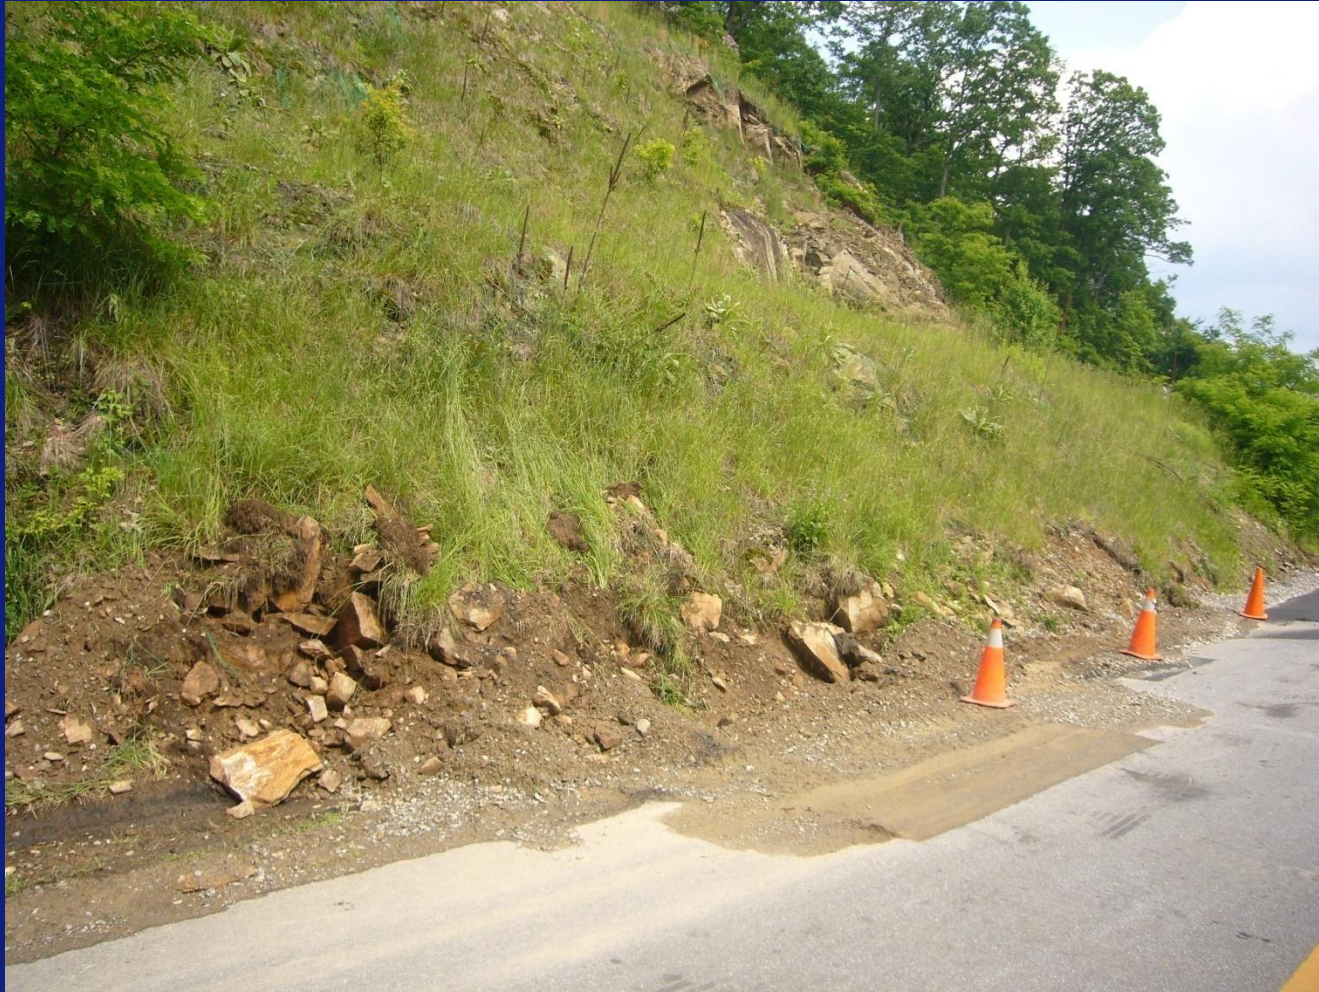
# Ongoing Movement

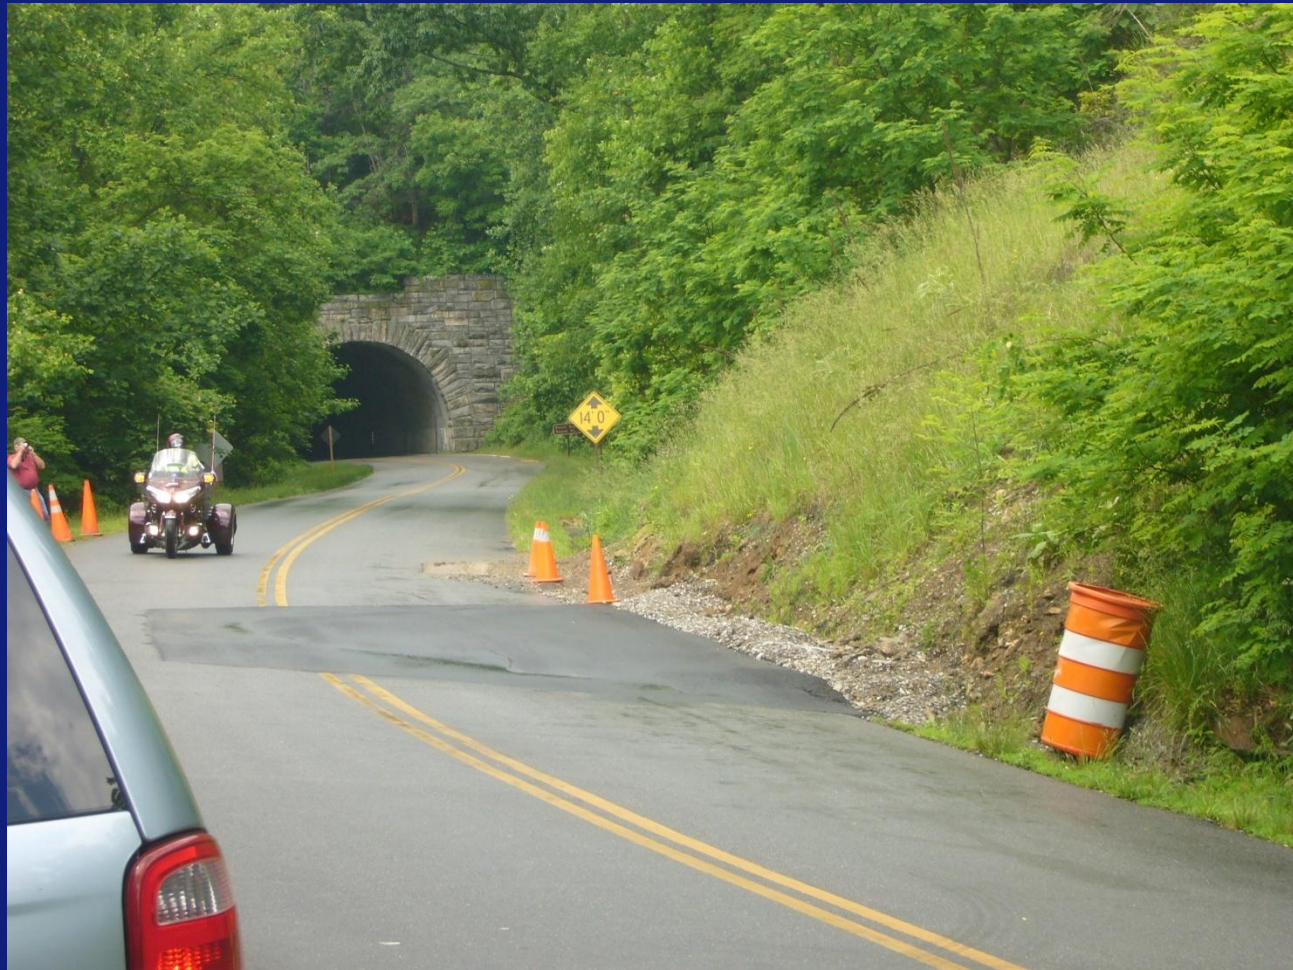
# Ongoing Movement

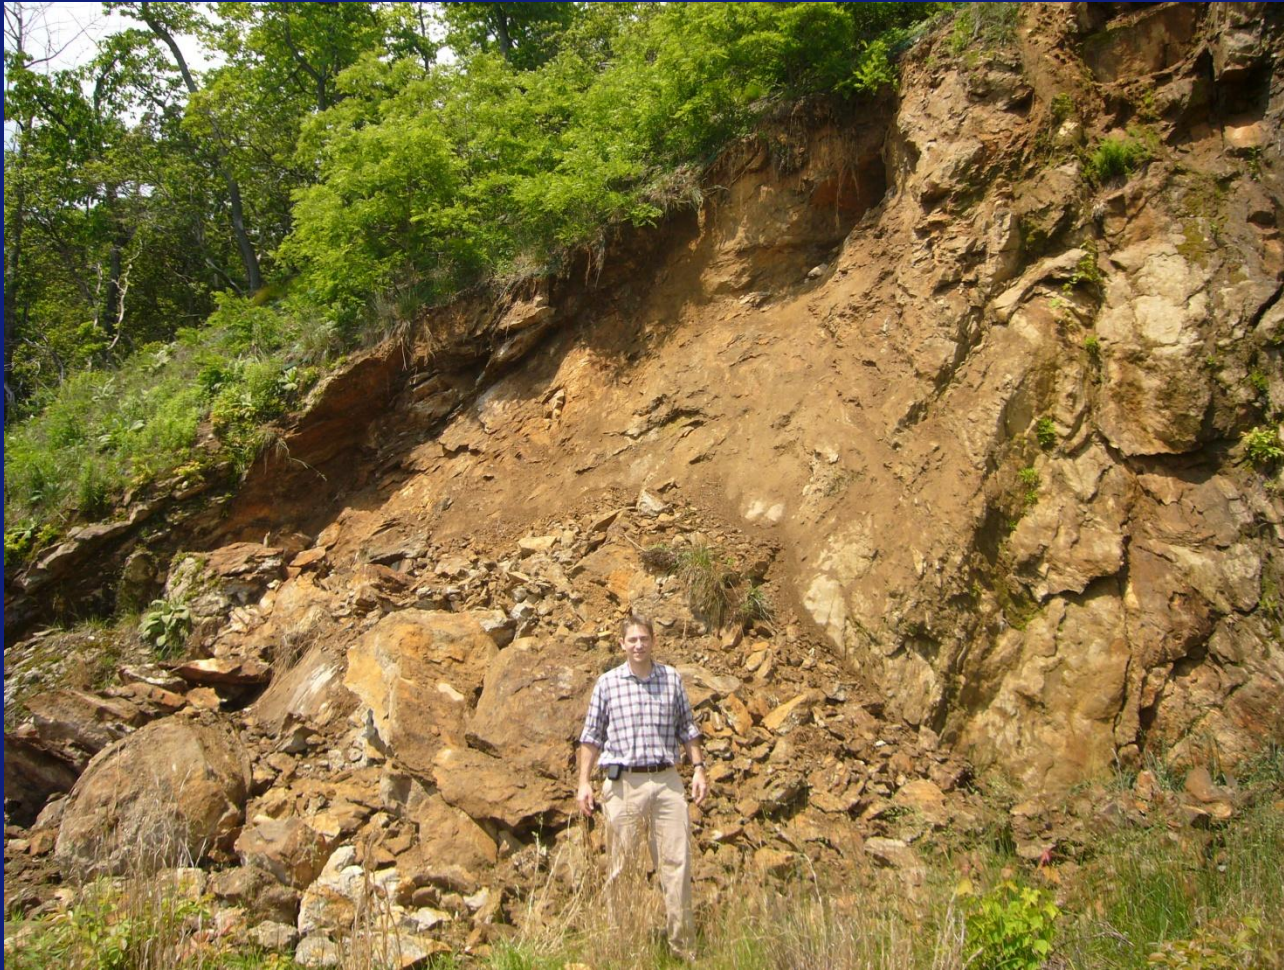
# Ongoing Movement

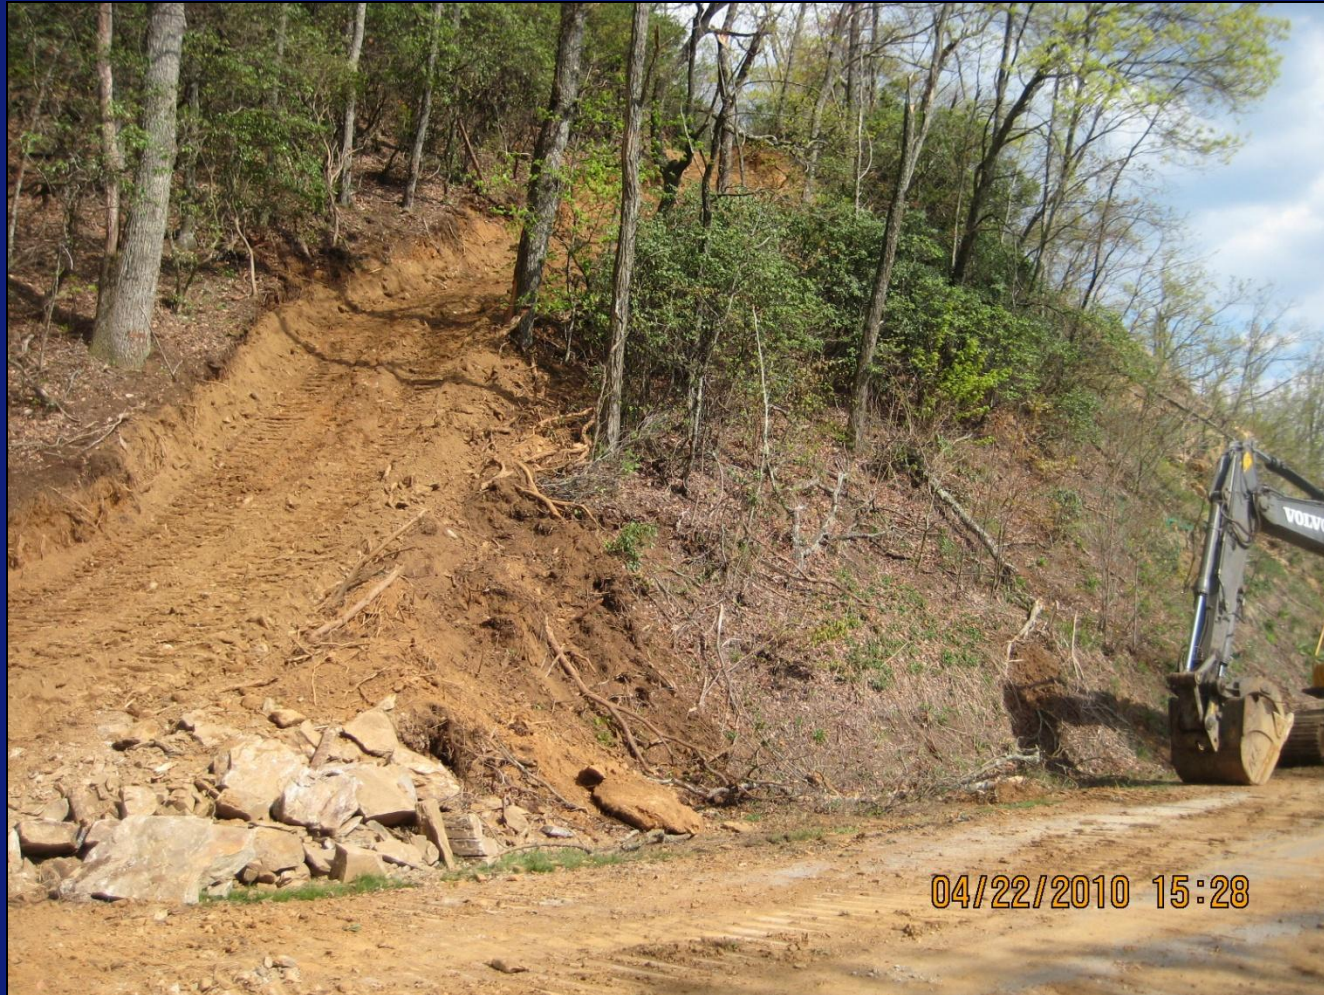
# Access Road

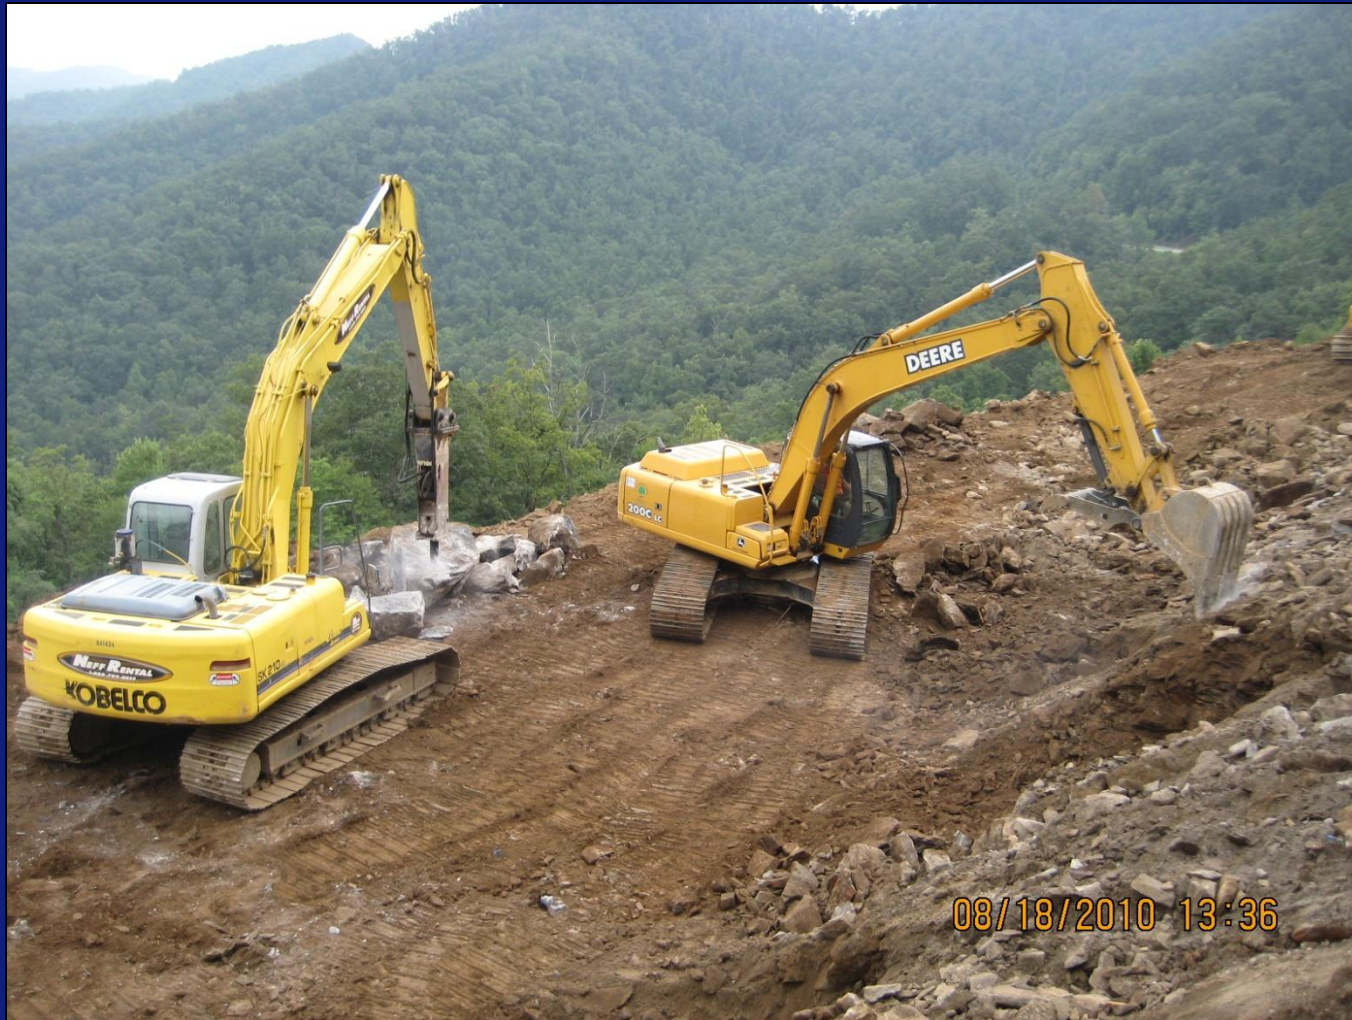
# Upper Work Bench

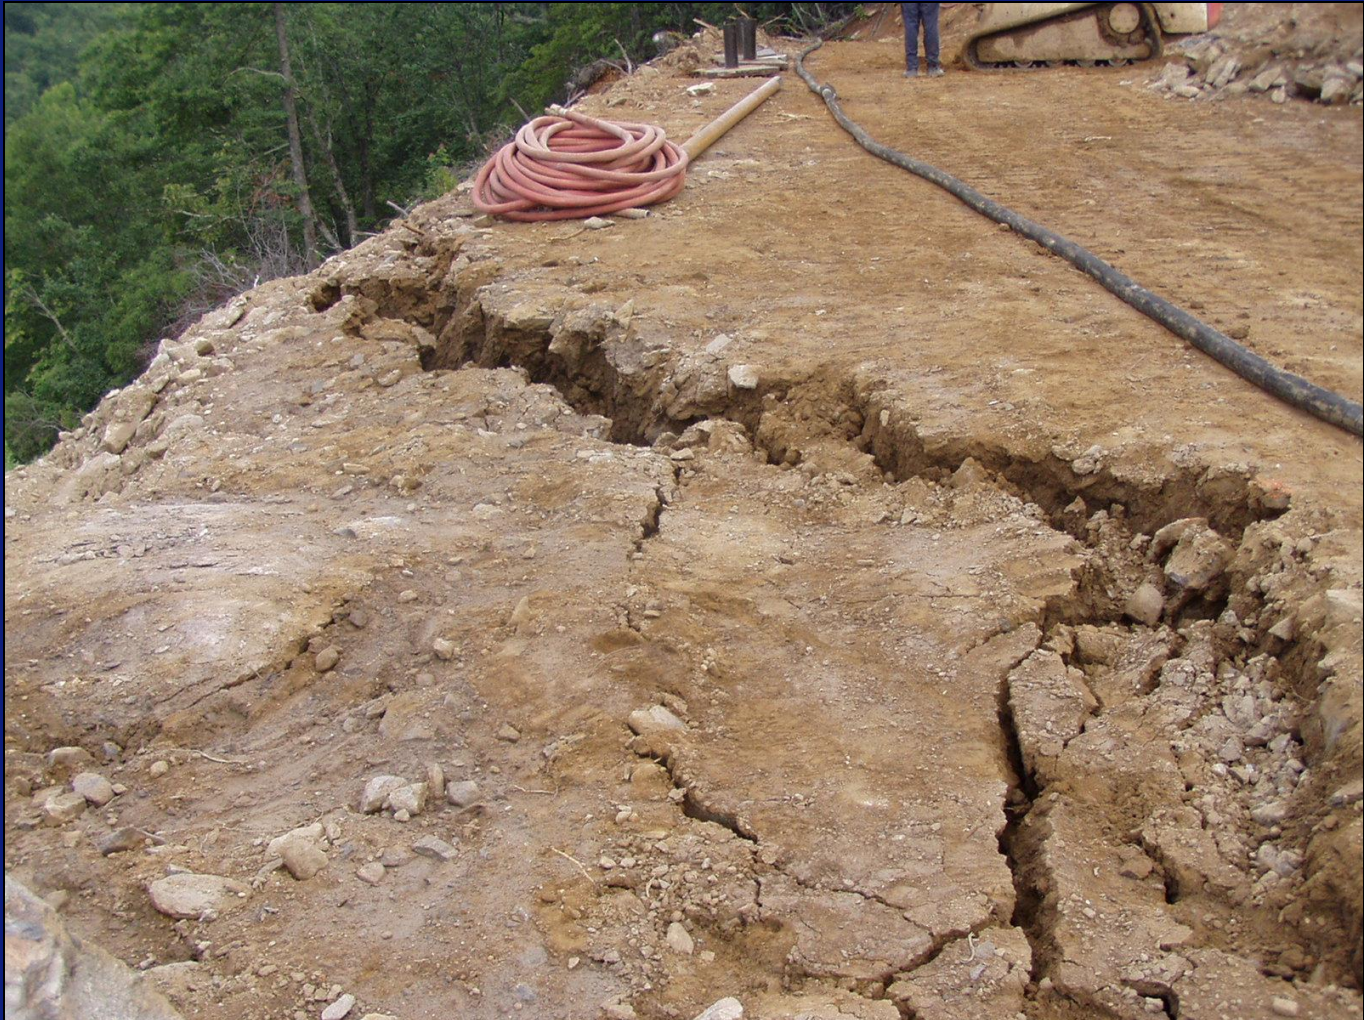
# Bench Failure

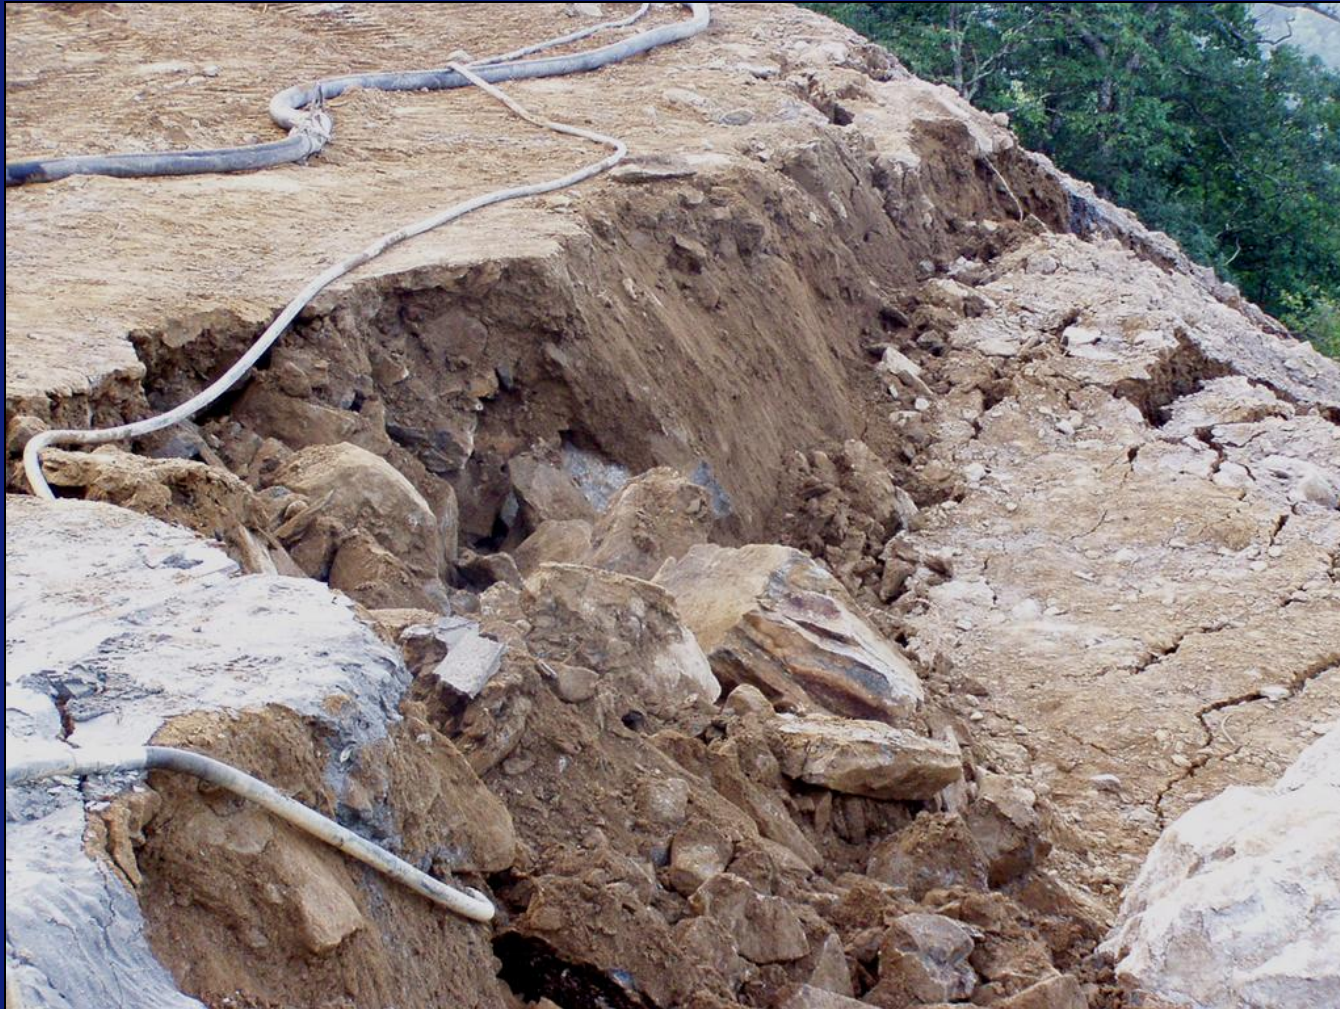
# Bench Failure
