Case Studies in Shallow Landslide Repair and Severe Erosion Mitigation along Roadway Networks in Appalachia, including Innovative Concepts for Roadway Widening

Soil Nail Launcher, Inc.

Outline

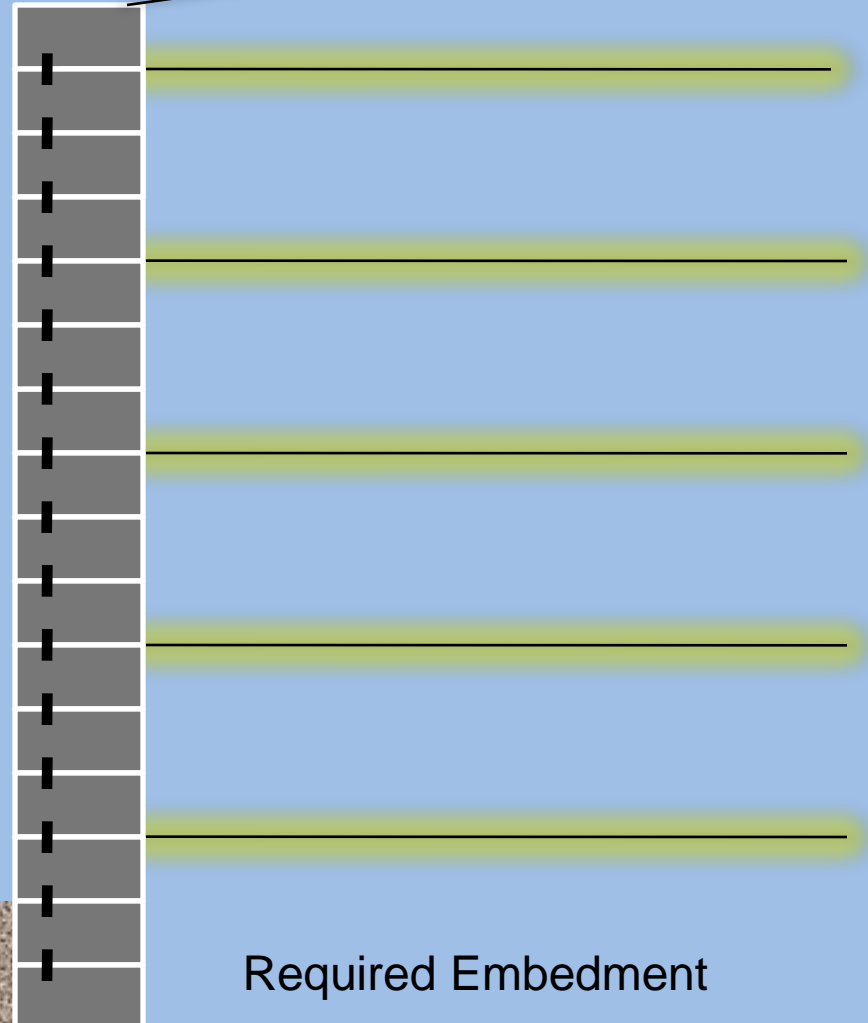
MSE

1. Reinforced Soil Structure
2. Quasi-tieback
3. Pin Connections
4. Strong reinforcement
5. Wide Spacing
6. Failure Rate

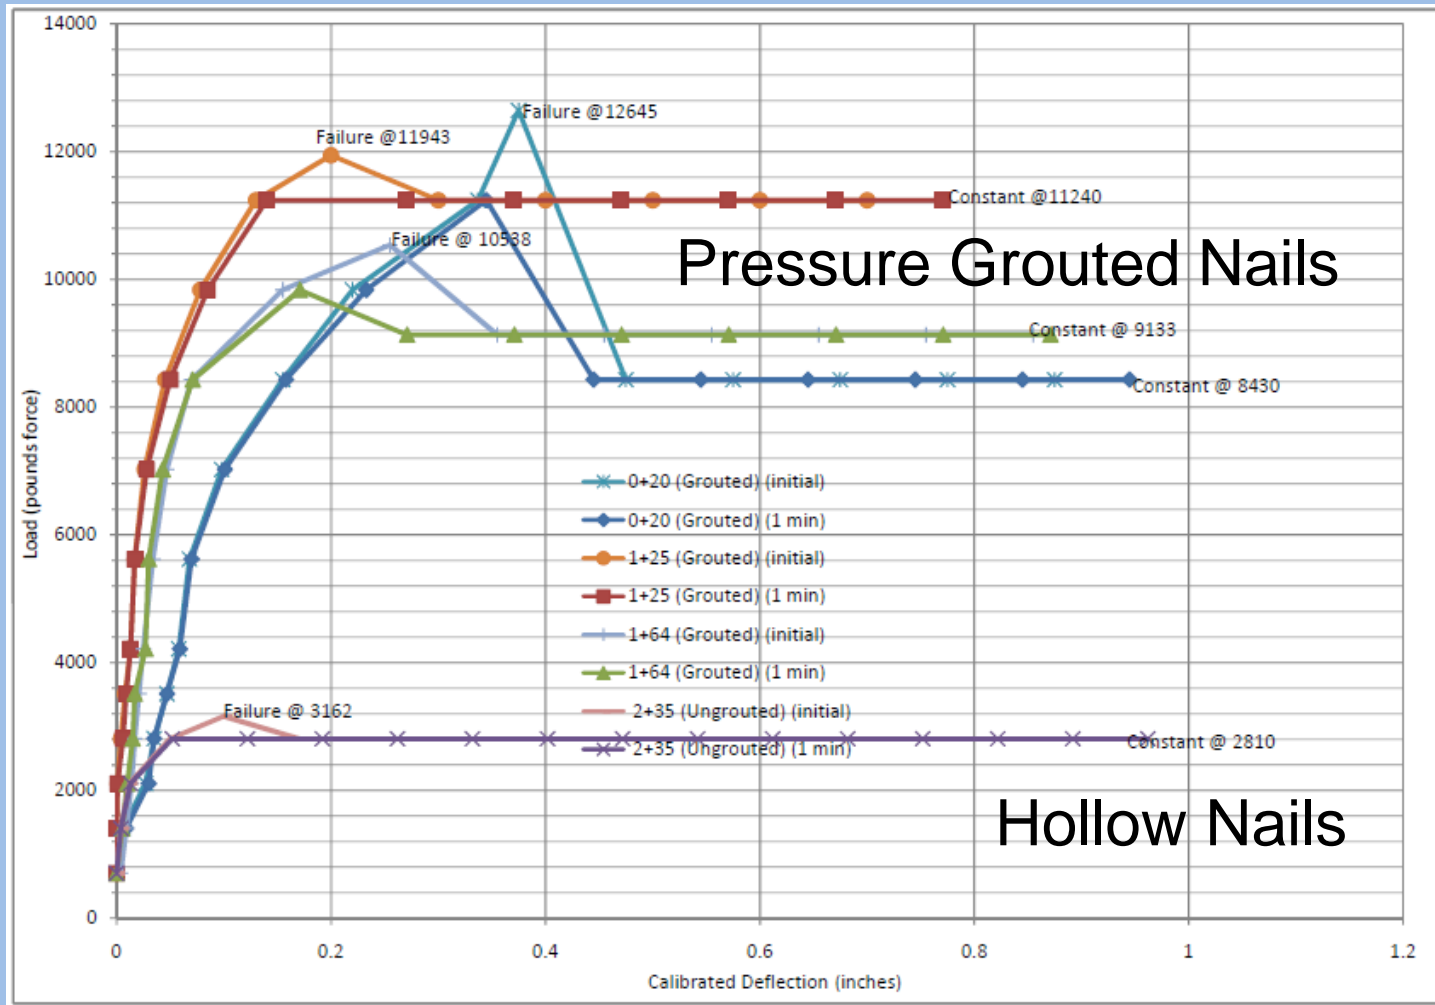
Pullout Test Results

1. Average bond = 3.1 psi (ungROUTED);
11.5 psi (grouted)

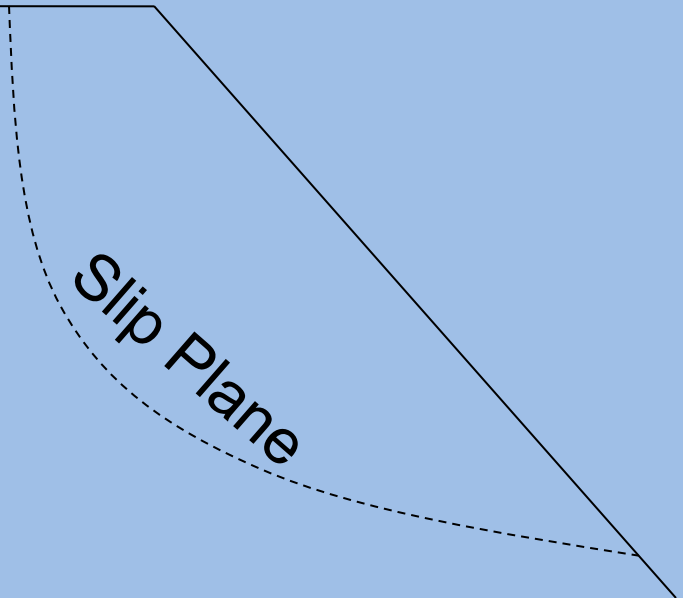
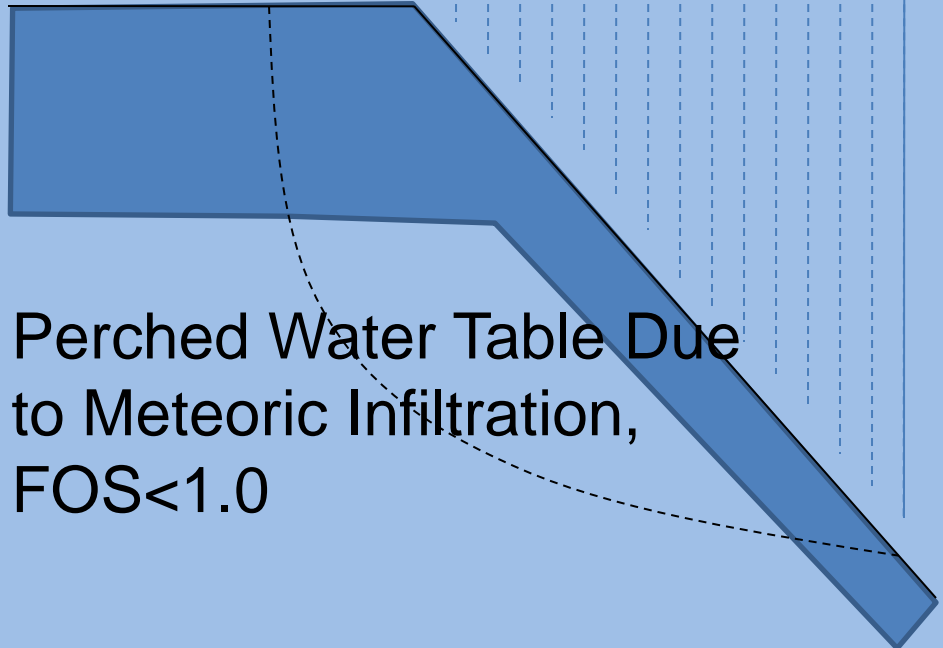
Landslide in dry conditions, $FOS > 1.0$

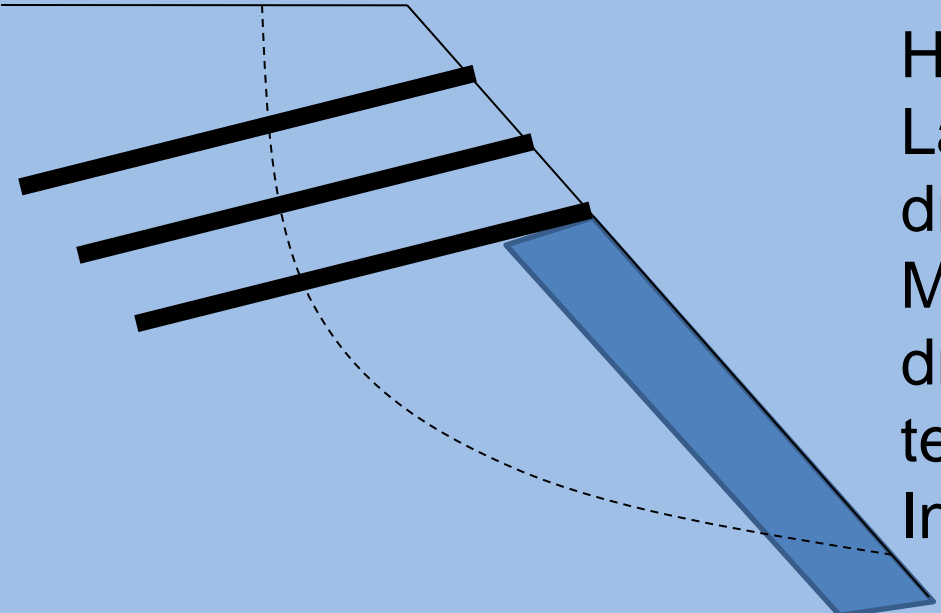
Perched Water Table Due to Meteoric Infiltration, $FOS < 1.0$

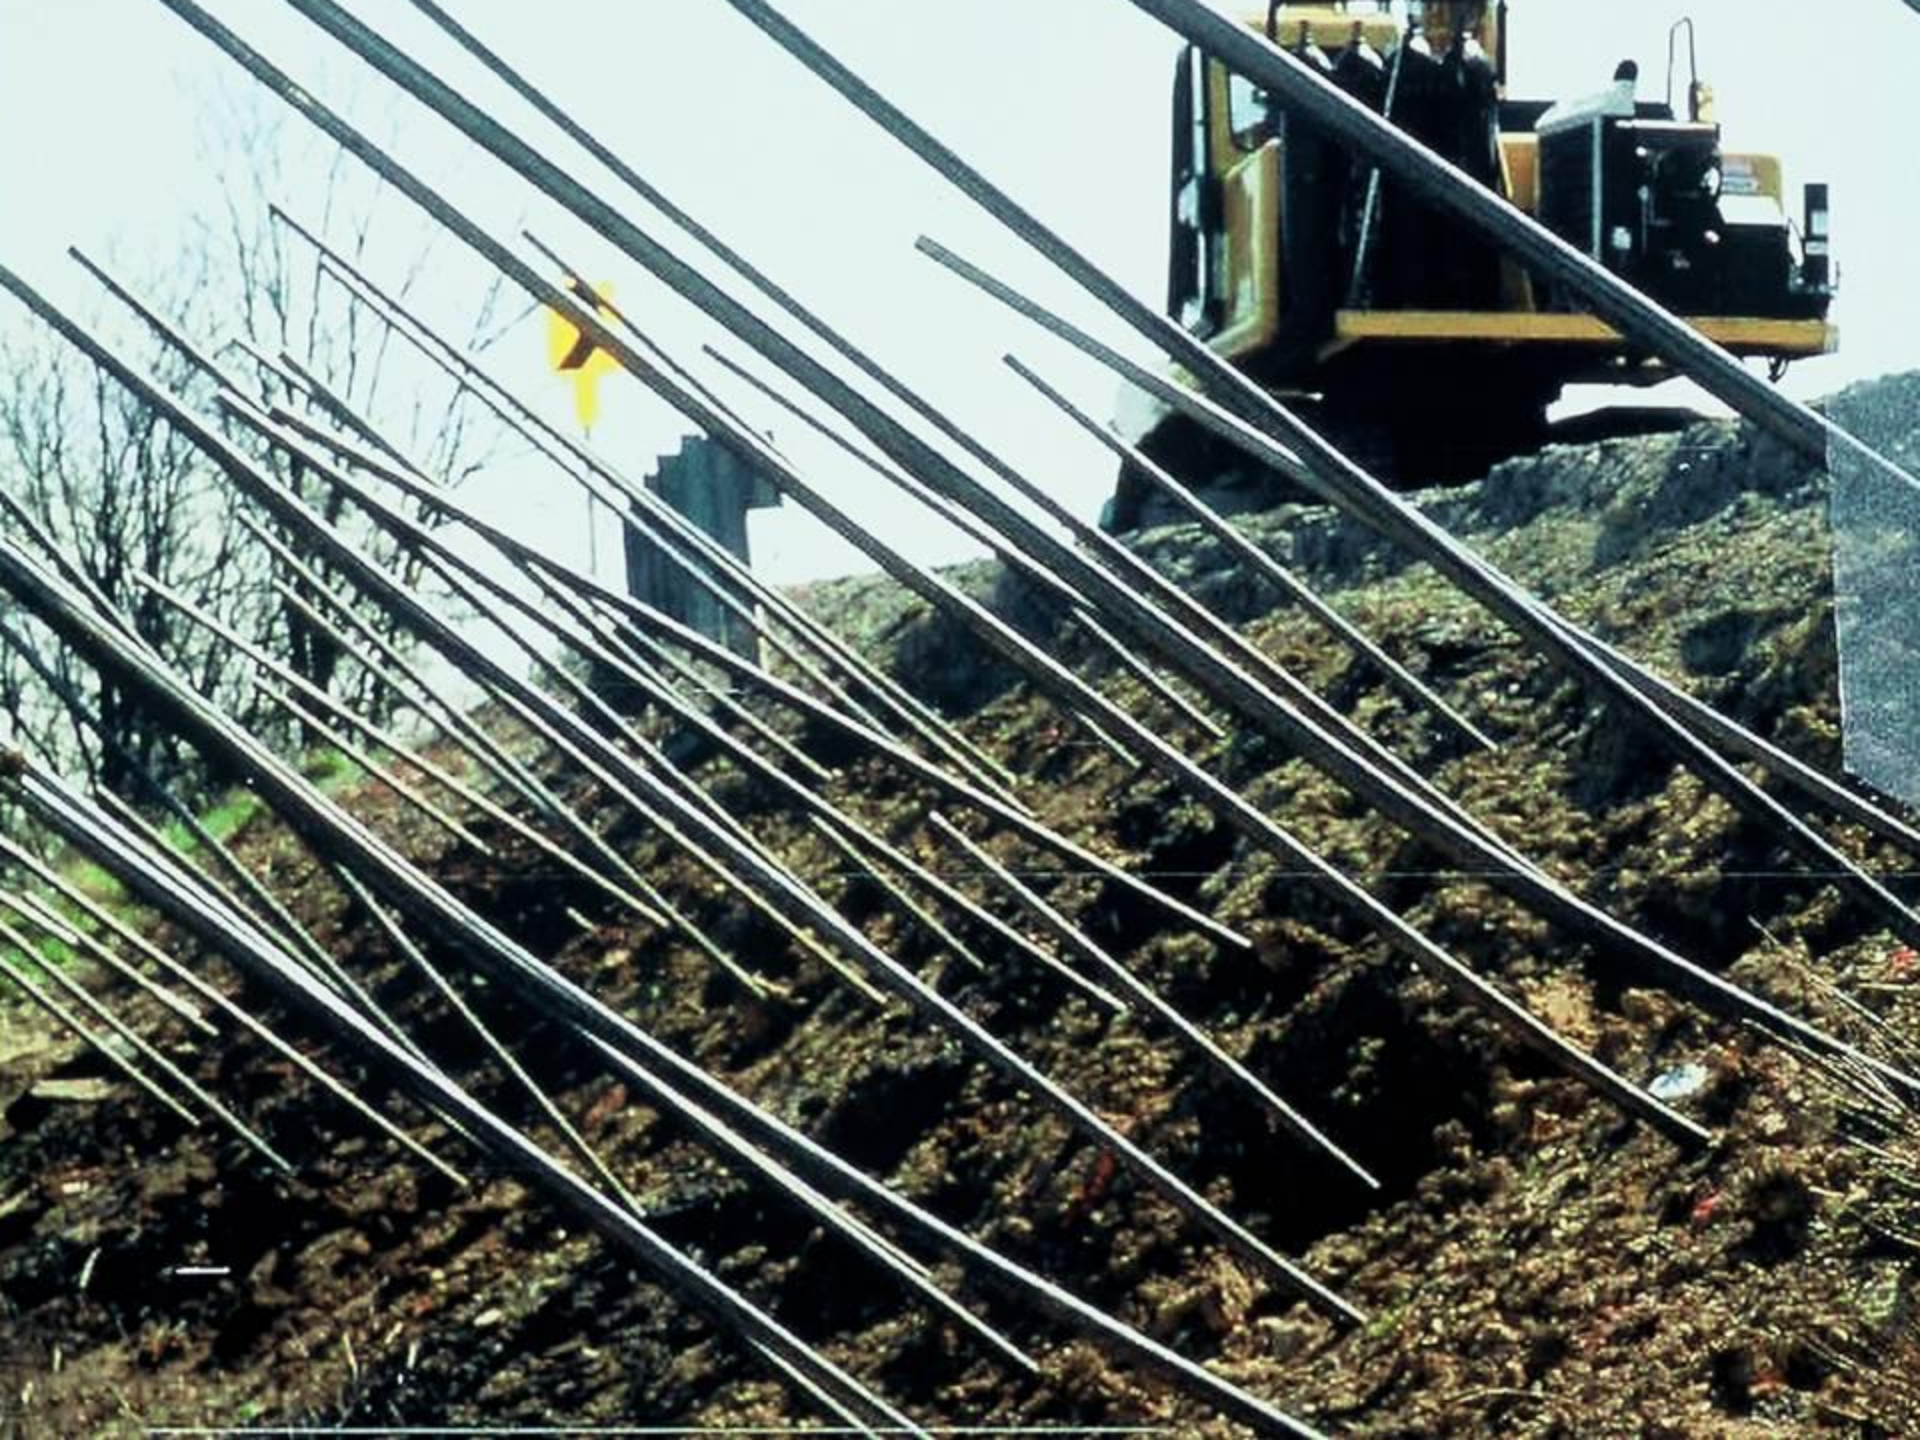
Hollow, Perforated Launched Soil Nails act as drains during high Moisture events, allowing drainage and acting as tensile inclusions, $FOS \gg 1.0$

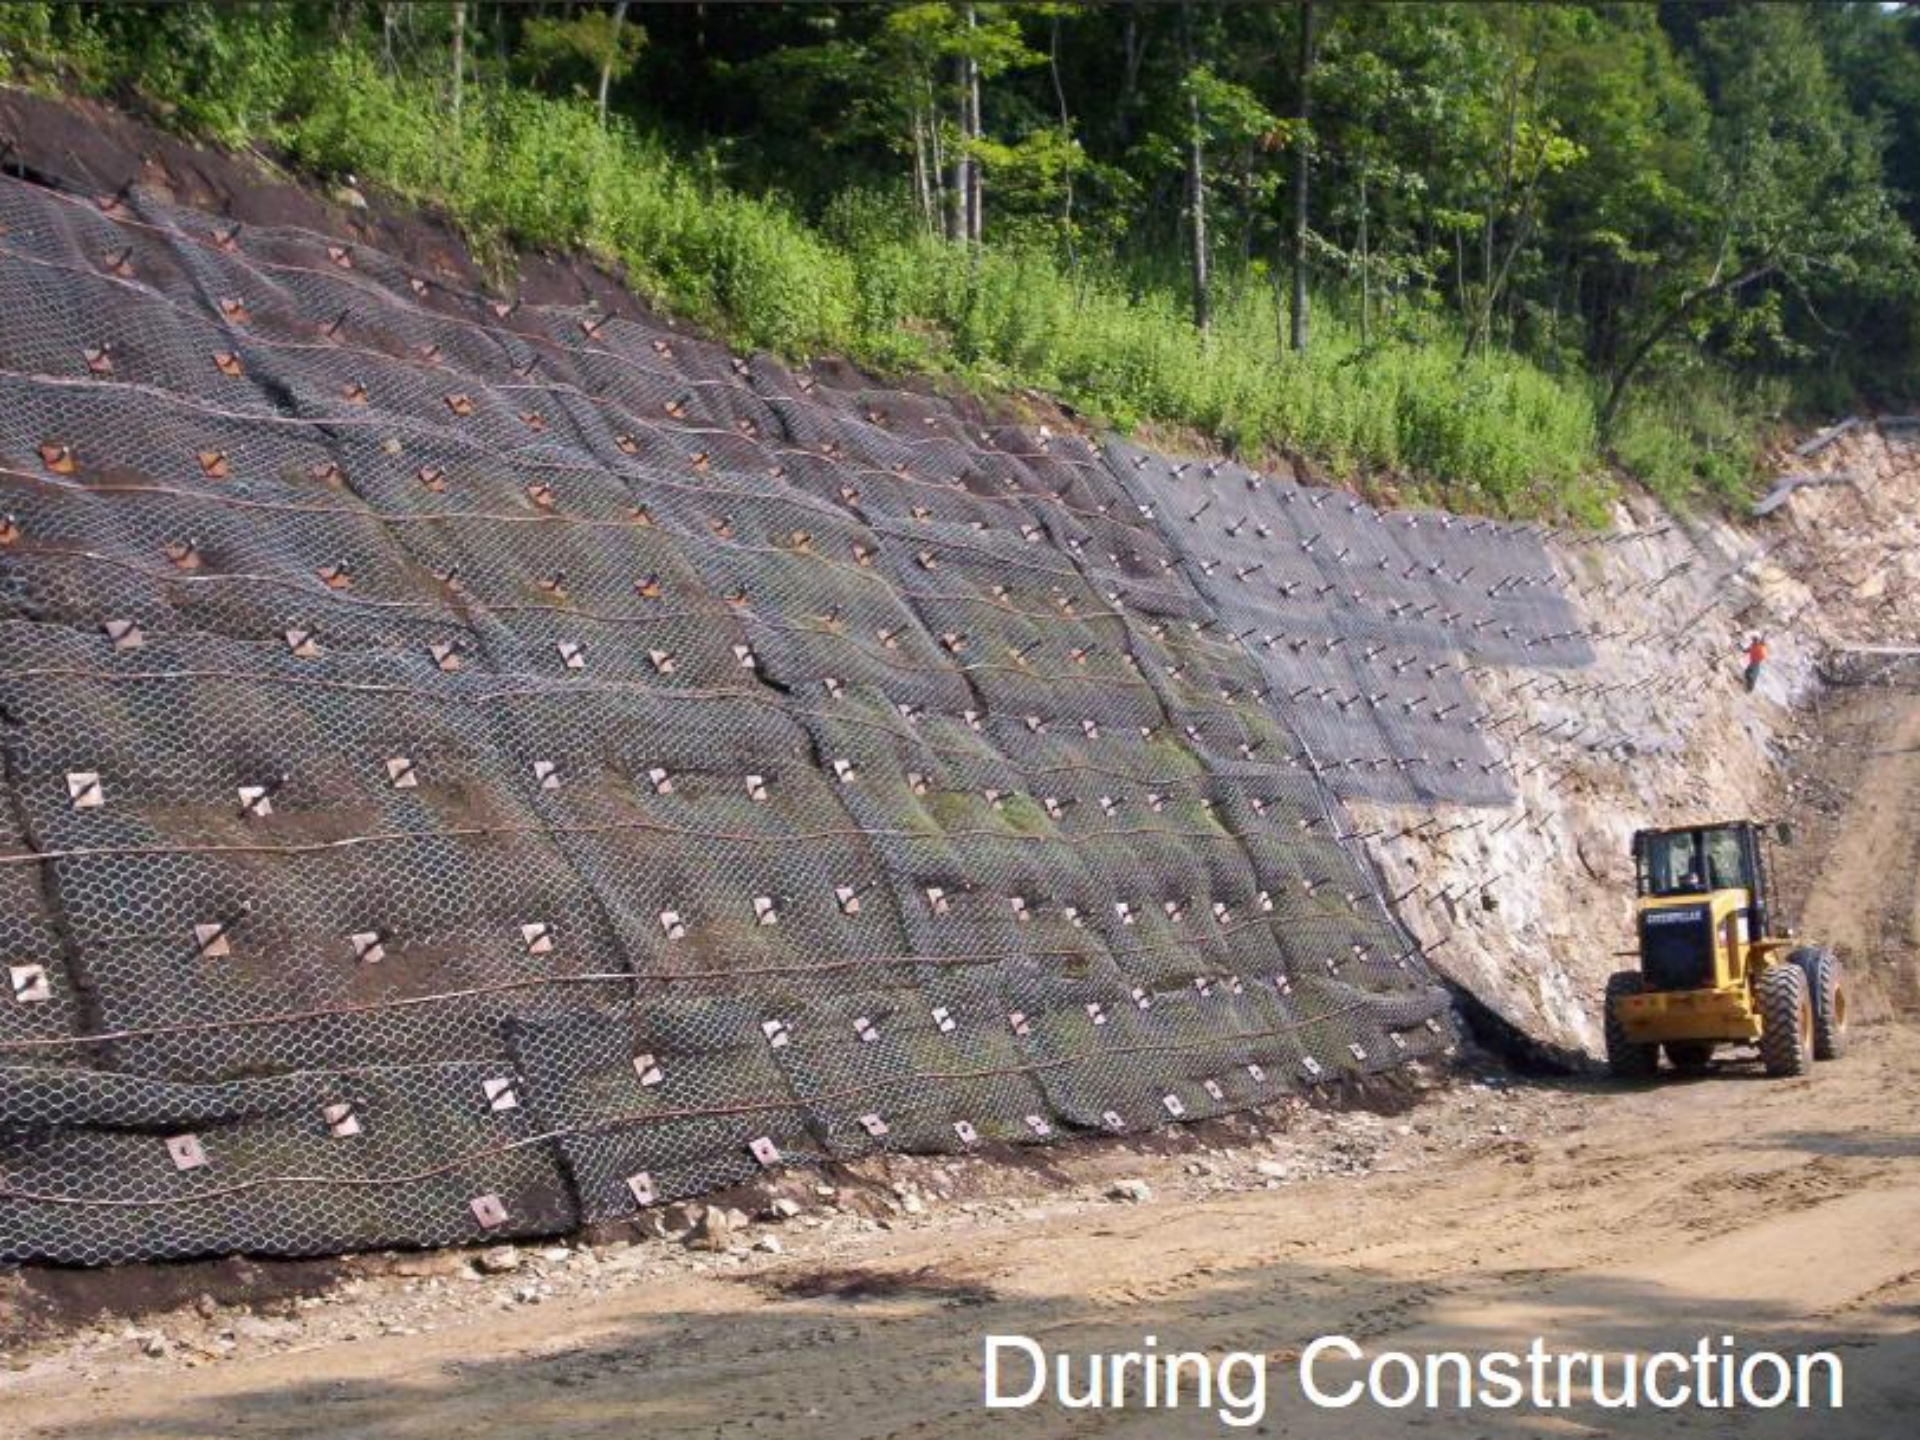
BioWall®
Not to Scale

Almost anything can be planted in this system; including live stakes, sprigs, bare root, plugs and seed.
