Innovative Geotechnical Solutions for Replacement of the Milton-Madison Bridge

Bart Asher, P.E., P.L.S.
Kentucky Transportation Cabinet

Scott Zang, P.E.
Michael Baker Jr., Inc.

River Pier Strengthening Evaluation

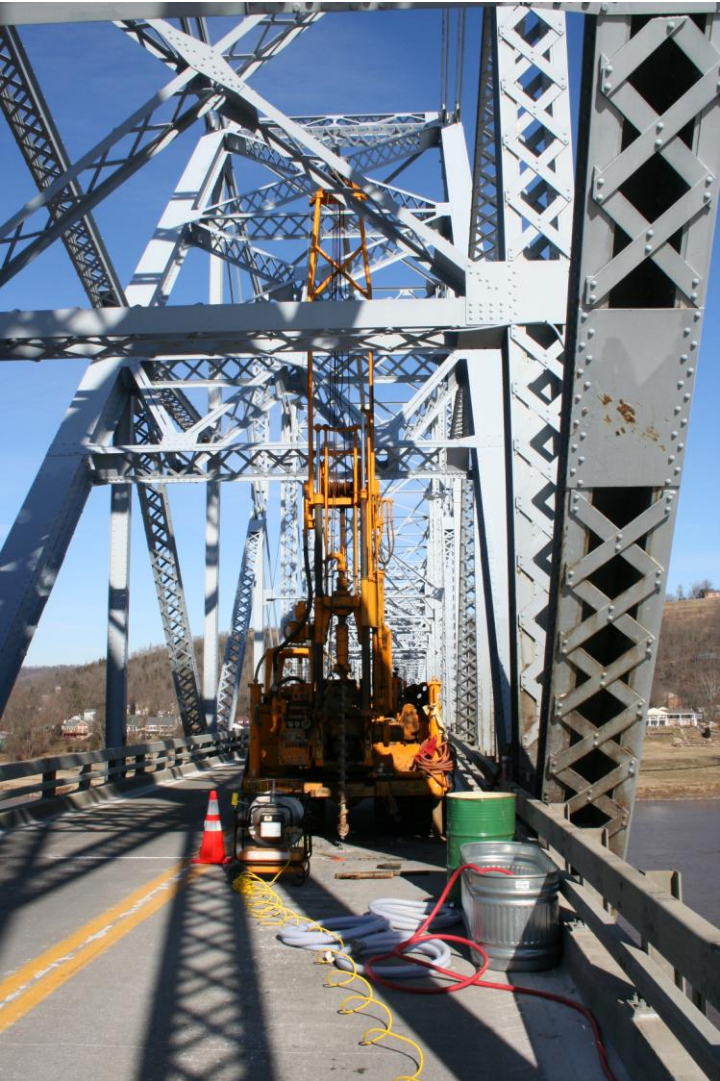
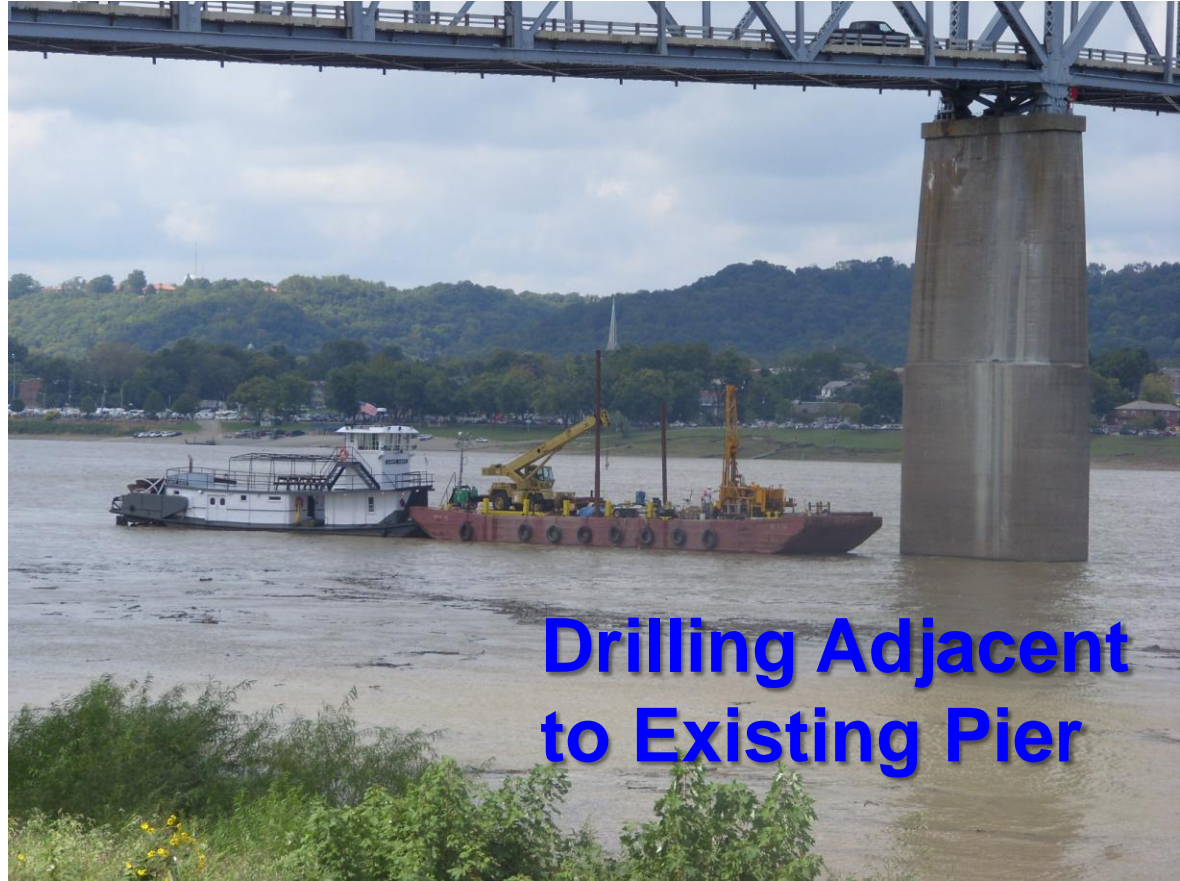
Subsurface Investigation

Drilling Adjacent to Existing Pier

← **Drilling Through Existing Pier**
