MINIMIZING GEOTECHNICAL SURPRISES

James K. Mitchell

43rd Southeast Transportation
Geotechnical Engineers Conference

Will examine two case histories involving geotechnical failures or special problems and evaluate each in terms of whether it should be considered unexpected (an act of God) or could/should have been anticipated.

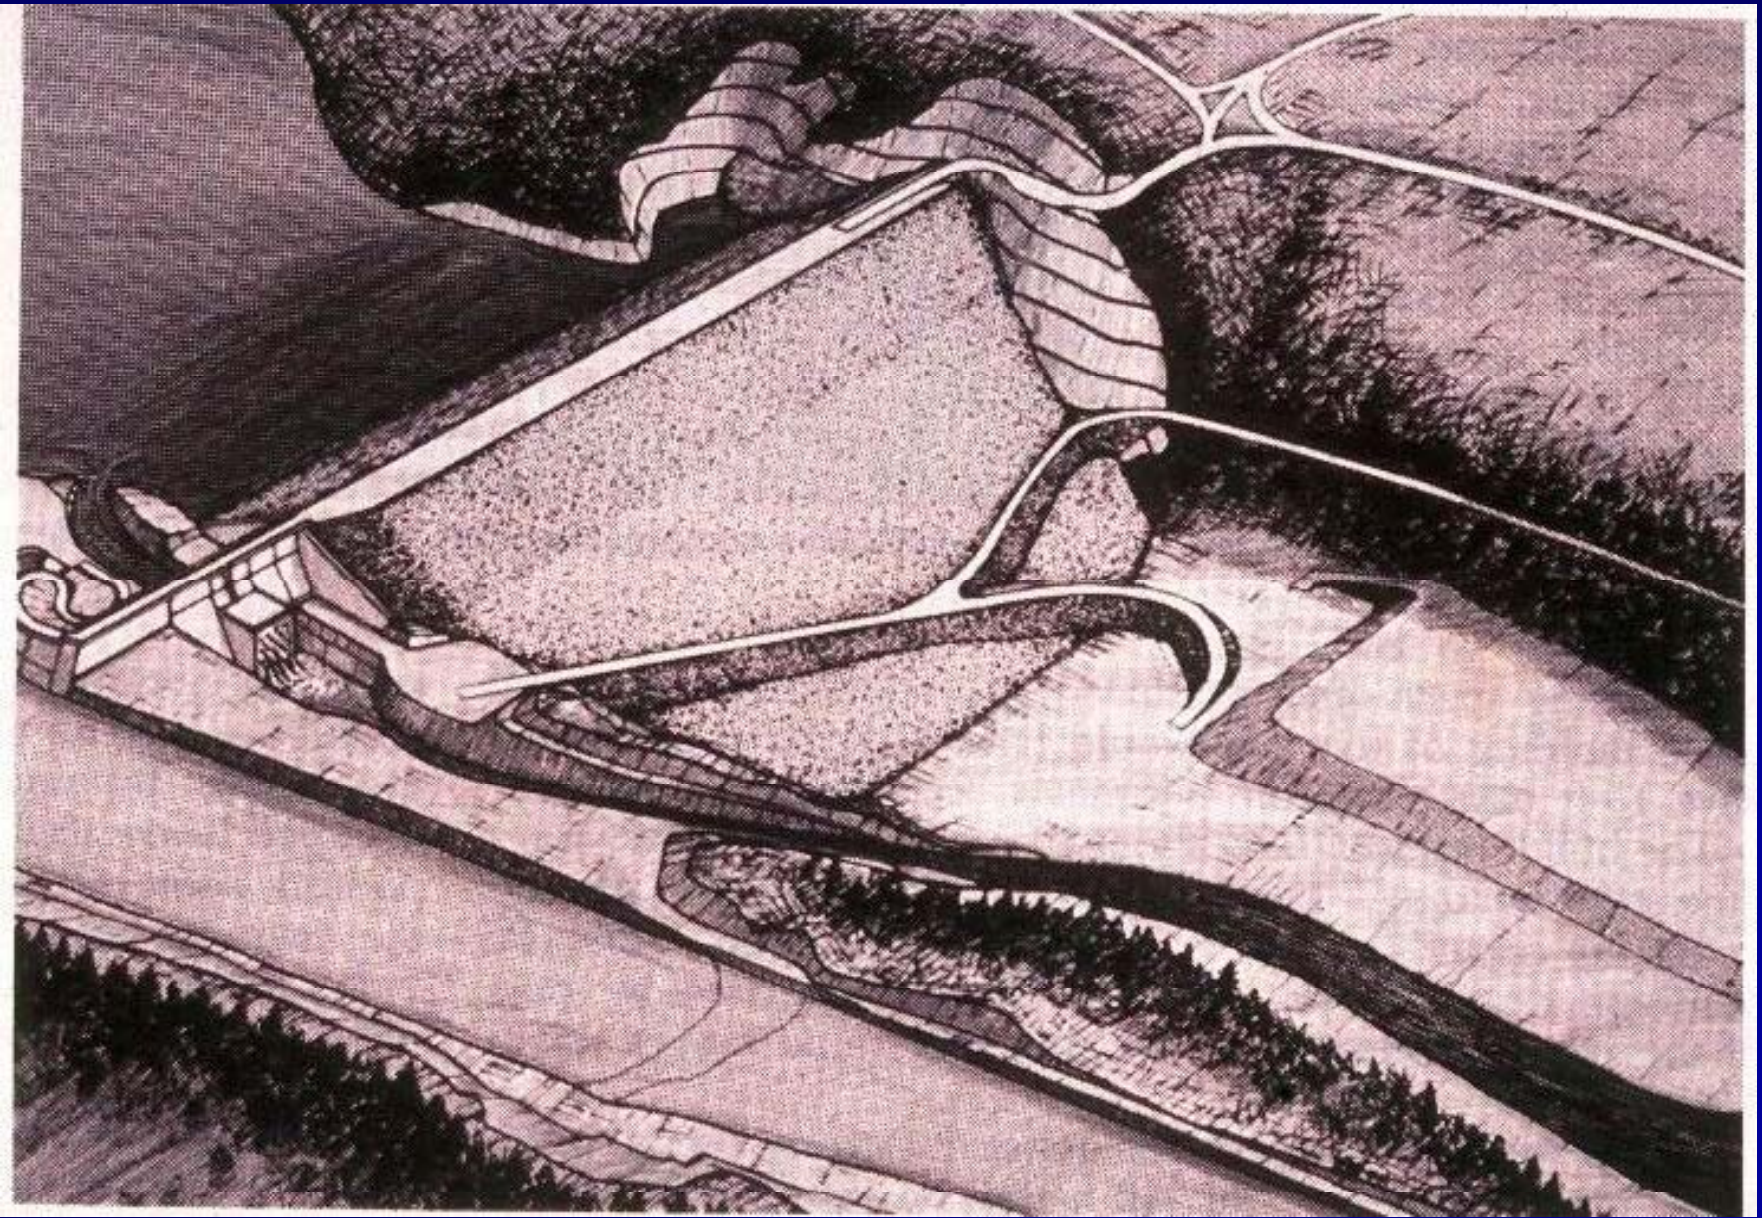
Sediment Retention Structure built by USACE to capture 650 million cu yd (500 cu m) ash and sediment over next several decades. Dam is 1800 ft (550m) long and 184 ft (56 m) high

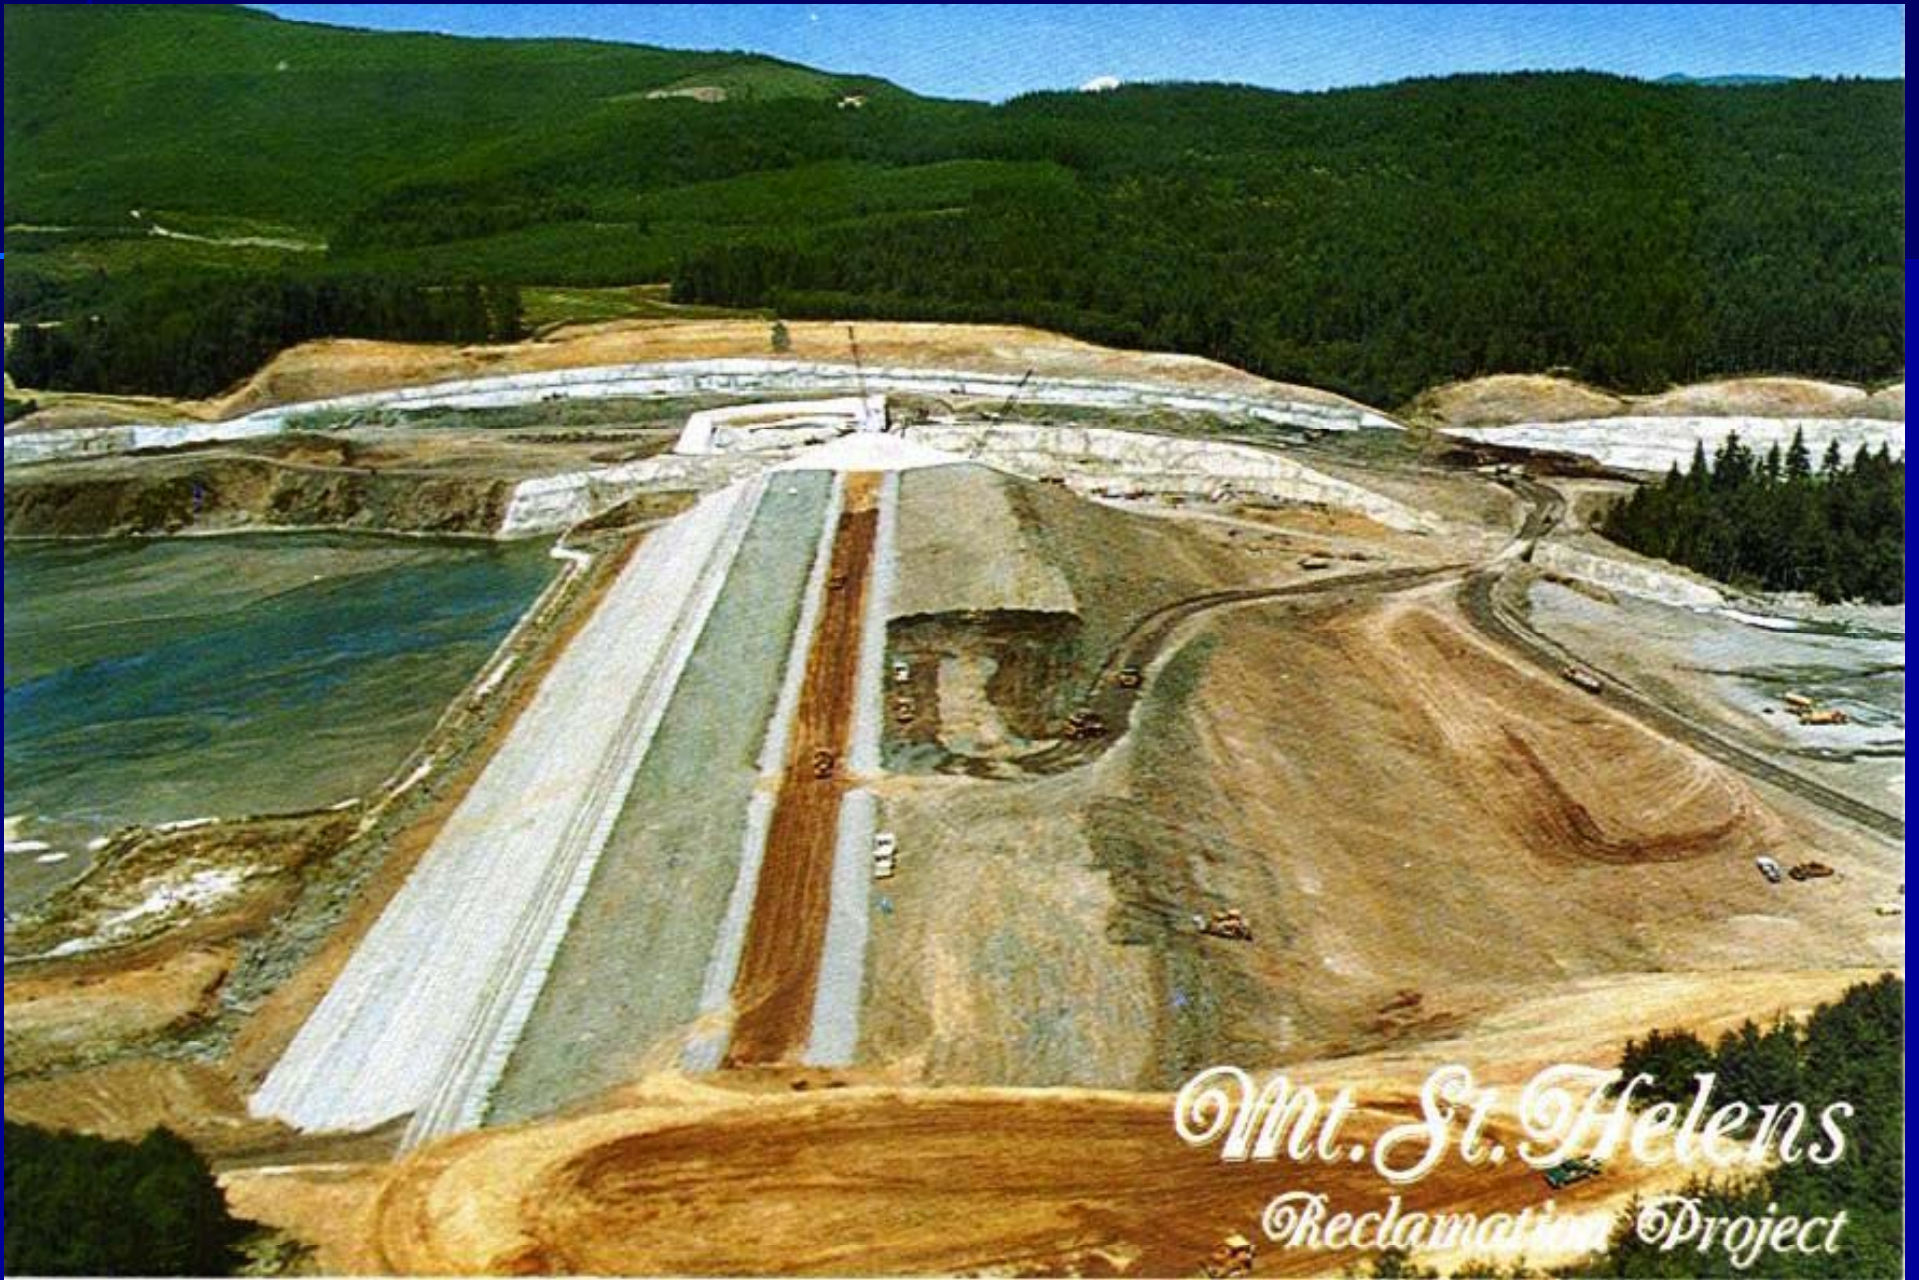
*Mt. St. Helens
Reclamation Project*

The Contractor's Problems:

- Glacial drift gravel was soft and unstable during excavation and wet weather (had hoped to use it as a stable base) - would not support construction equipment.
- Stockpiled excavated material was unstable - flowed up to 500 ft (152 m) until stable slope at 2 - 5 degrees.
- Fine-grained sediments above gravels were unstable.
- Slimes in right abutment area unable to support construction equipment.
- In-situ water contents well above optimum.
- Right abutment impervious overburden, designated for use in core, softened during compaction and appeared wettest in areas subjected to heaviest construction traffic.
- Flow breccia exhibited slaking.

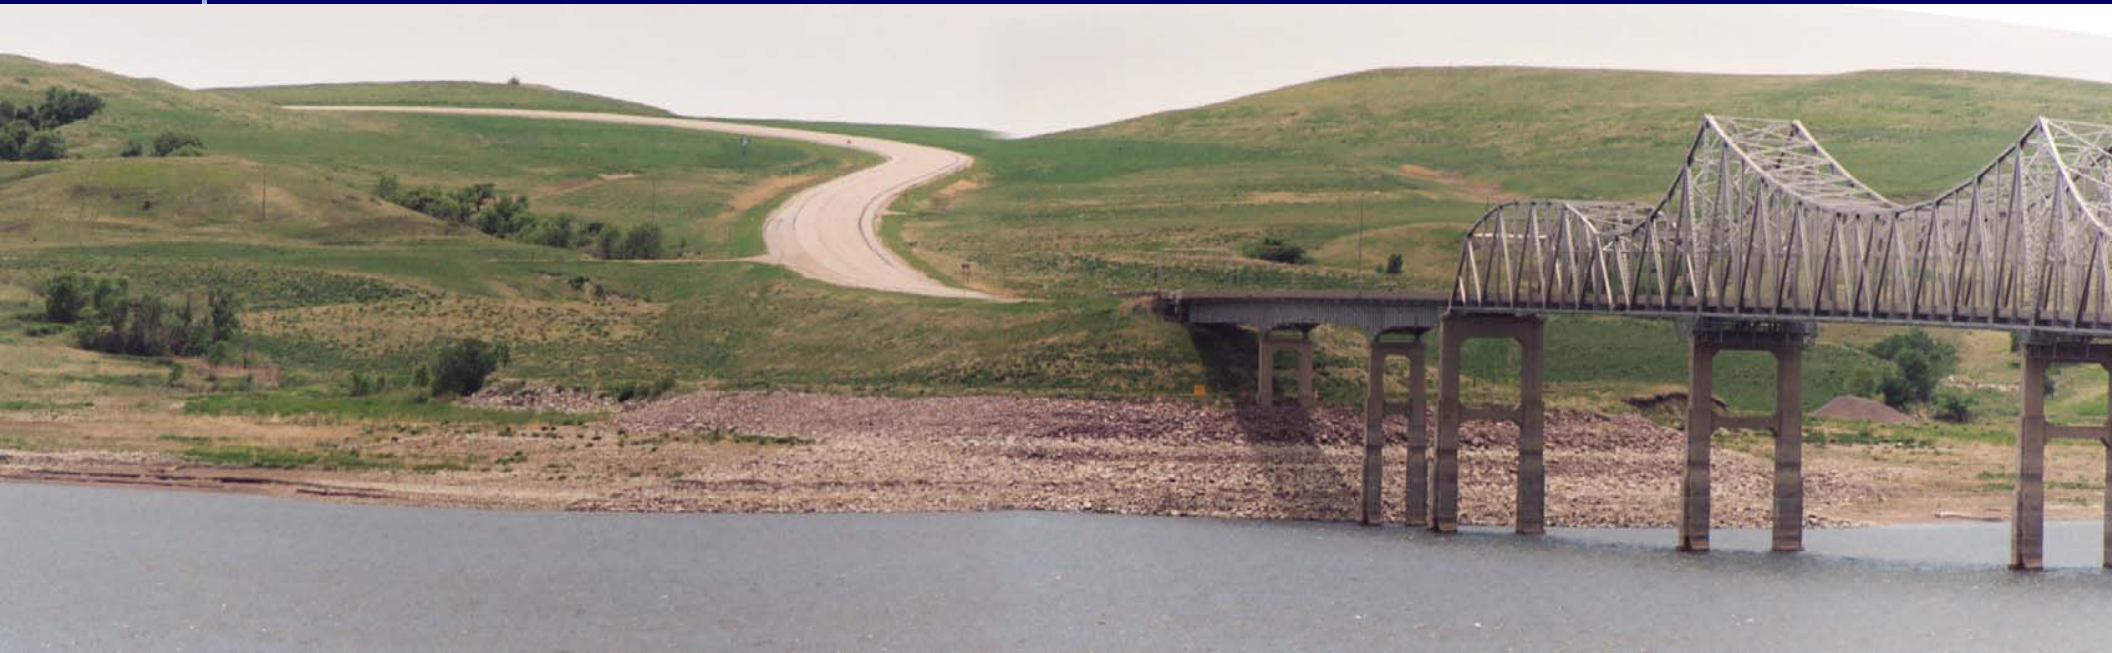
View of Cut Six Years Later

Excavation of slide near its head. (Slide courtesy of Vern Schaefer)
