TROUBLESHOOTING PILE DRIVING PROBLEMS WITH A-GAME METHODS STGEC 2023

Jesse G Rauser, PE
Assistant Geotechnical Engineer Administrator
LADOTD

LA 75 - BAYOU BREAUX BRIDGE

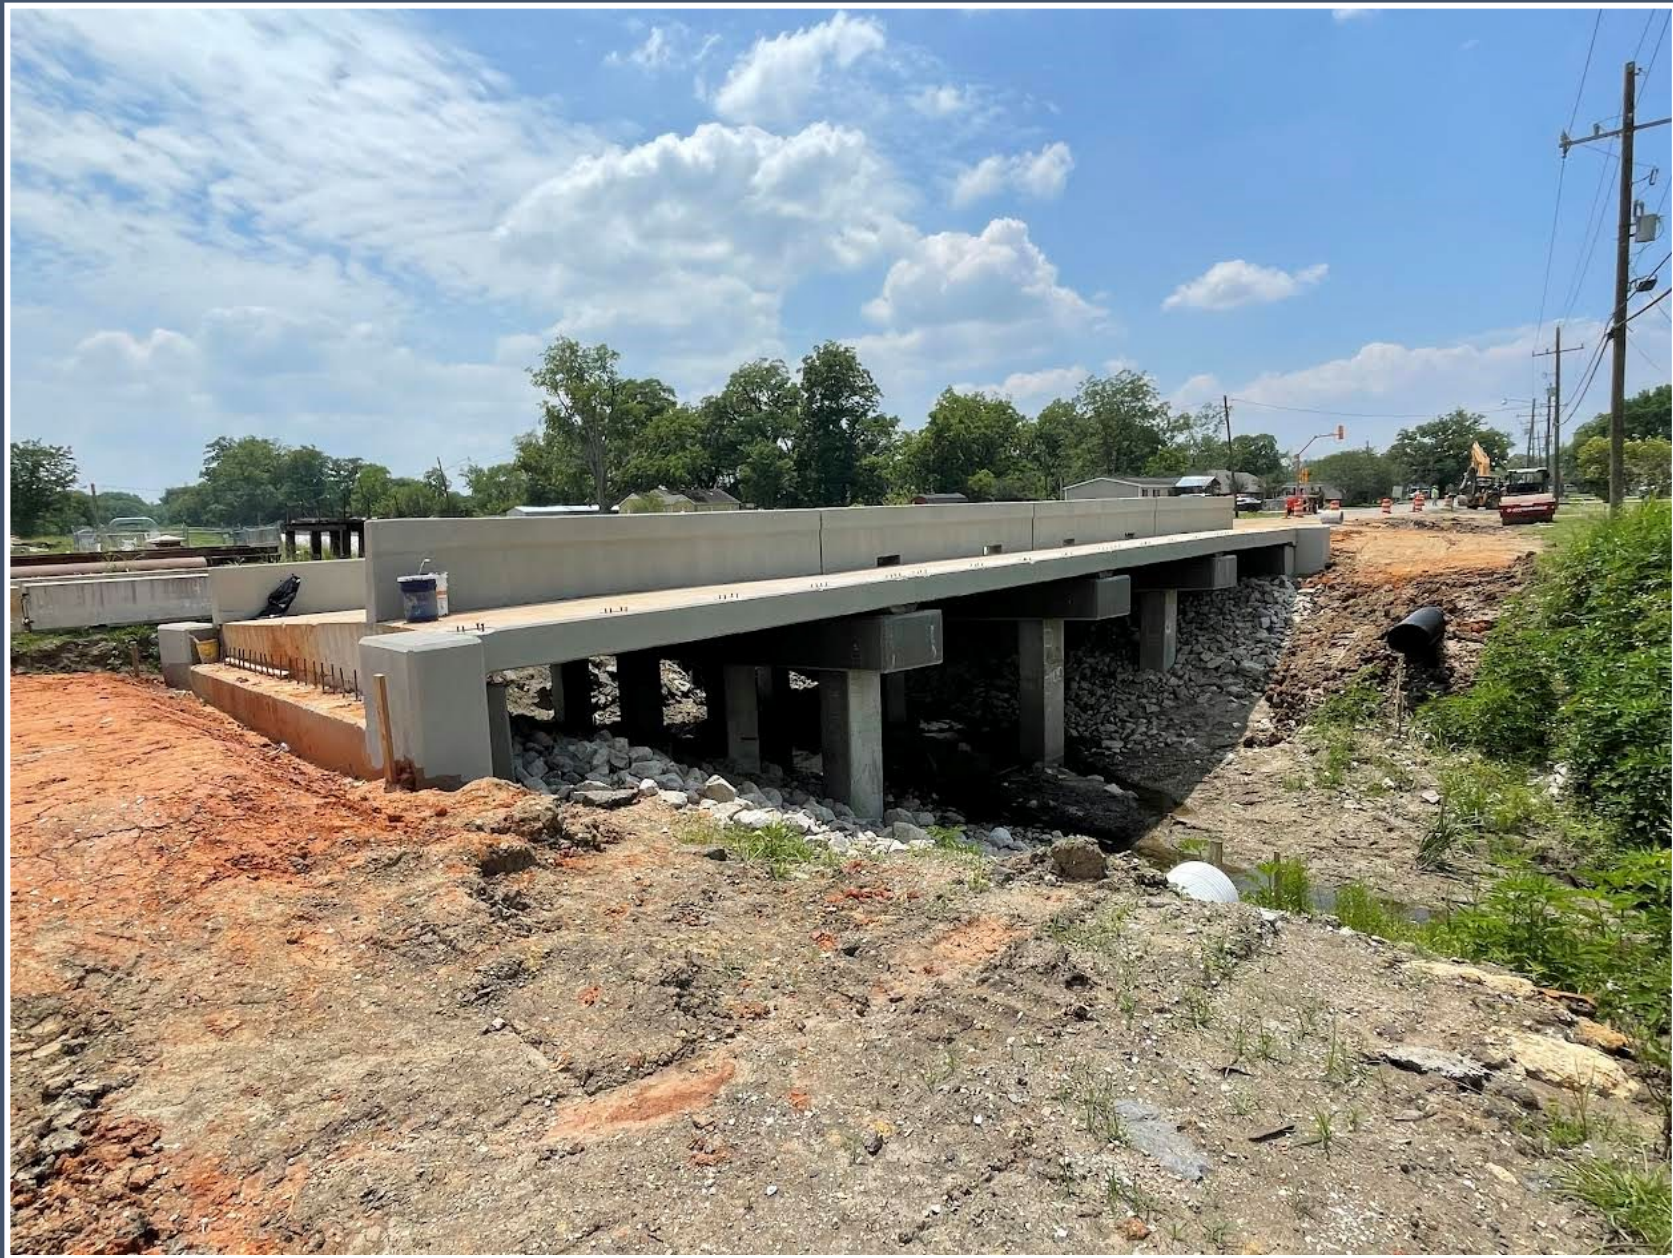
Abandoned Broken Pile

- Pile Driving Analyzer (PDA) was added to monitor the stresses on the piles
- Bent 2 was redesigned from a three-pile bent to a four-pile bent
 - The piles were all driven to grade at Bent 2 without hitting any “obstructions” or damaging the piles
- The damaged pile was cut-off at the ground surface, re-driving the pile was deemed unsafe
