# Clearing the Fog on the Aging I-77 Rock Slopes

**Ryan Tinsley, PG**  
HDR Engineering, Inc.

**David Lee, PE**  
VDOT Materials Division  
Salem District

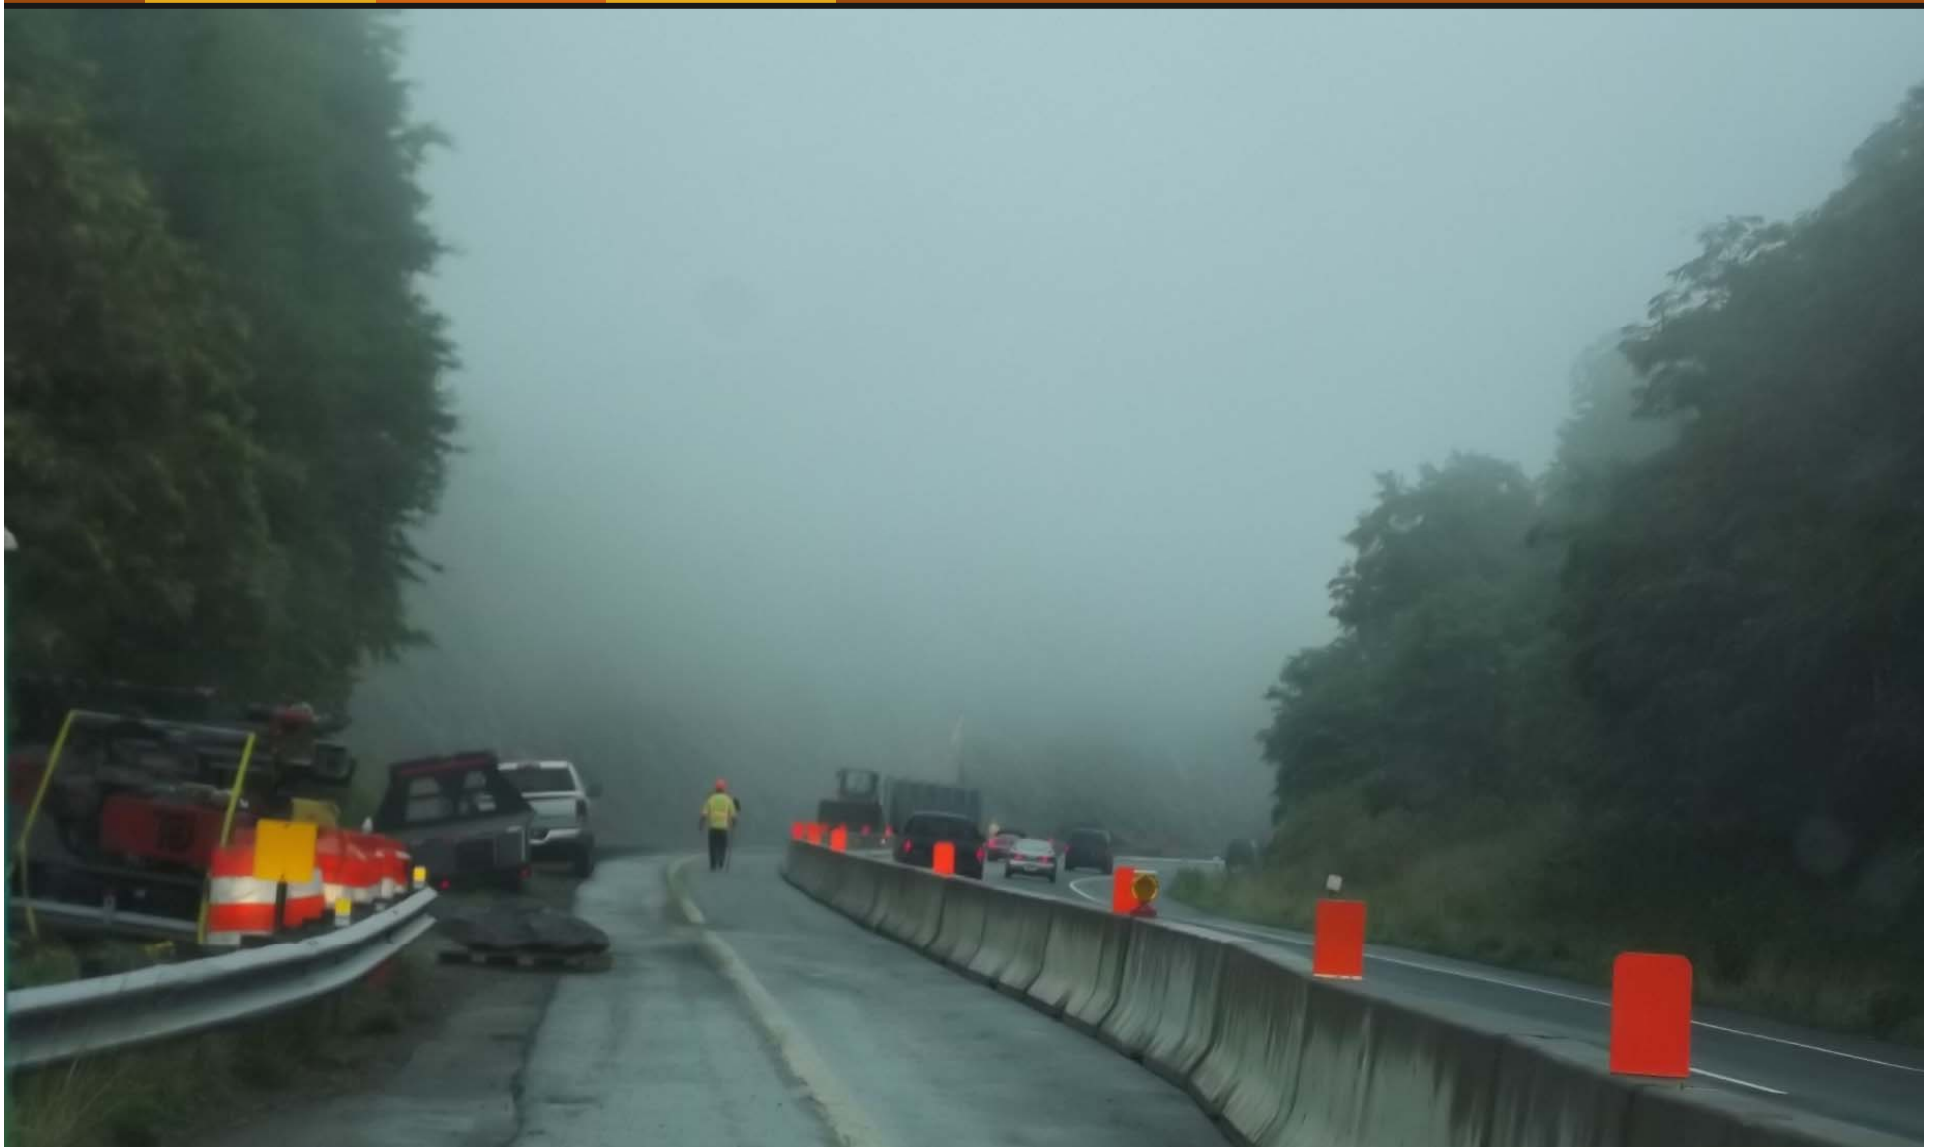
# I-77 Corridor Challenges: Foggy Conditions

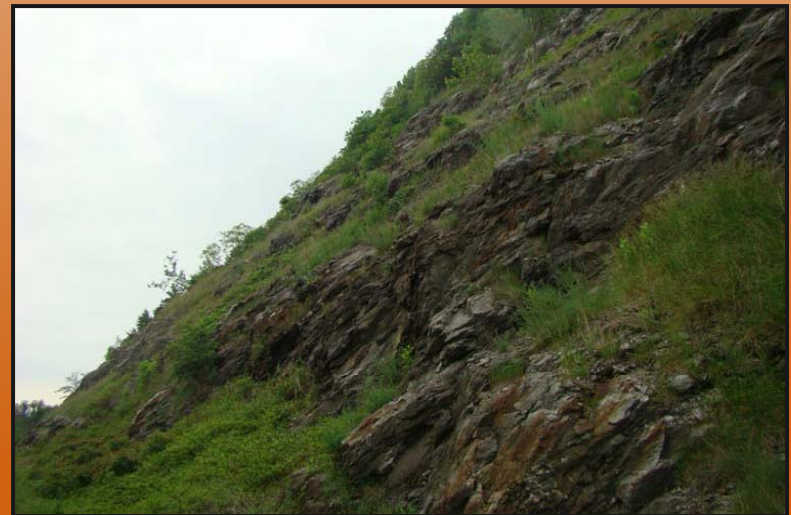
Continuous and Adverse Orientation

Slopes Showing Their Age

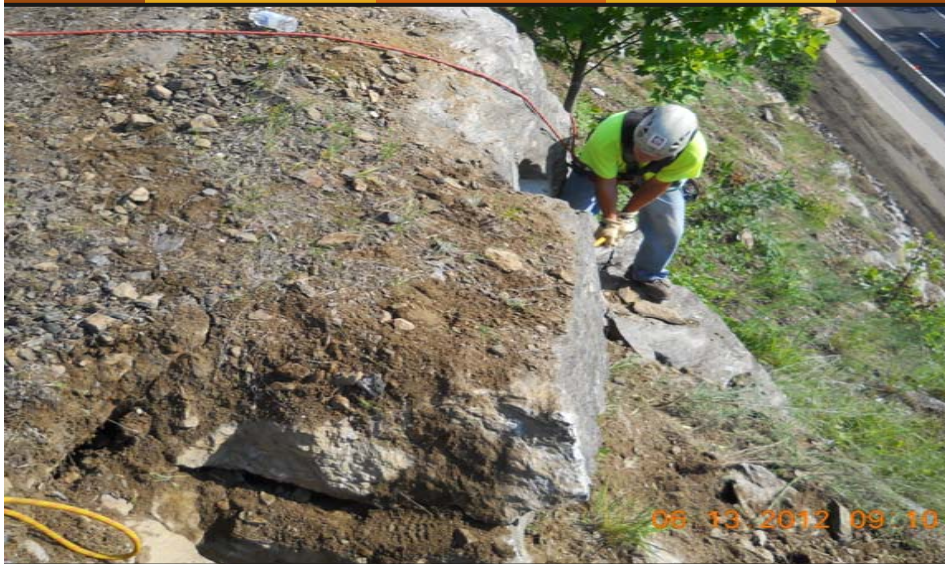
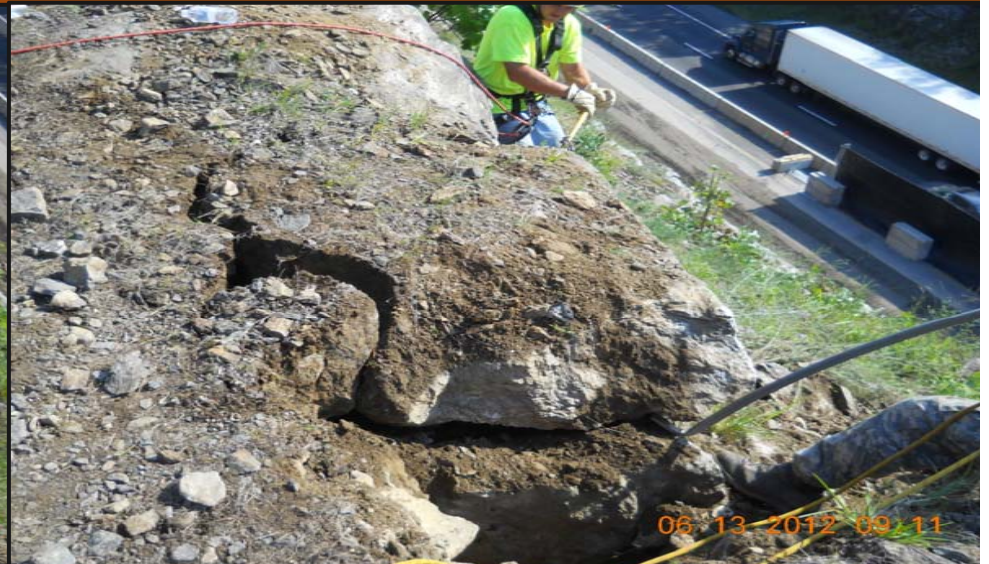
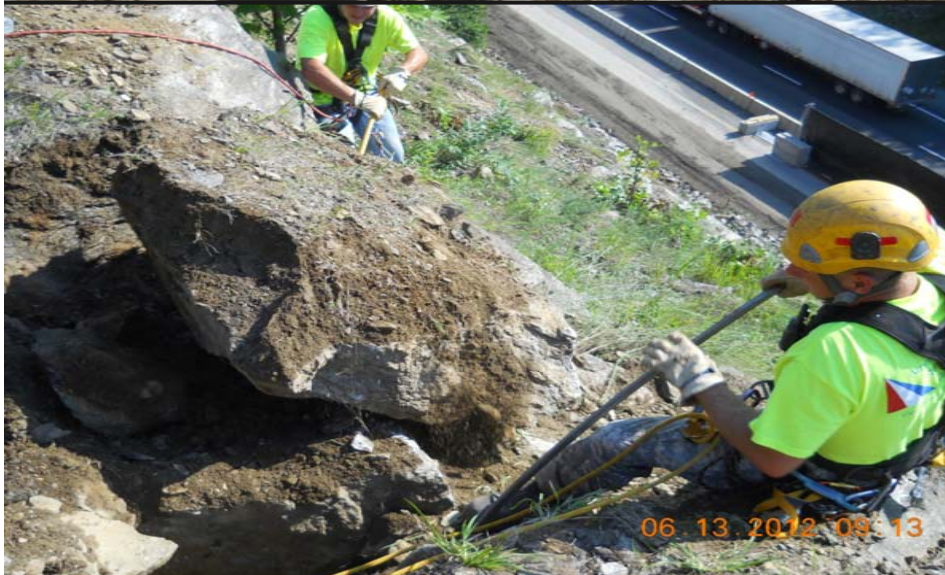
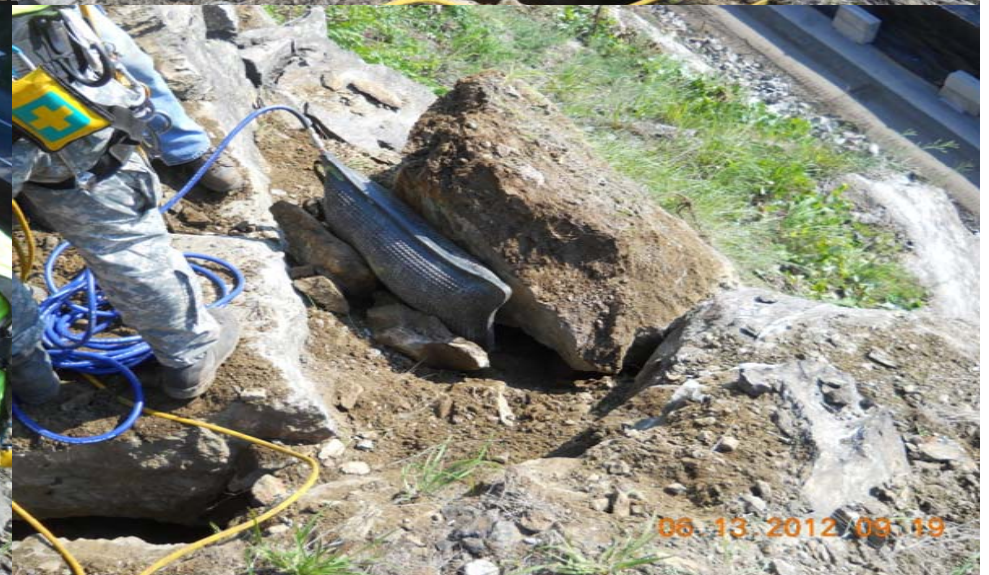
# Scaling Around Overhangs

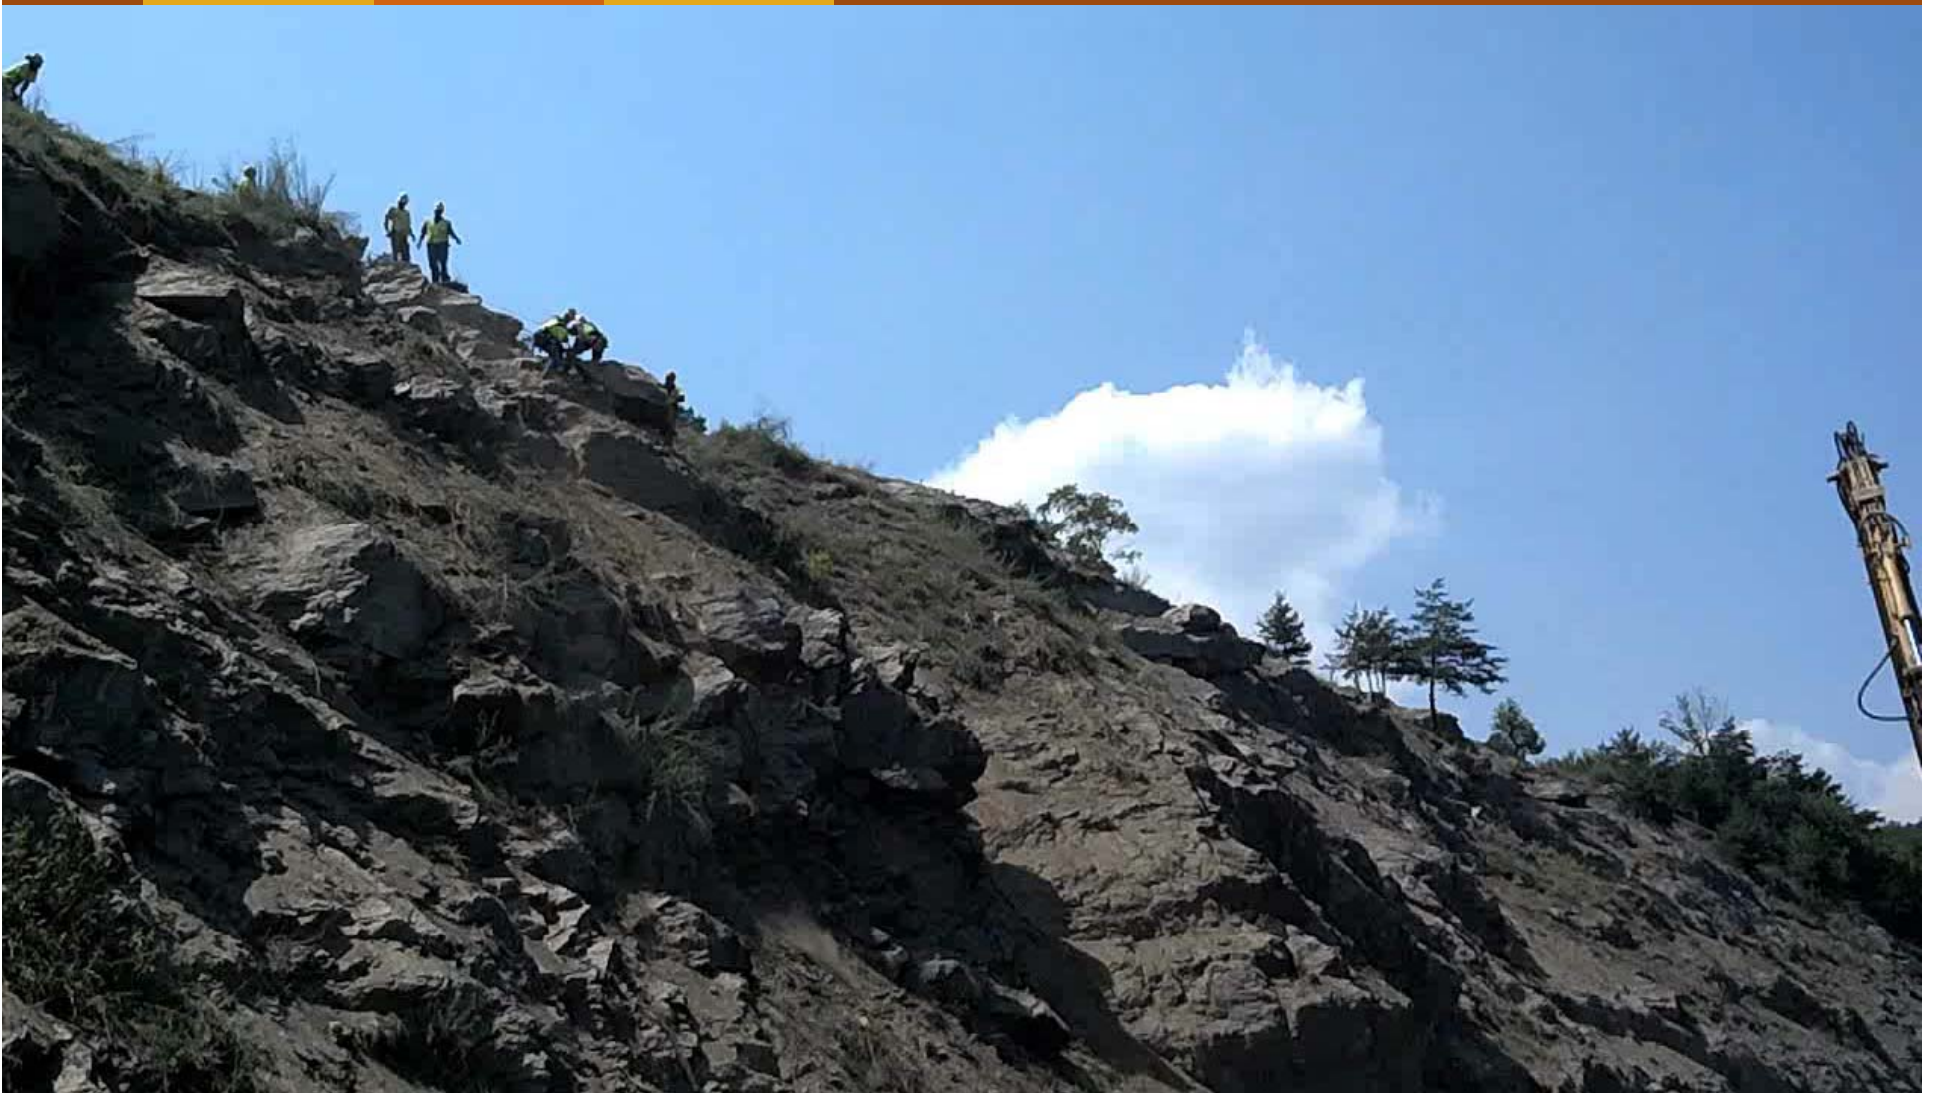
# Scaling Around Overhangs

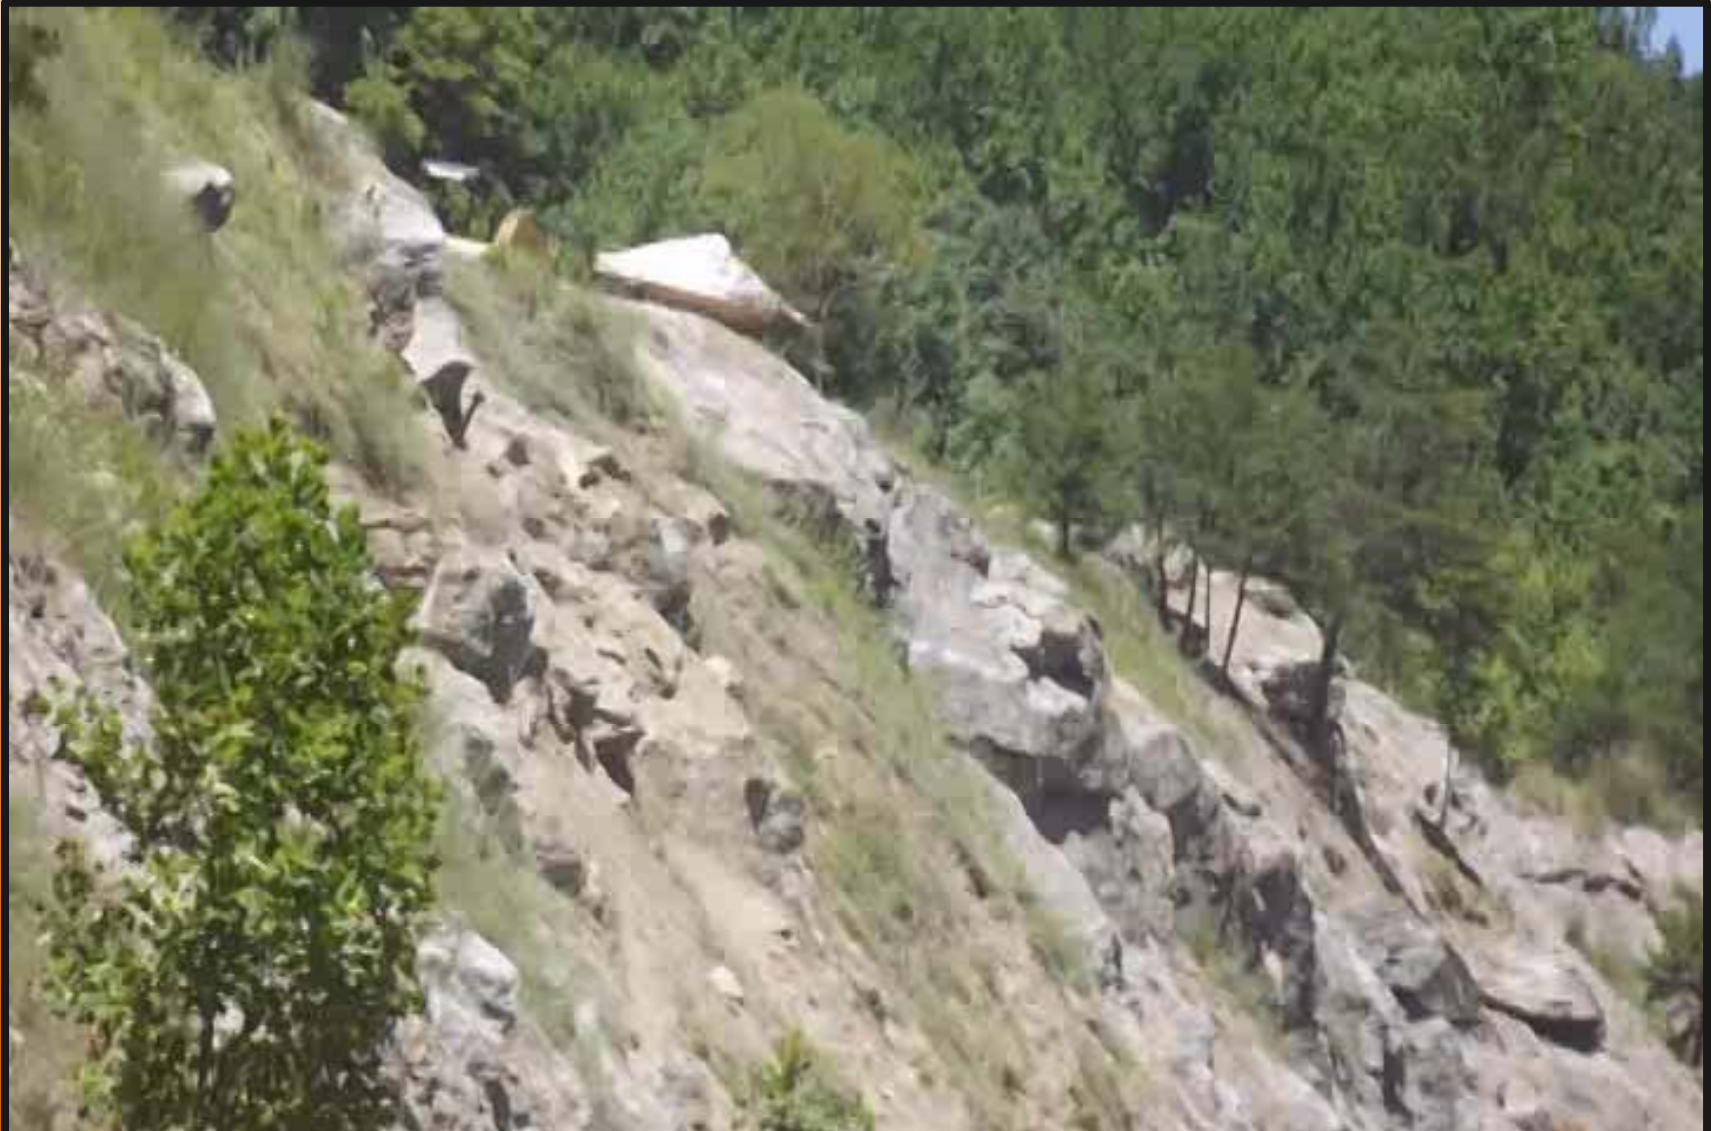
# Rock Overhang Blasting

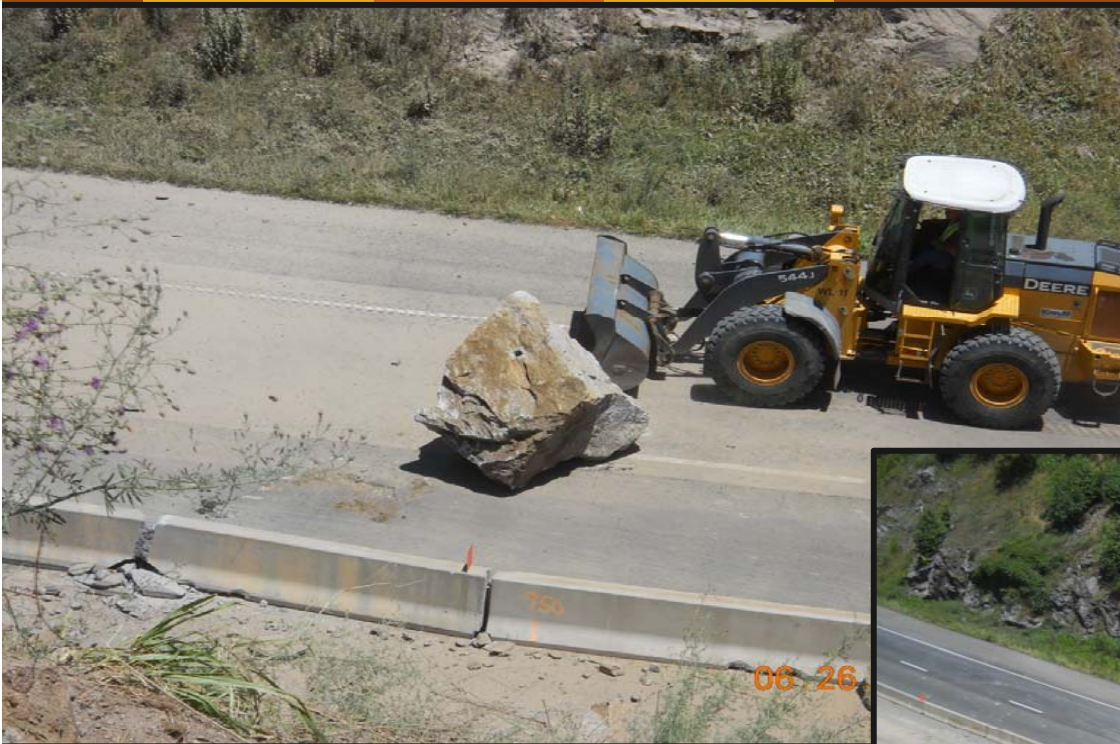
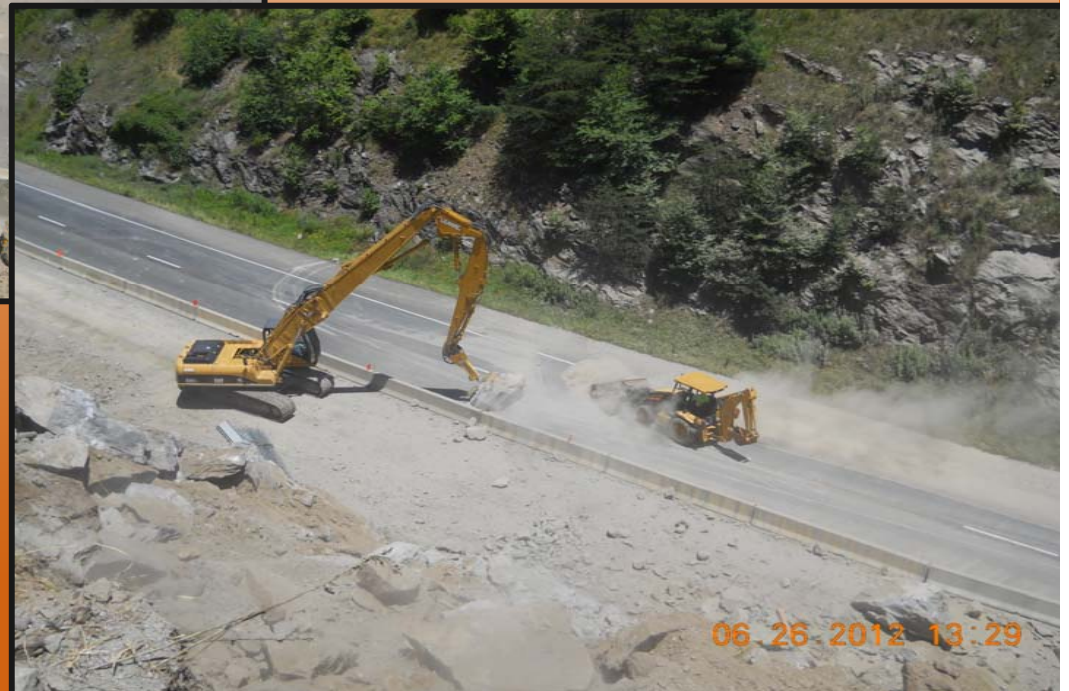
# Rock Removal After Blast

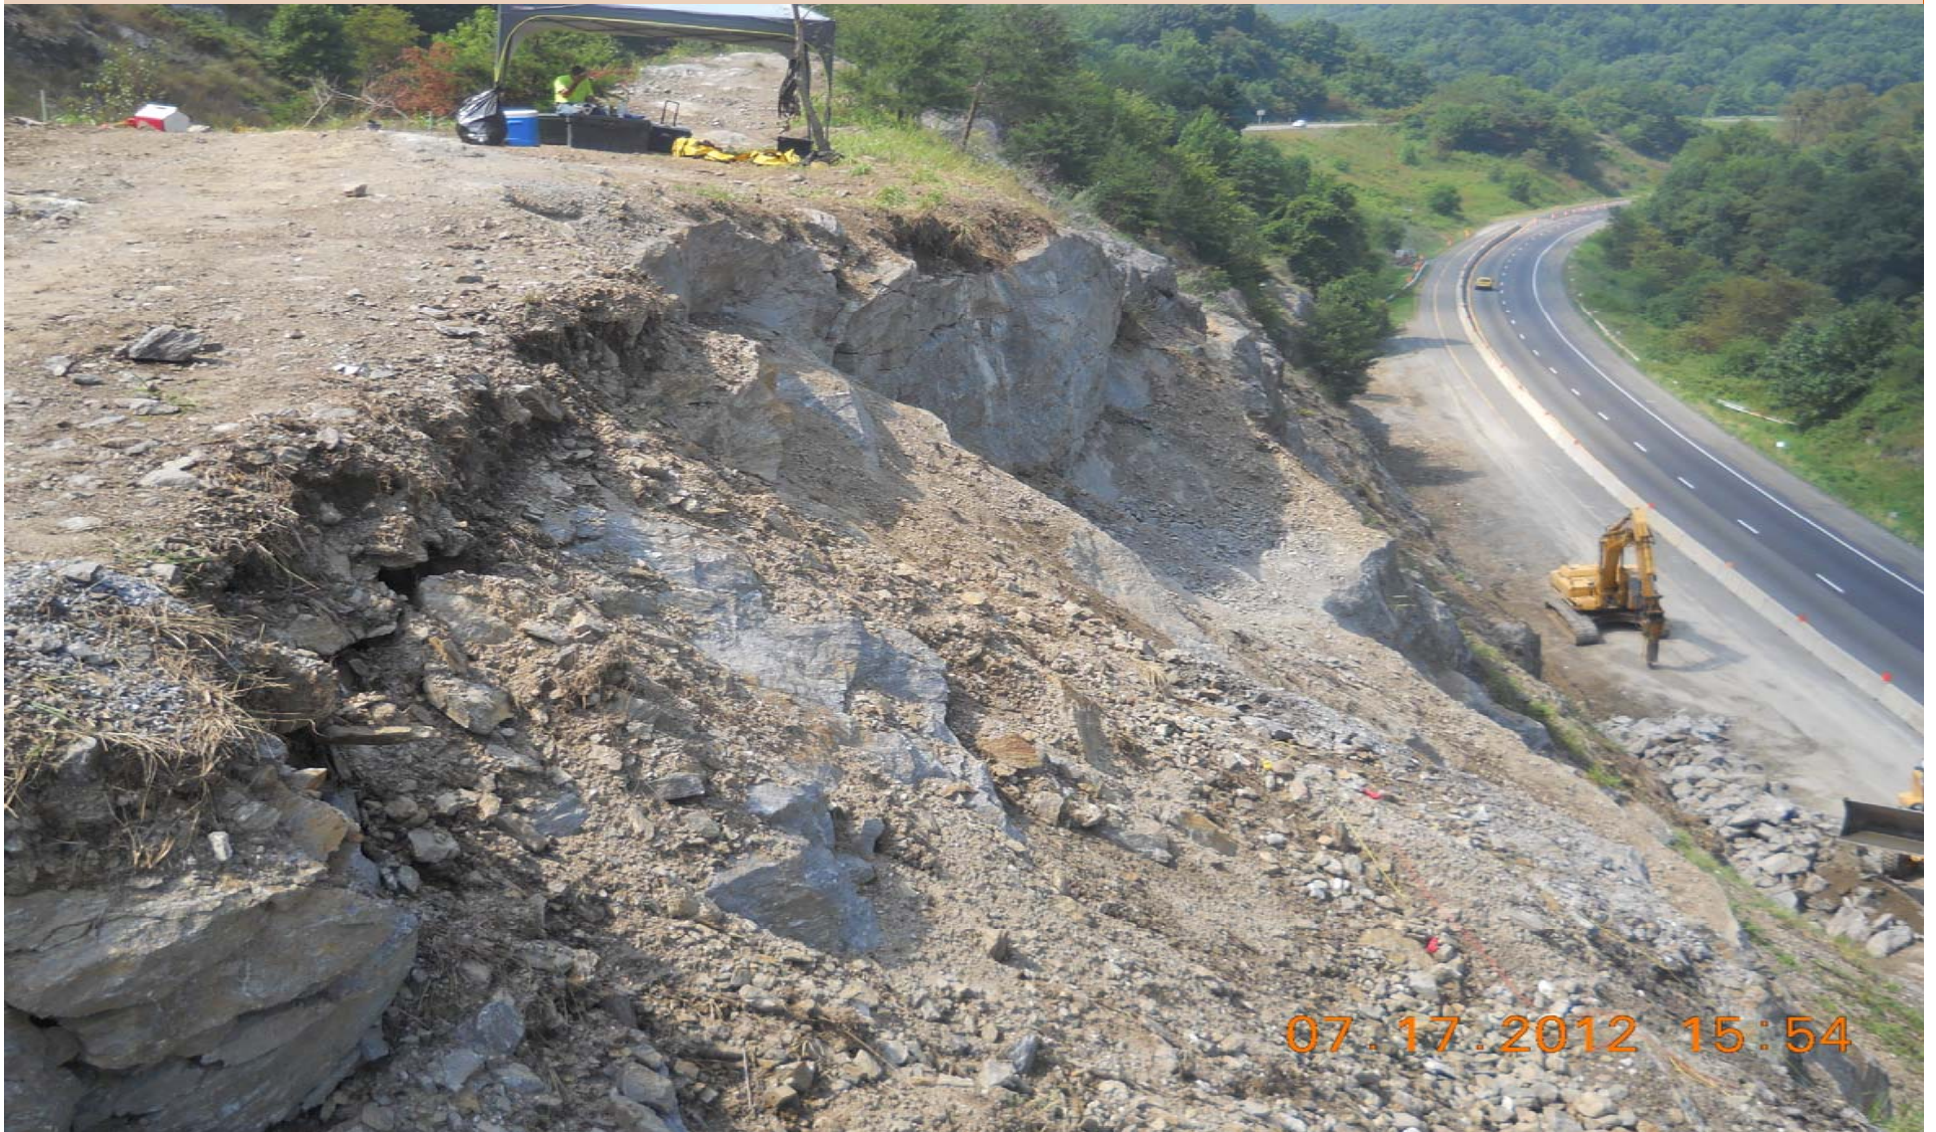
# After Blast & Clean Up

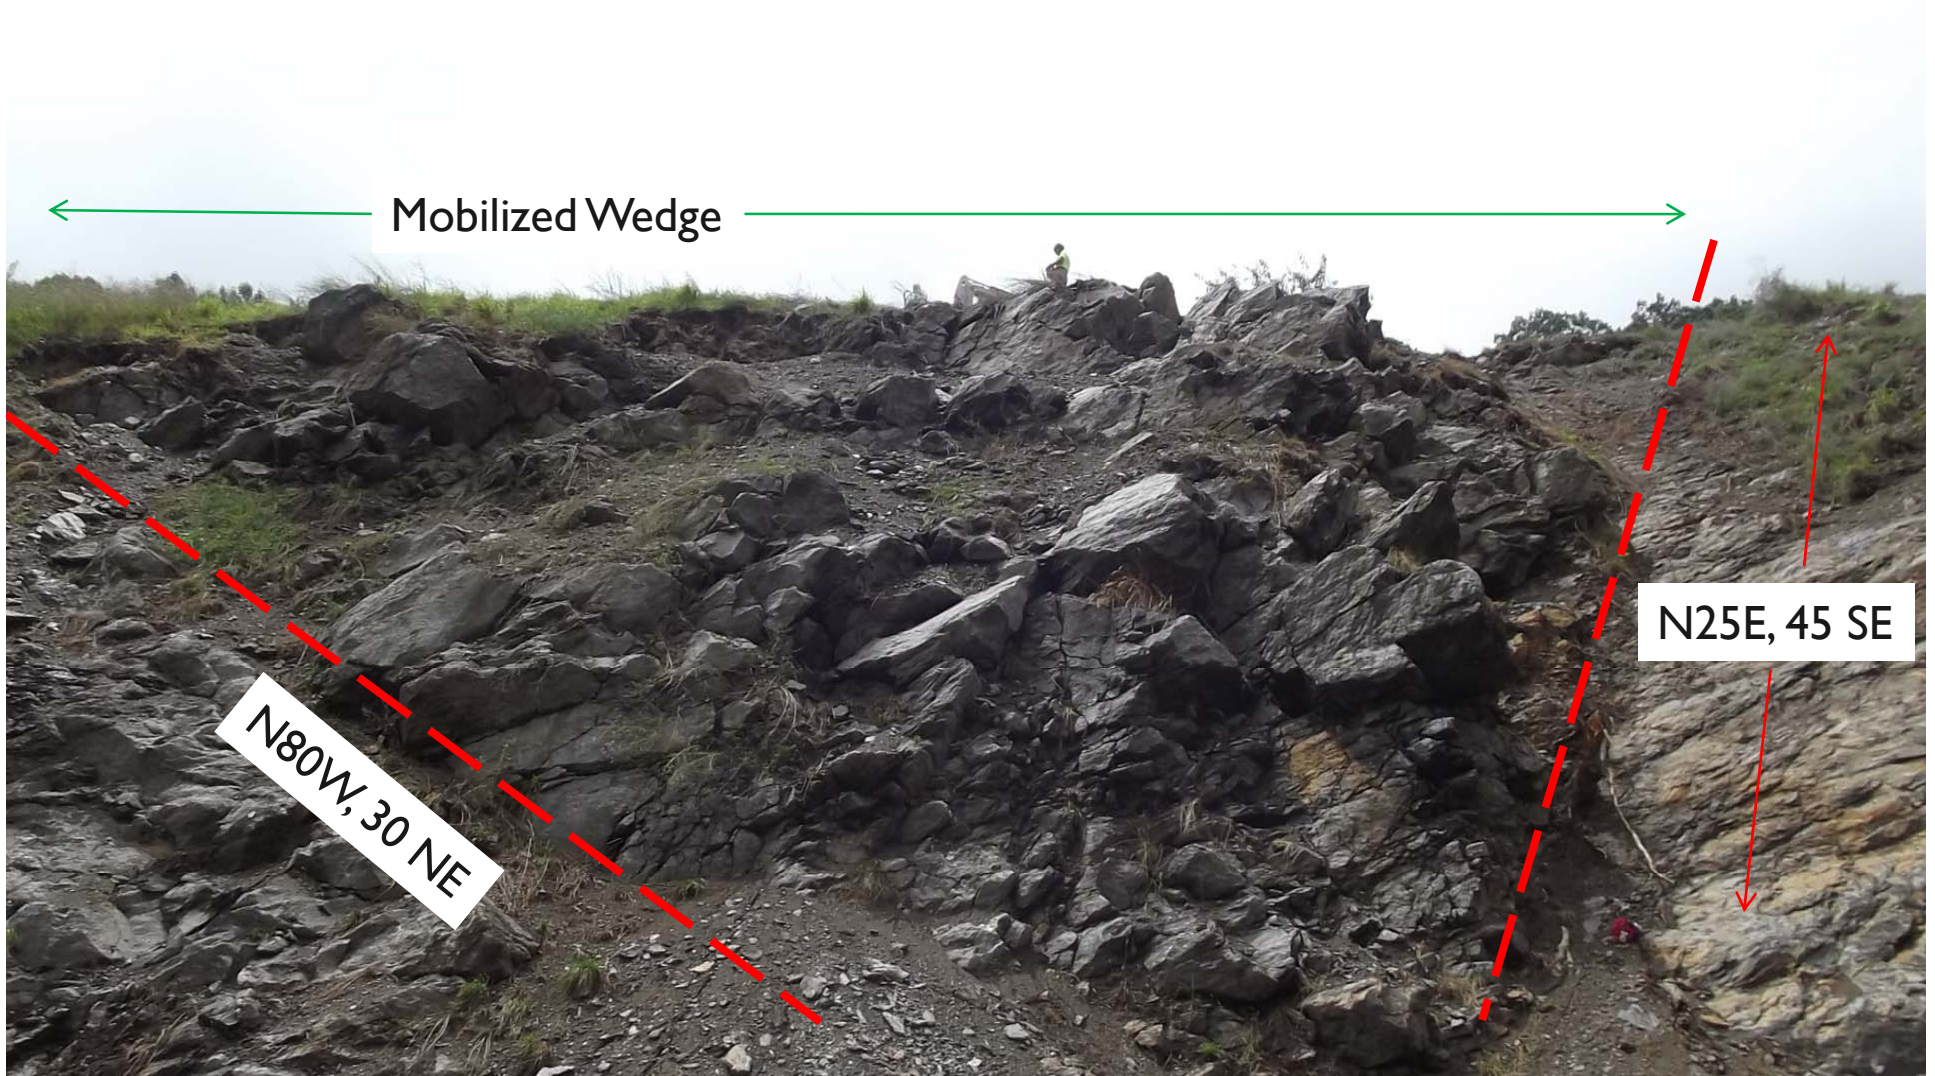
# Large Wedge Removal

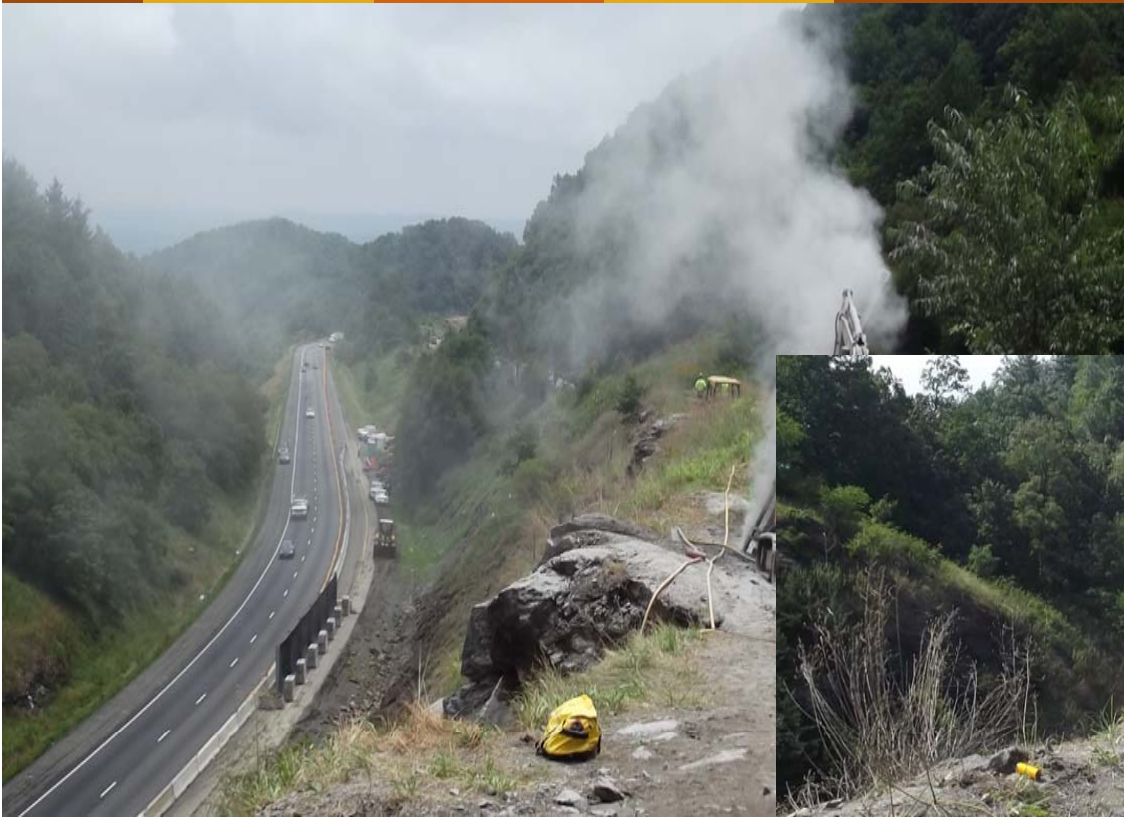
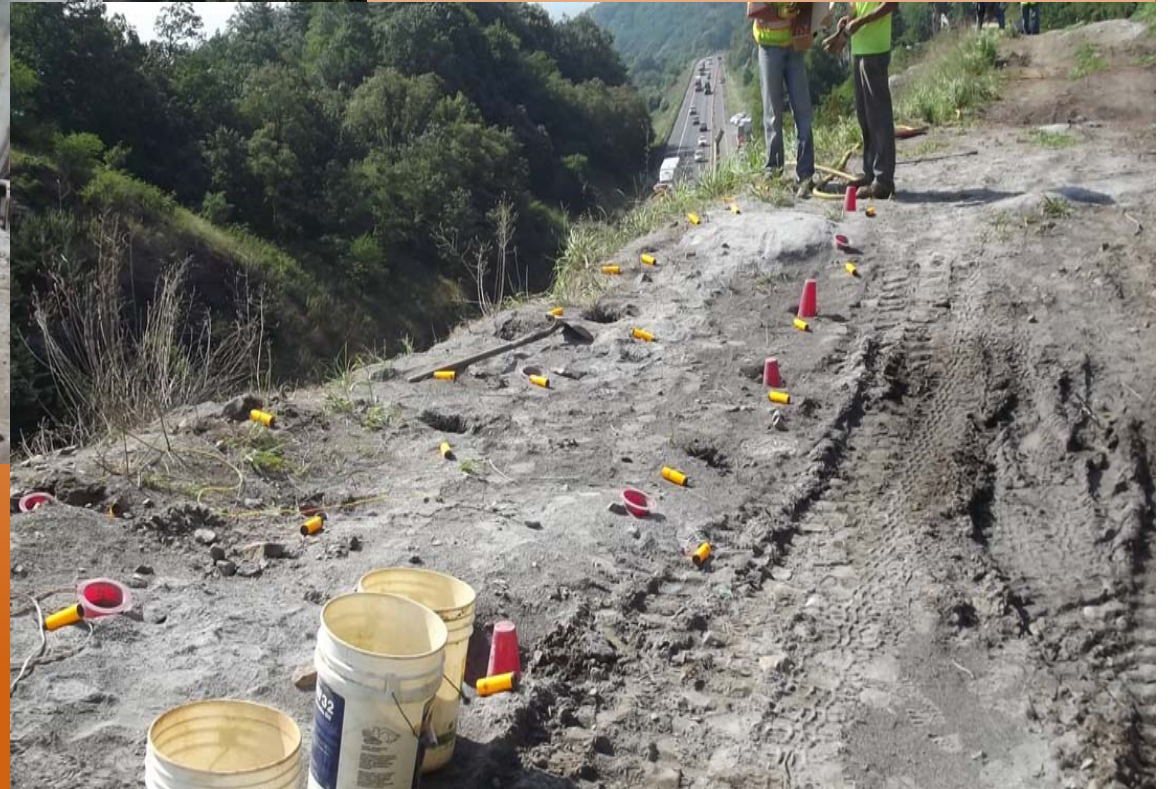
# Wedge Removal Begins: 7/13/2012

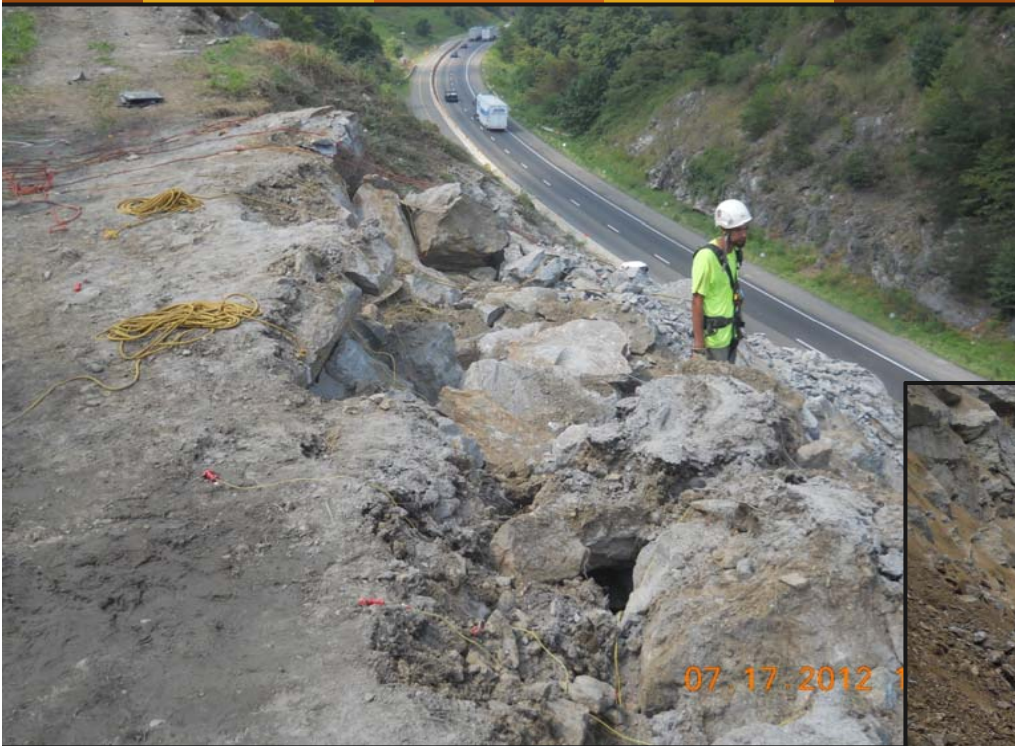
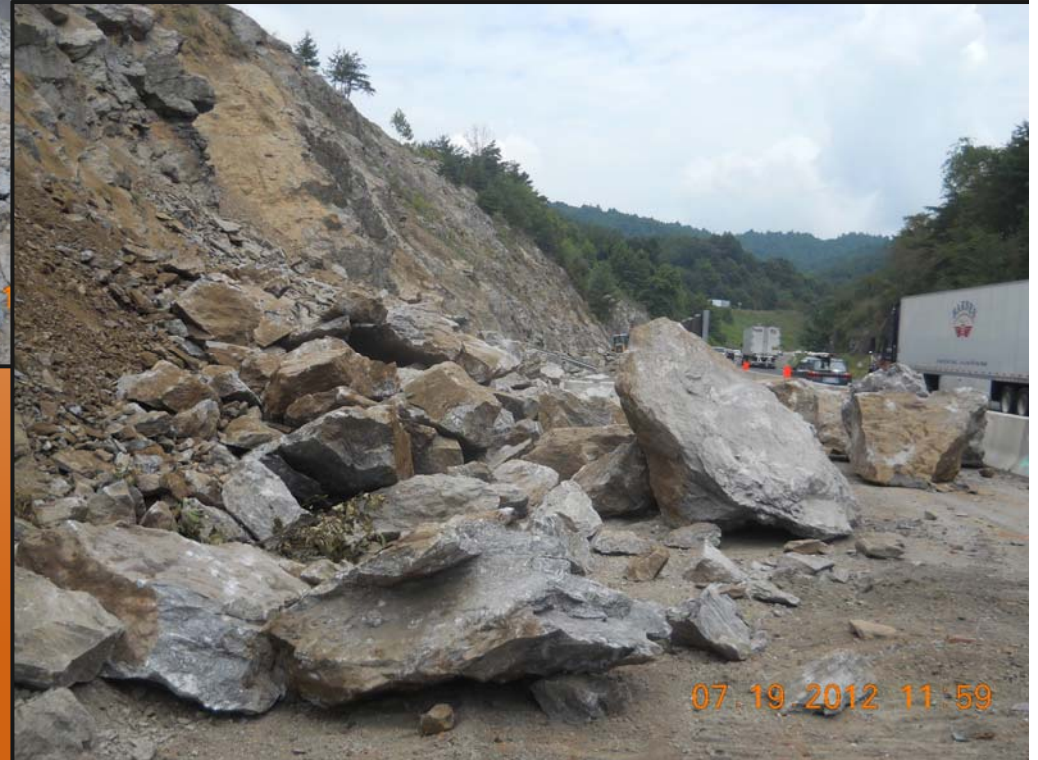
# After 1<sup>st</sup> Blast within Wedge

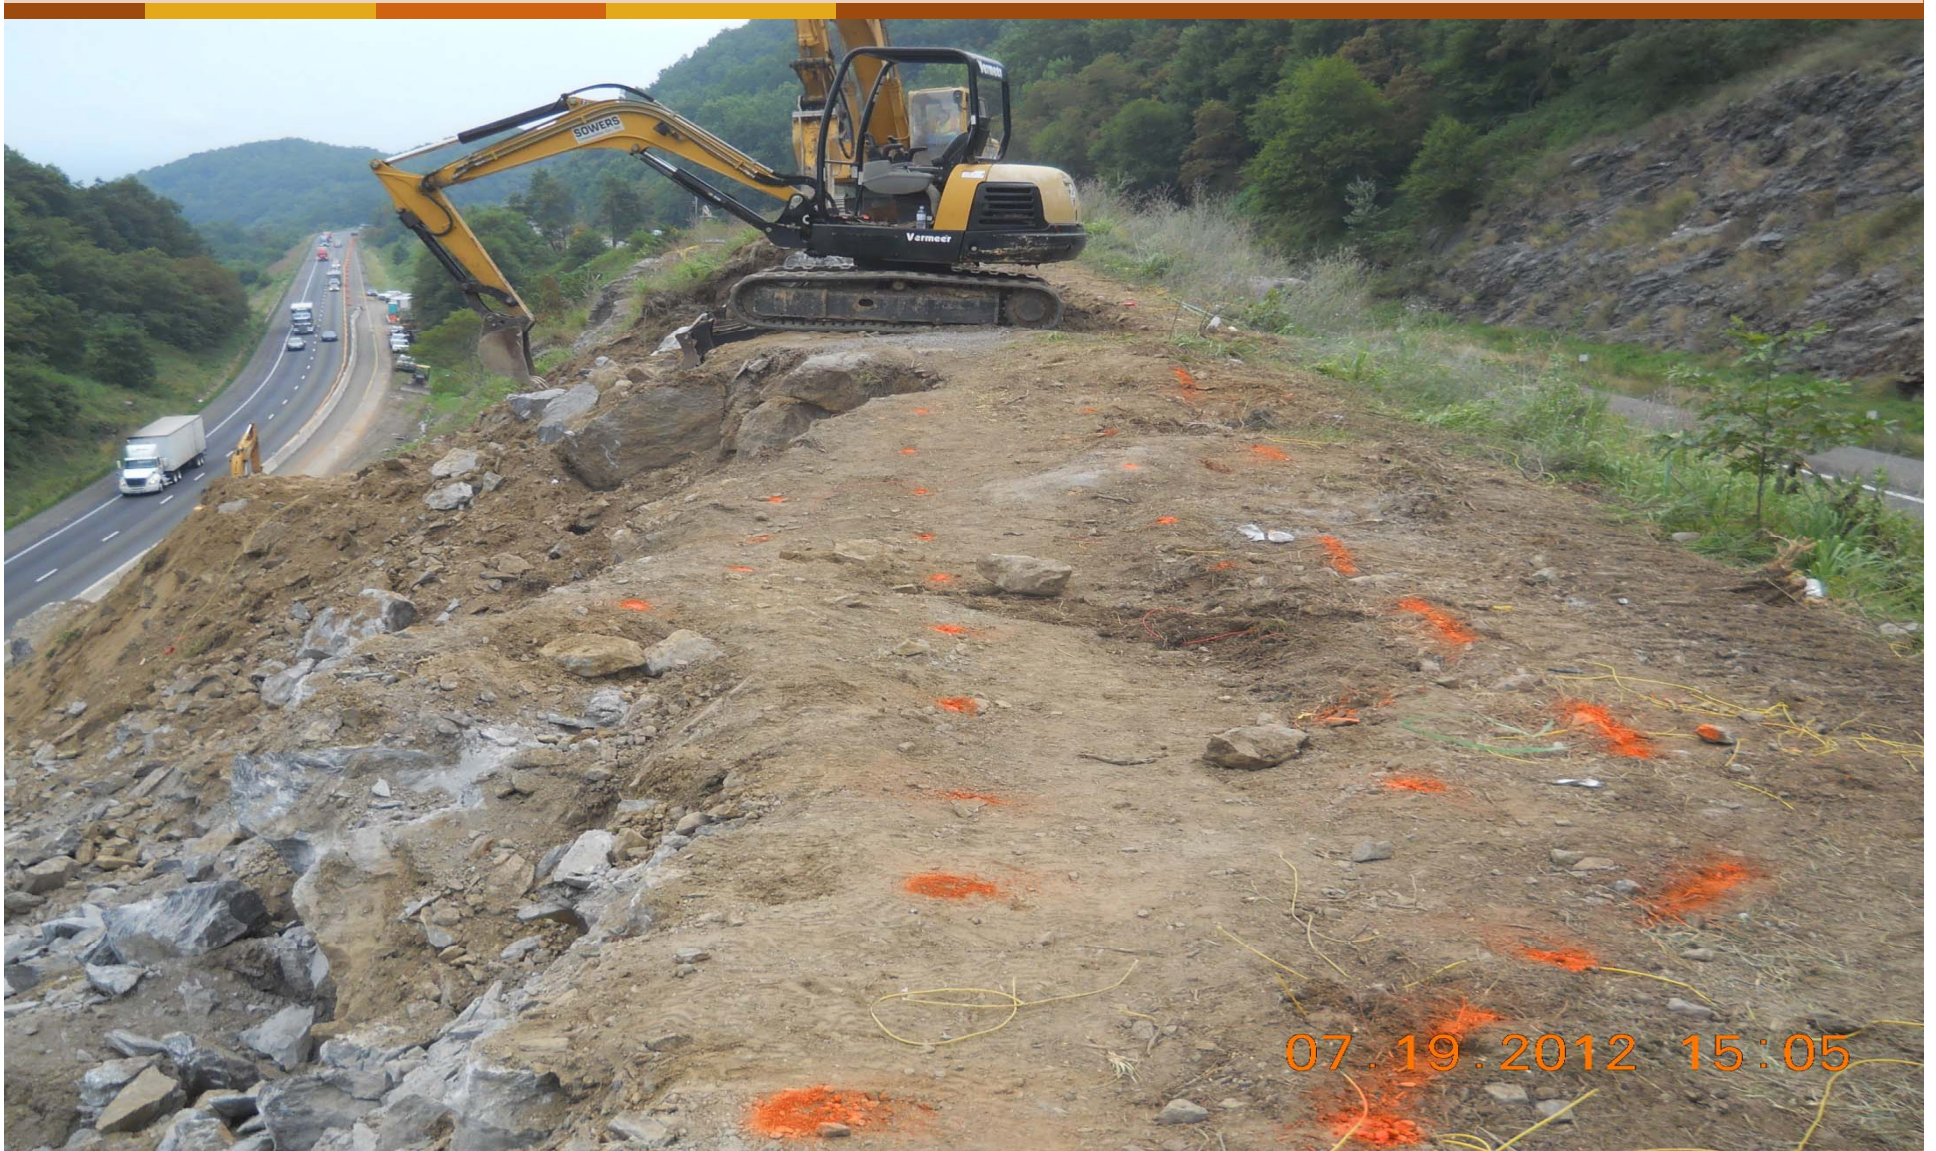
# Layout of 2<sup>nd</sup> Blast

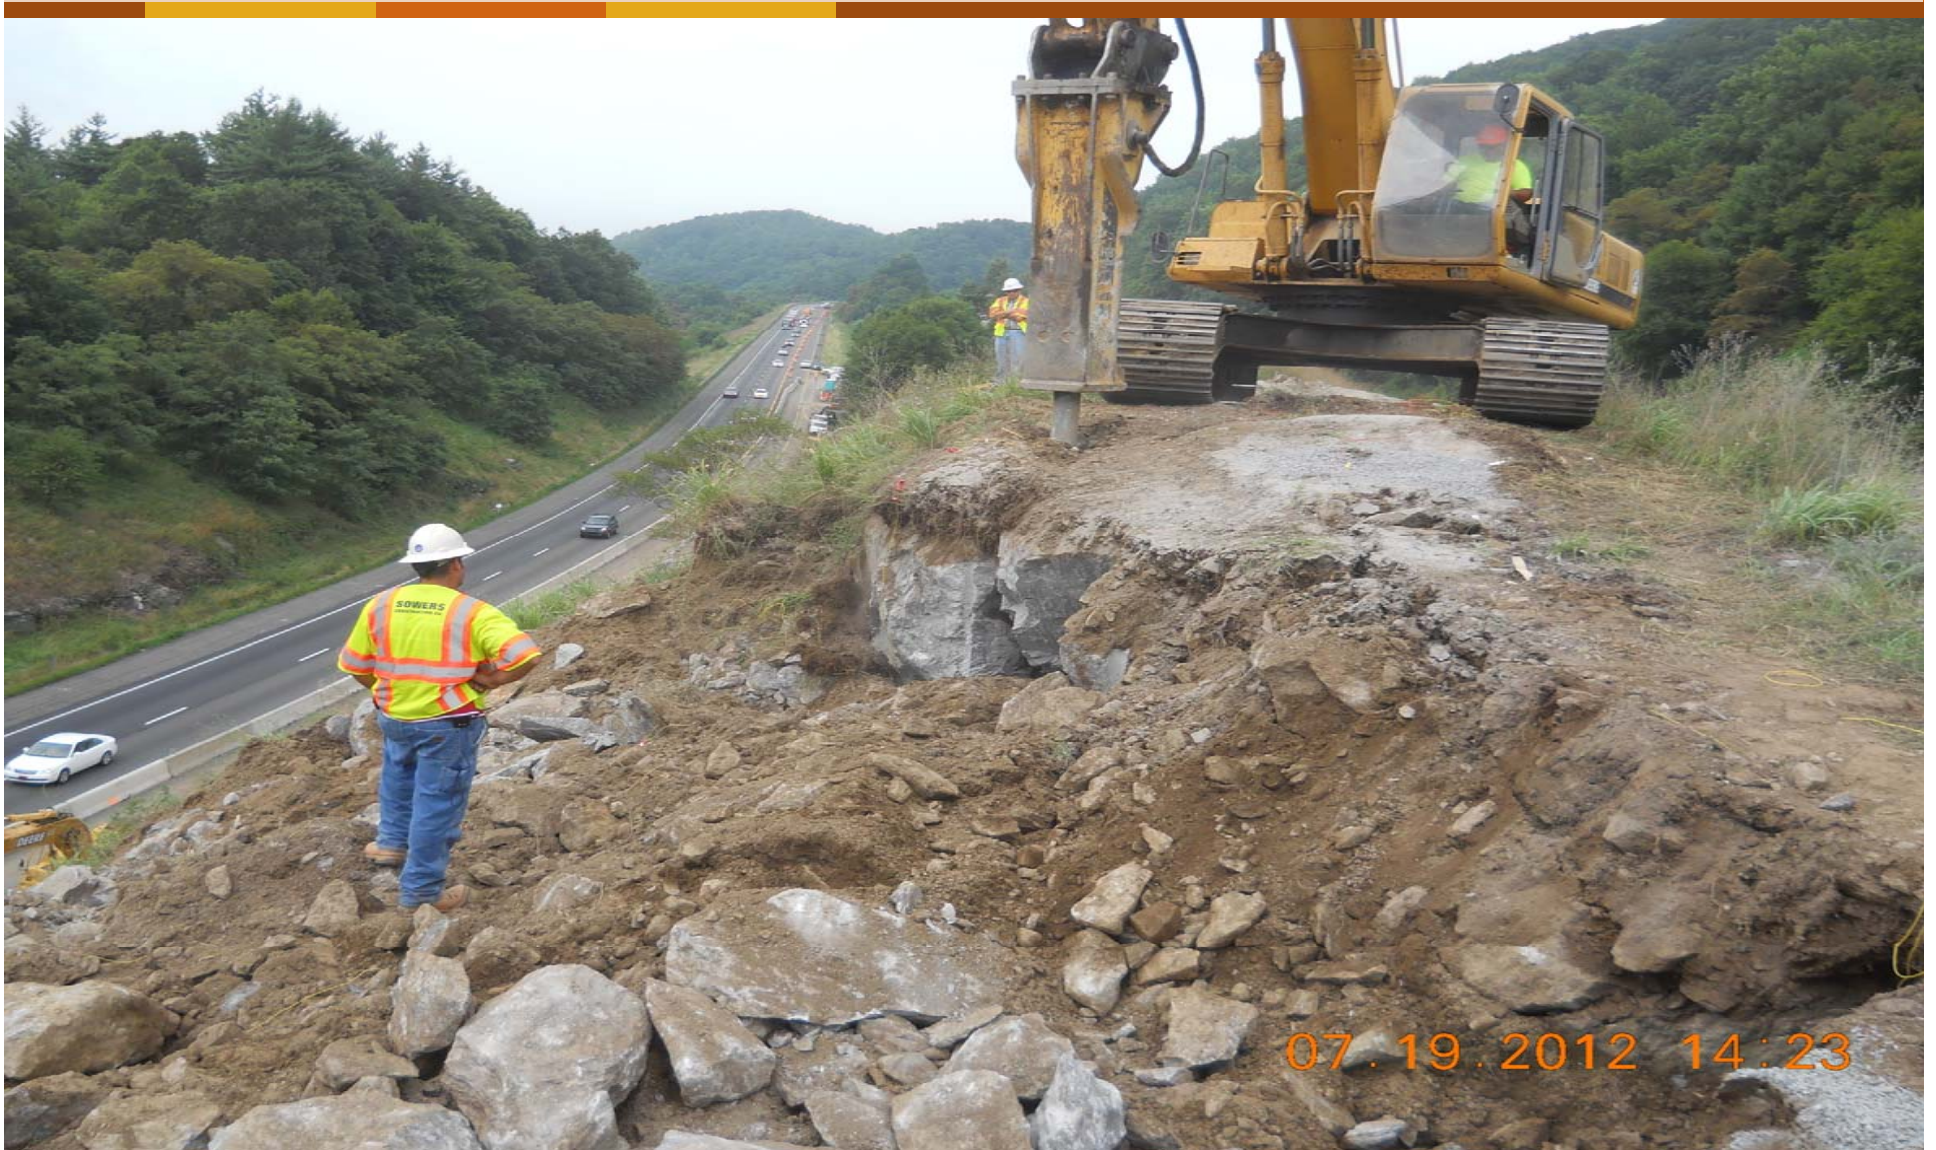
# After 2<sup>nd</sup> Blast
