# Clearing the Fog on the Aging I-77 Rock Slopes

**Ryan Tinsley, PG**  
HDR Engineering, Inc.

**David Lee, PE**  
VDOT Materials Division  
Salem District

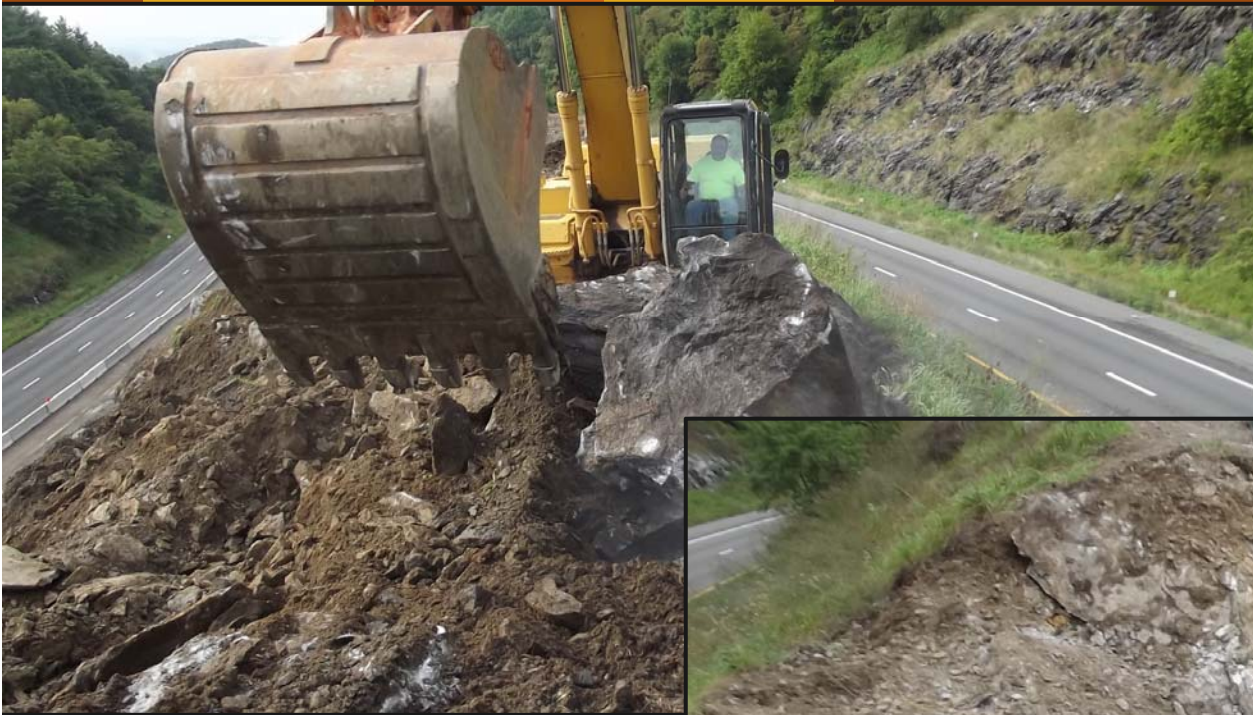
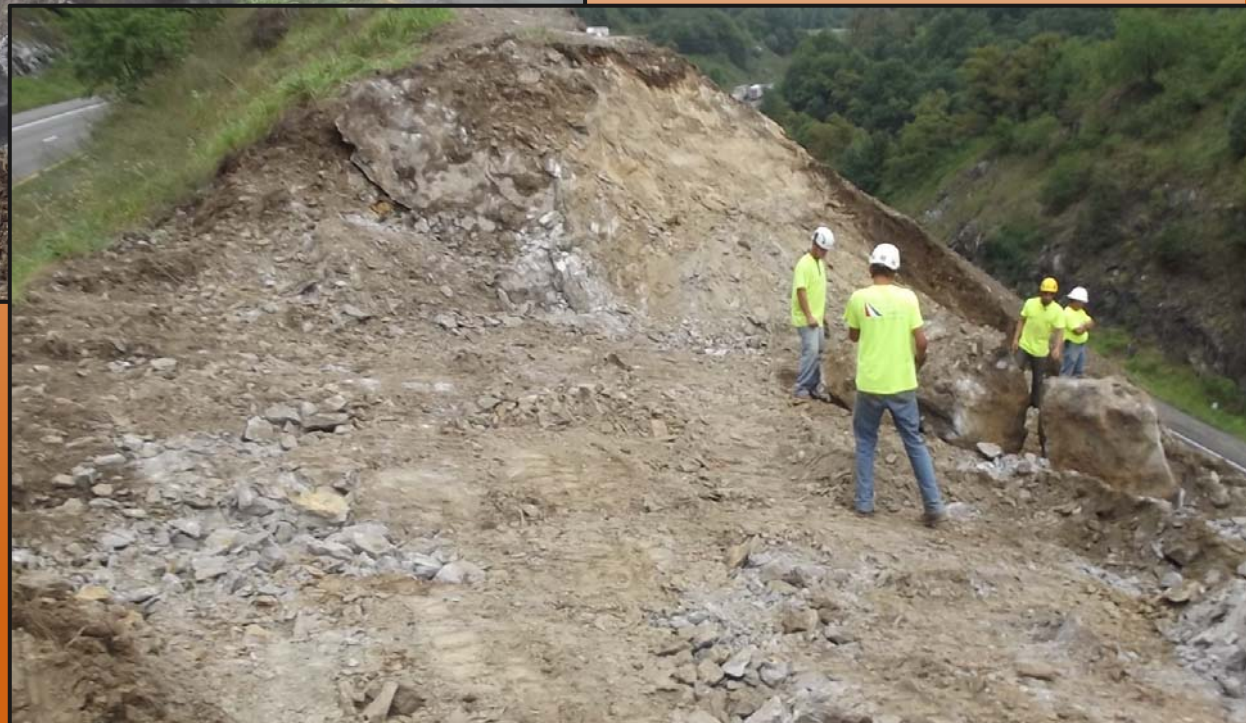
# Change in Plan

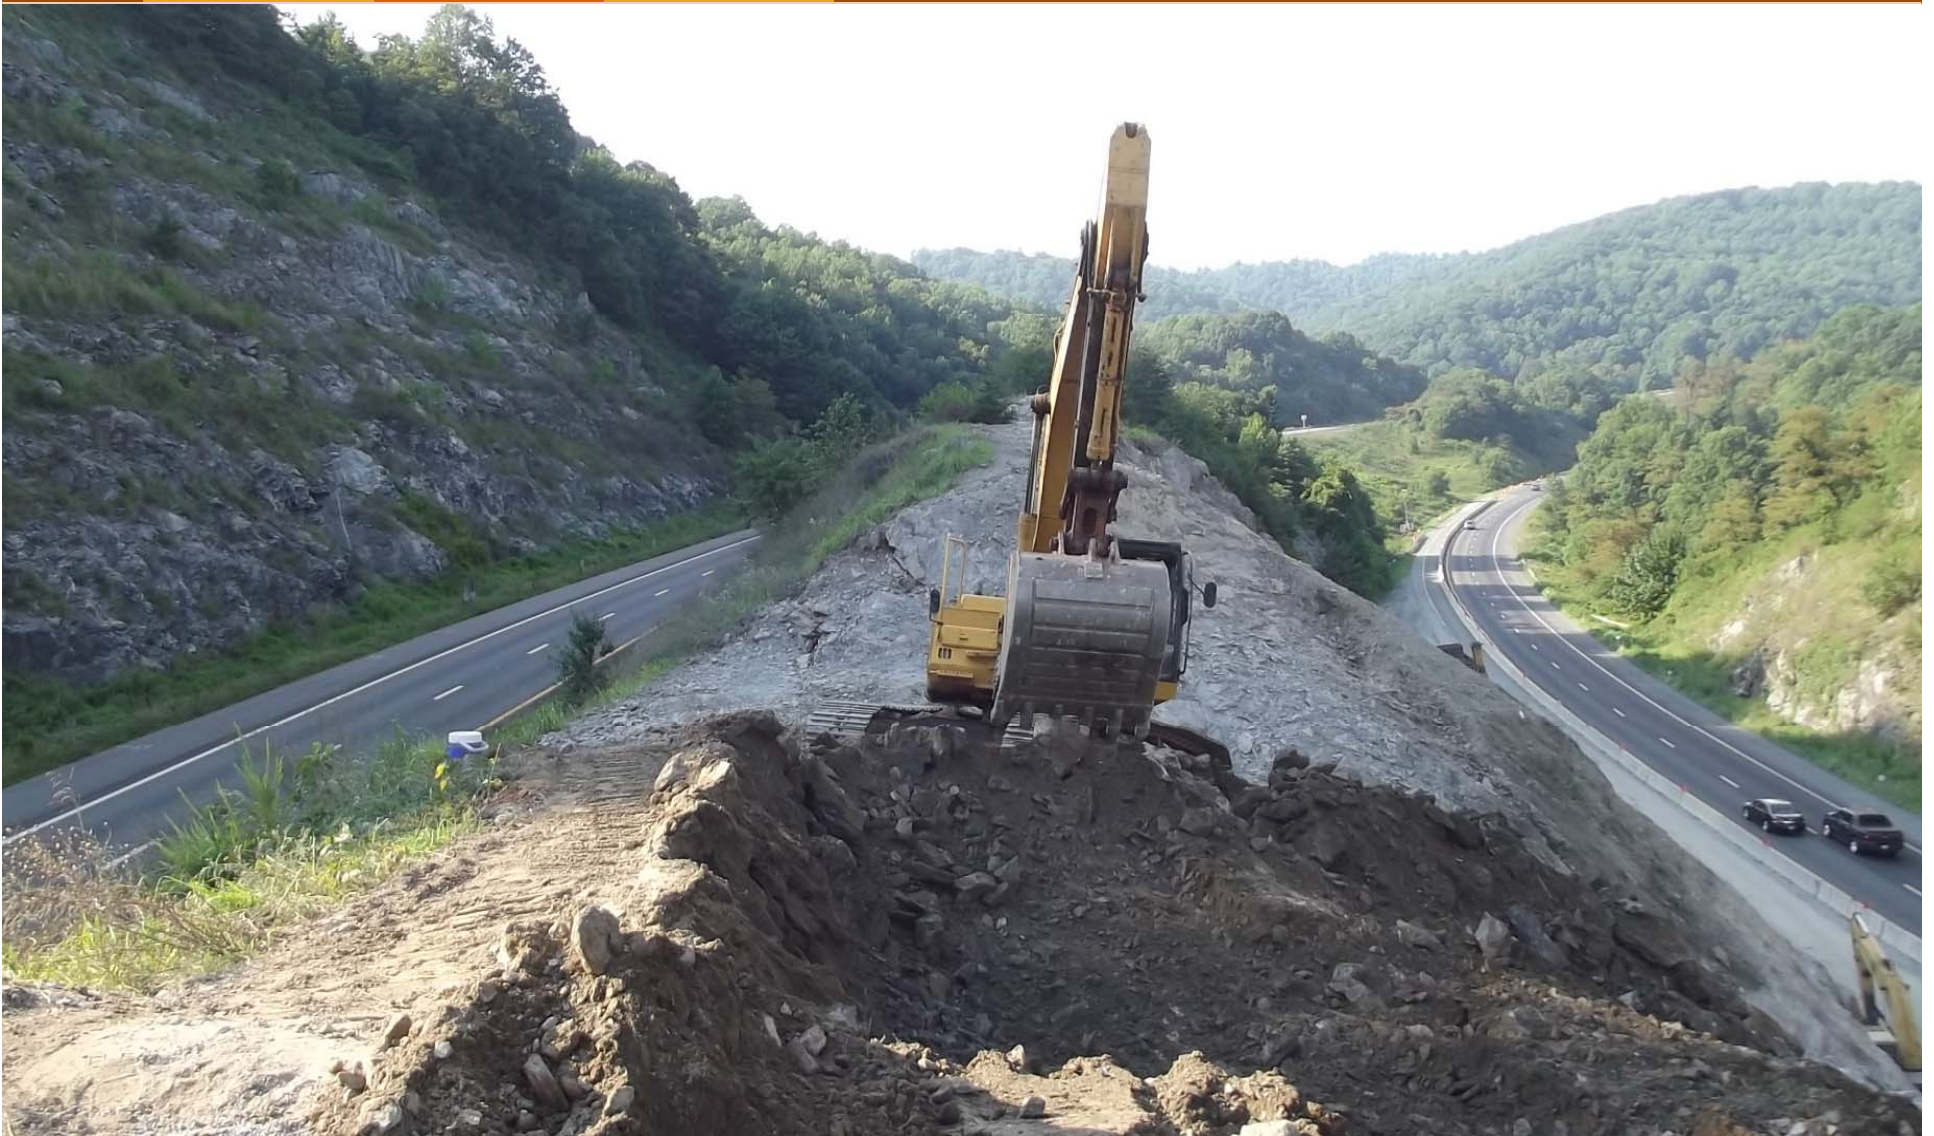
# Excavation of Fill Continues

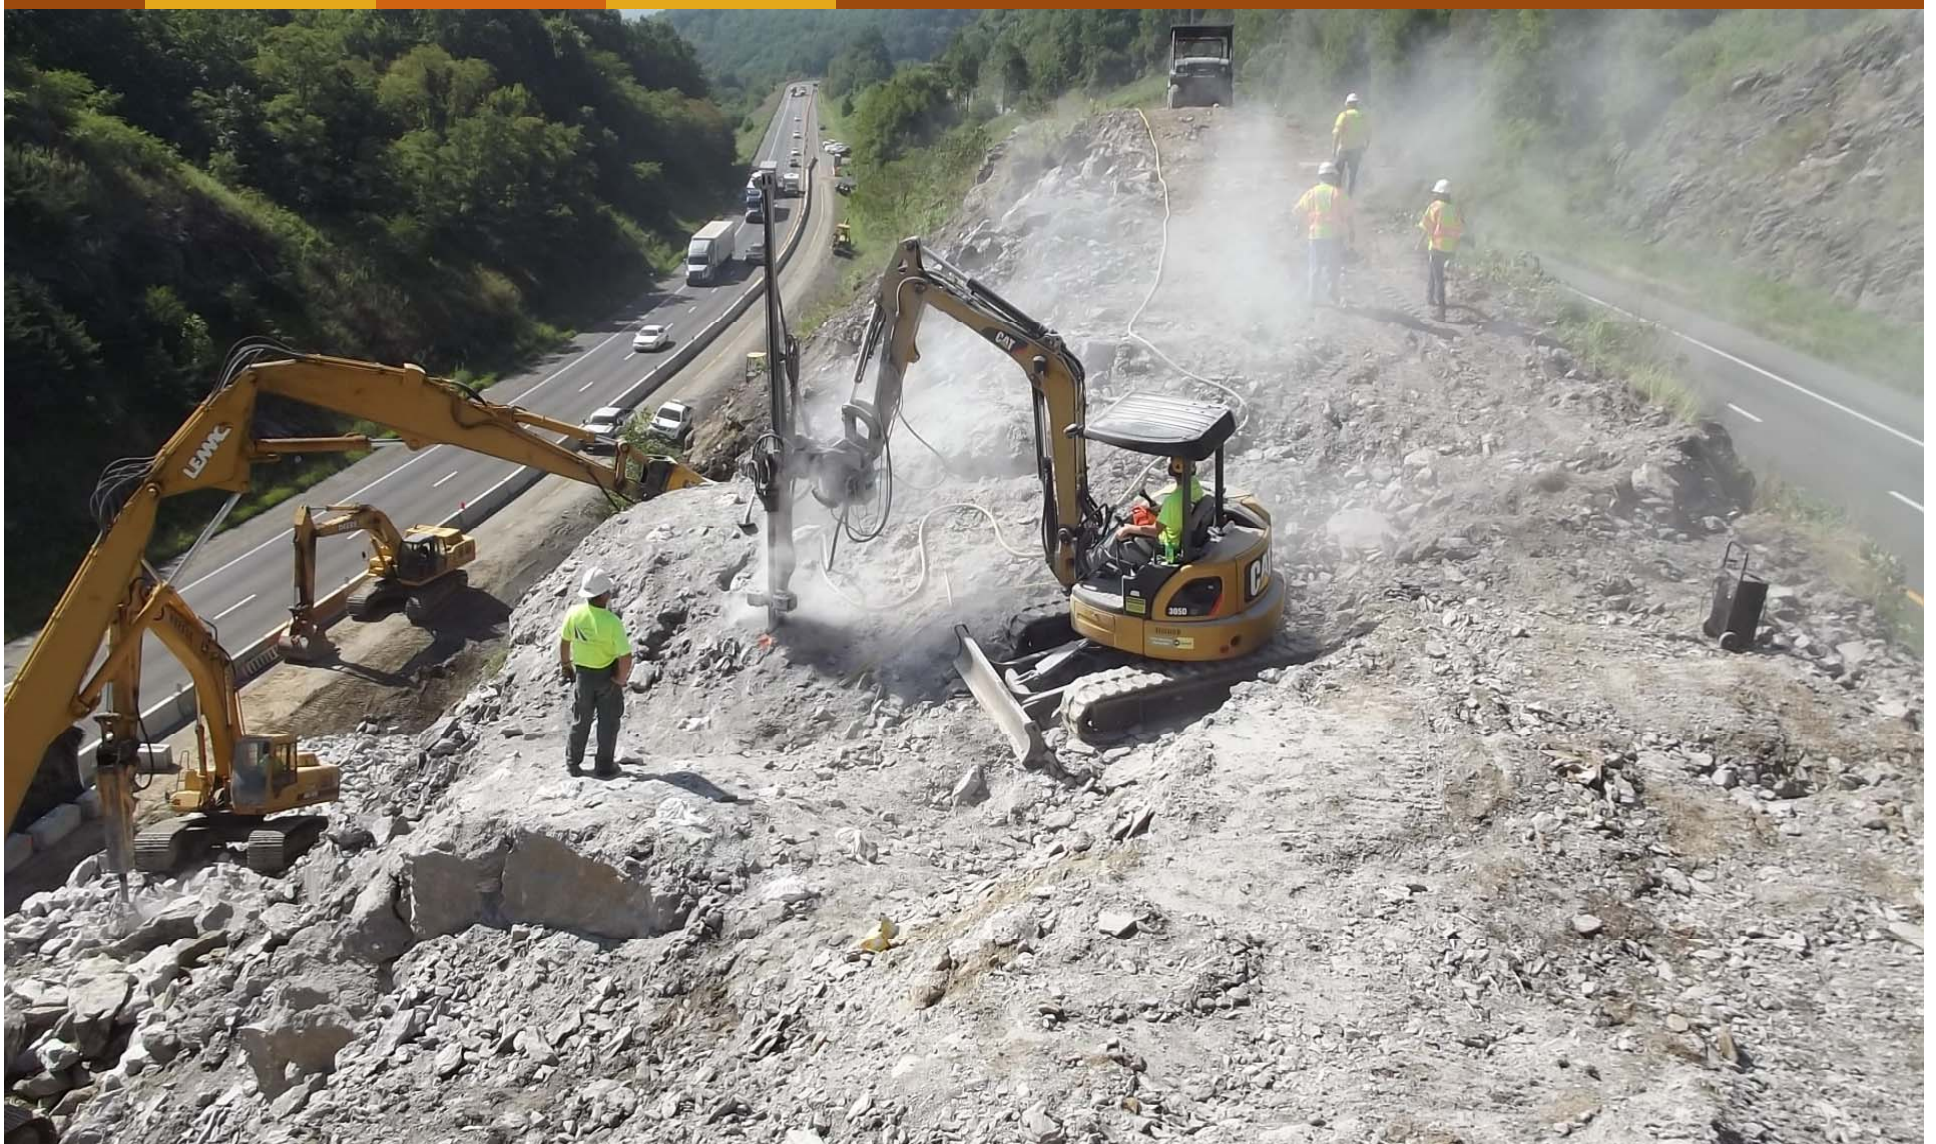
# Top and Bottom Approach

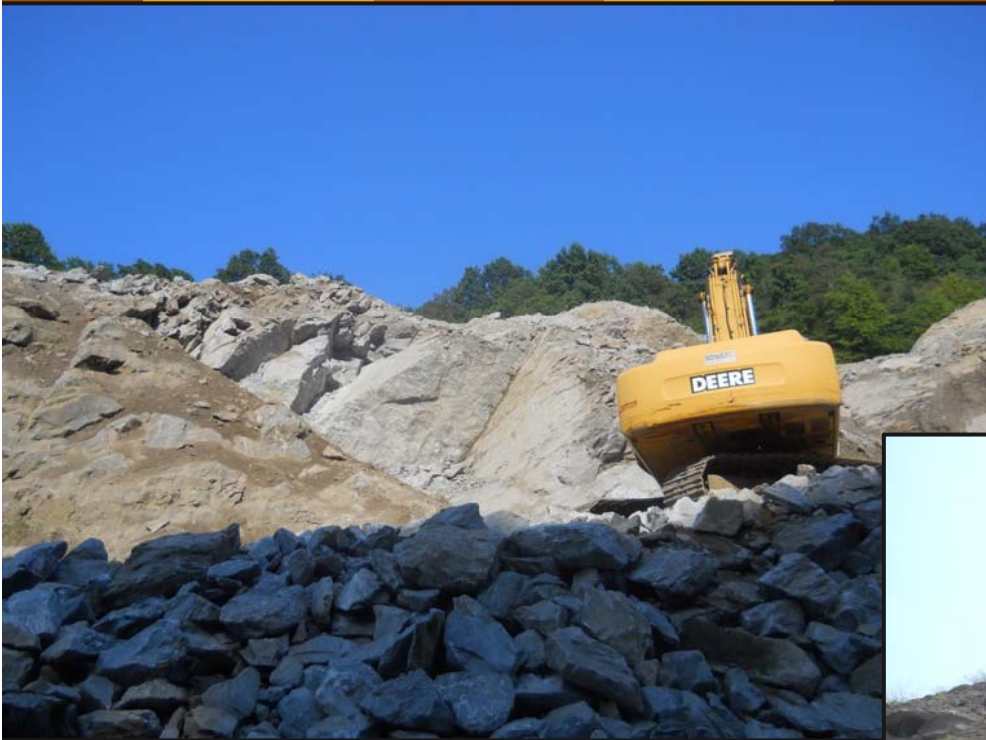
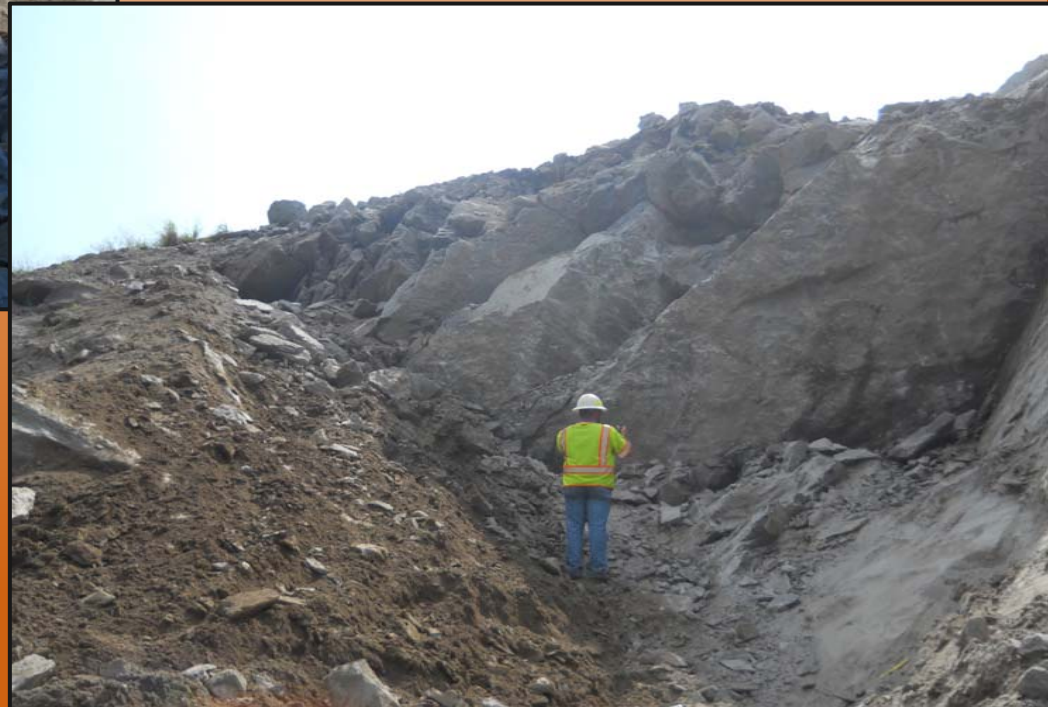
# From the bottom

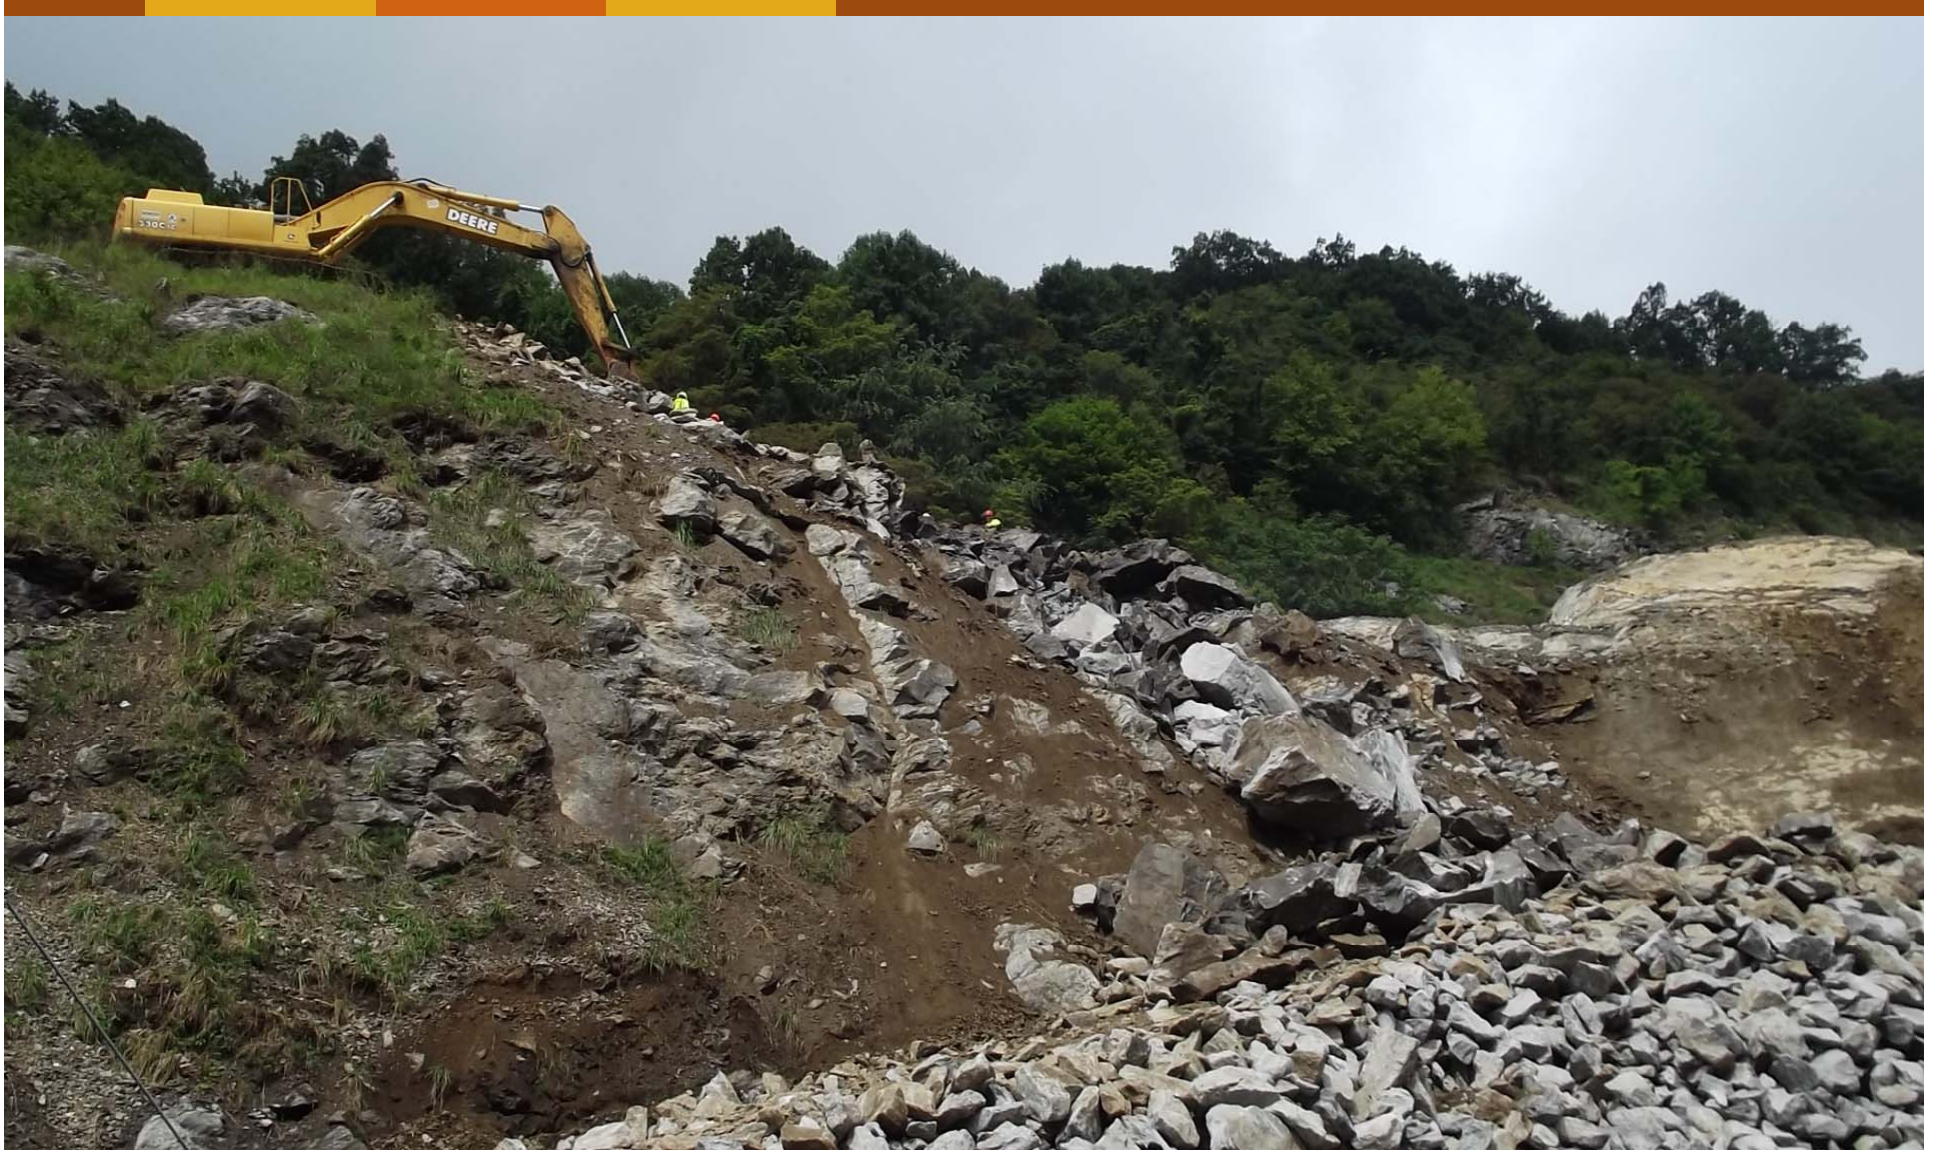
# After the Wedge Blast

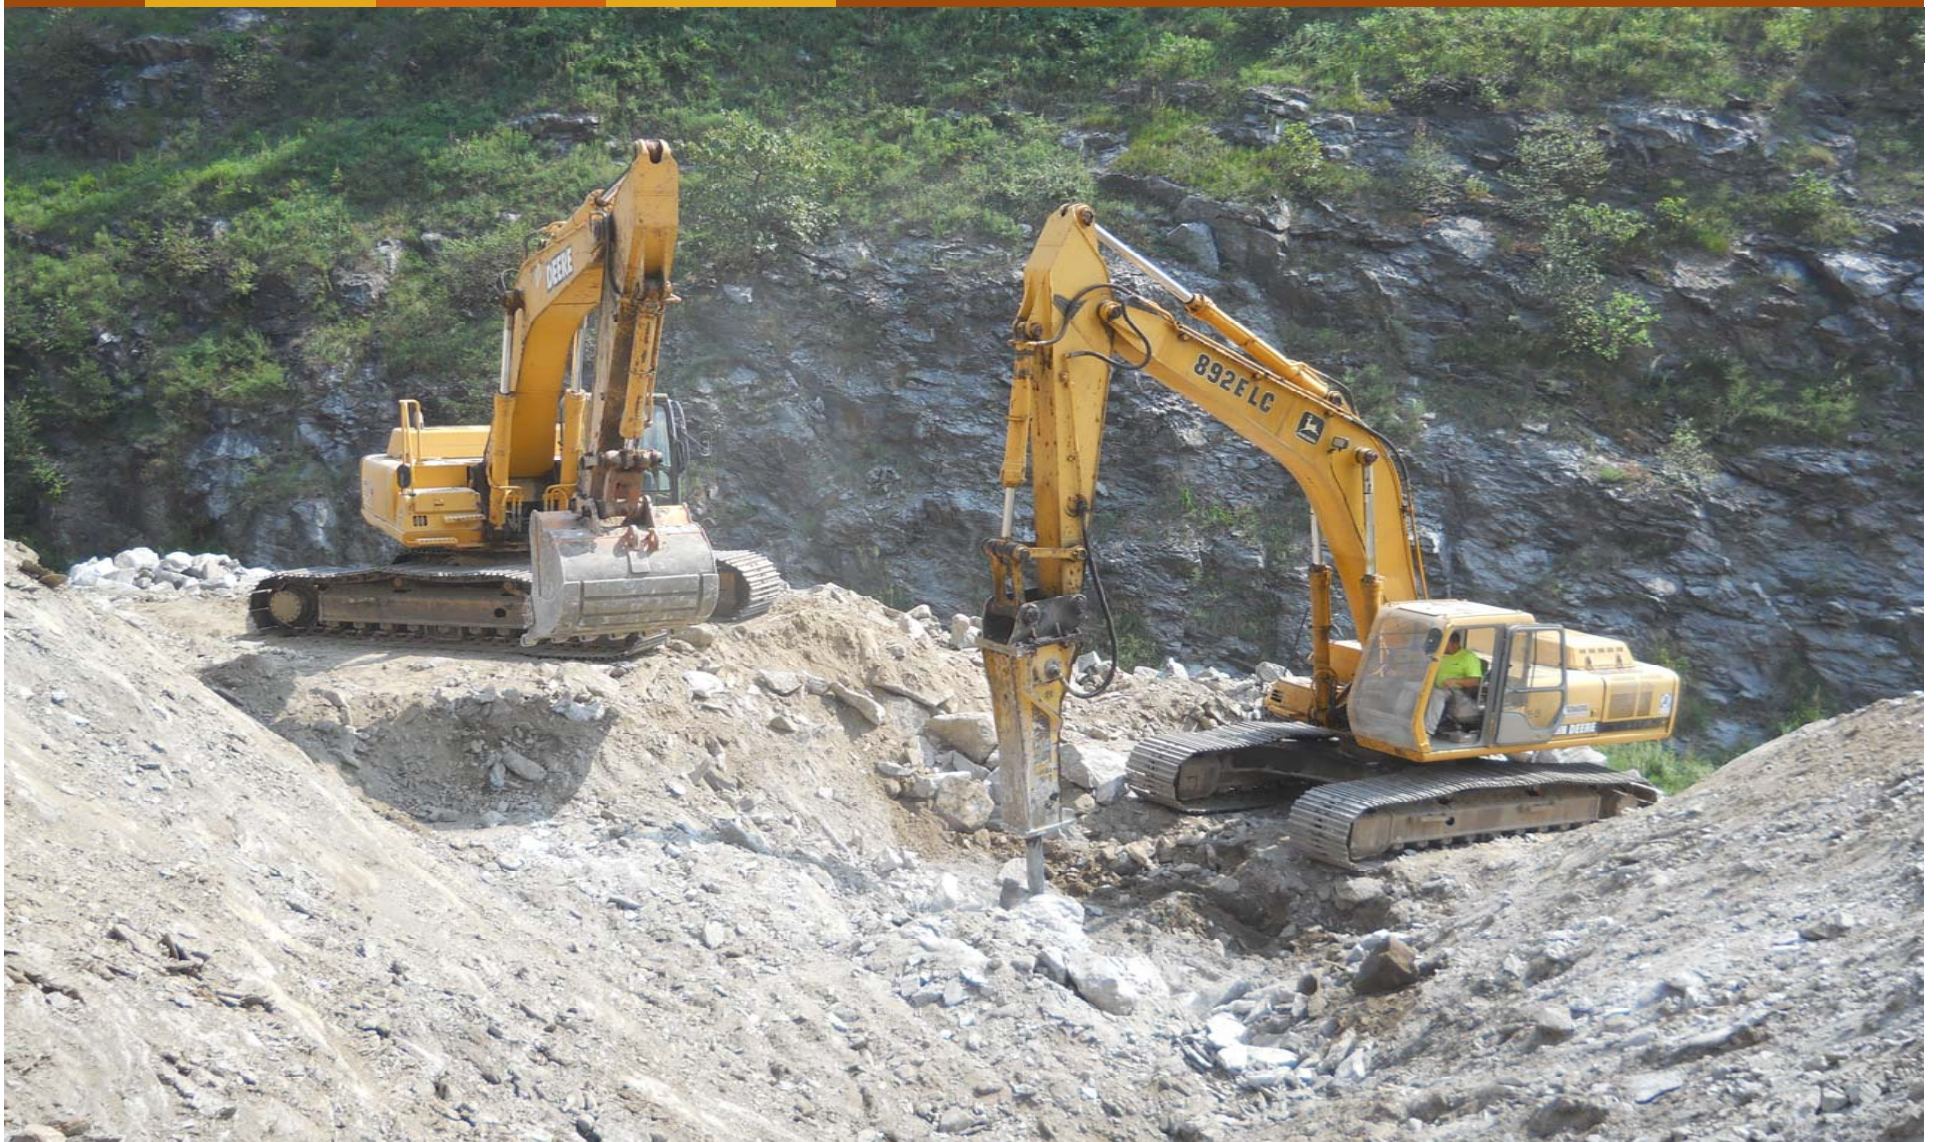
# Mechanical Removal Below

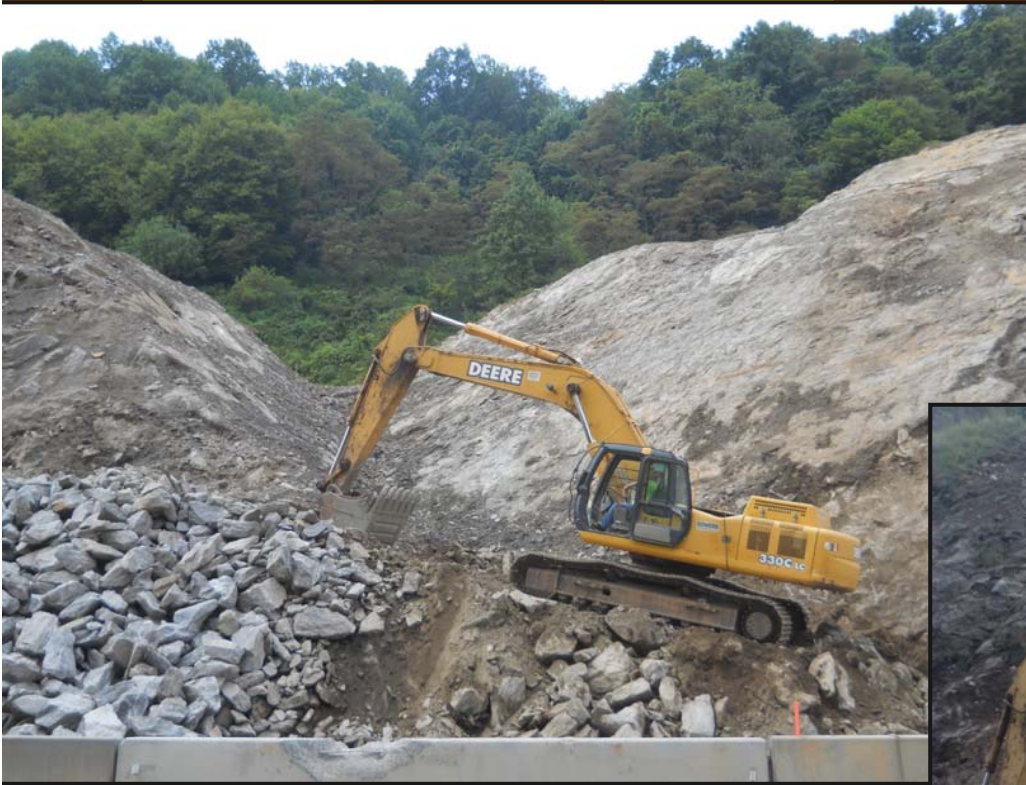
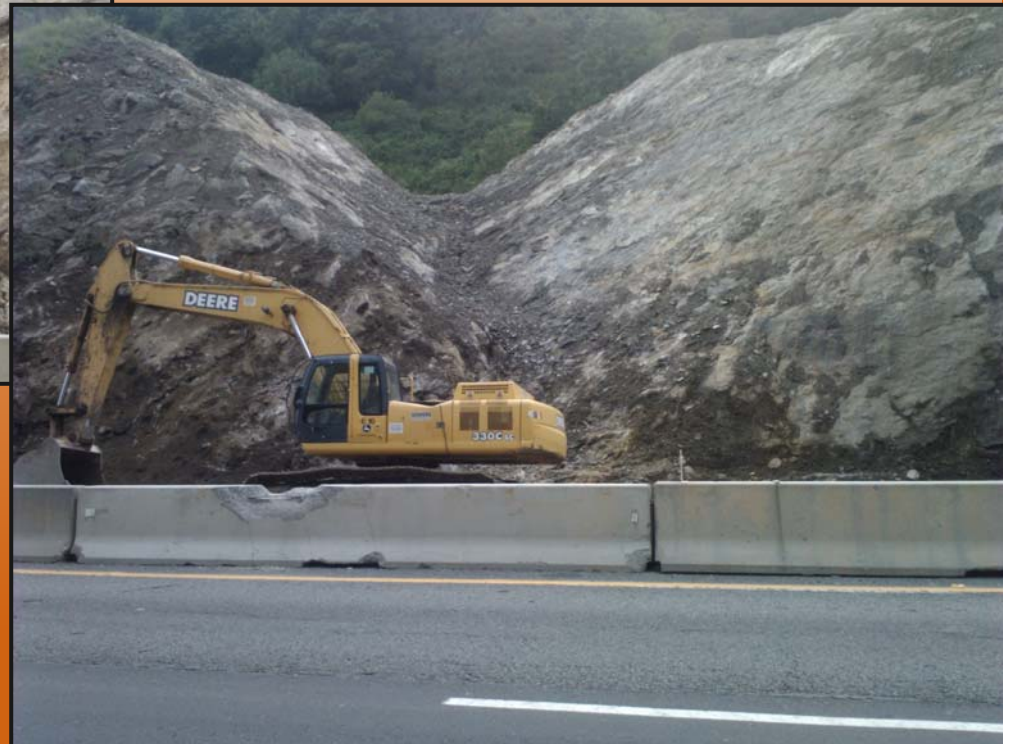
# The planes come together

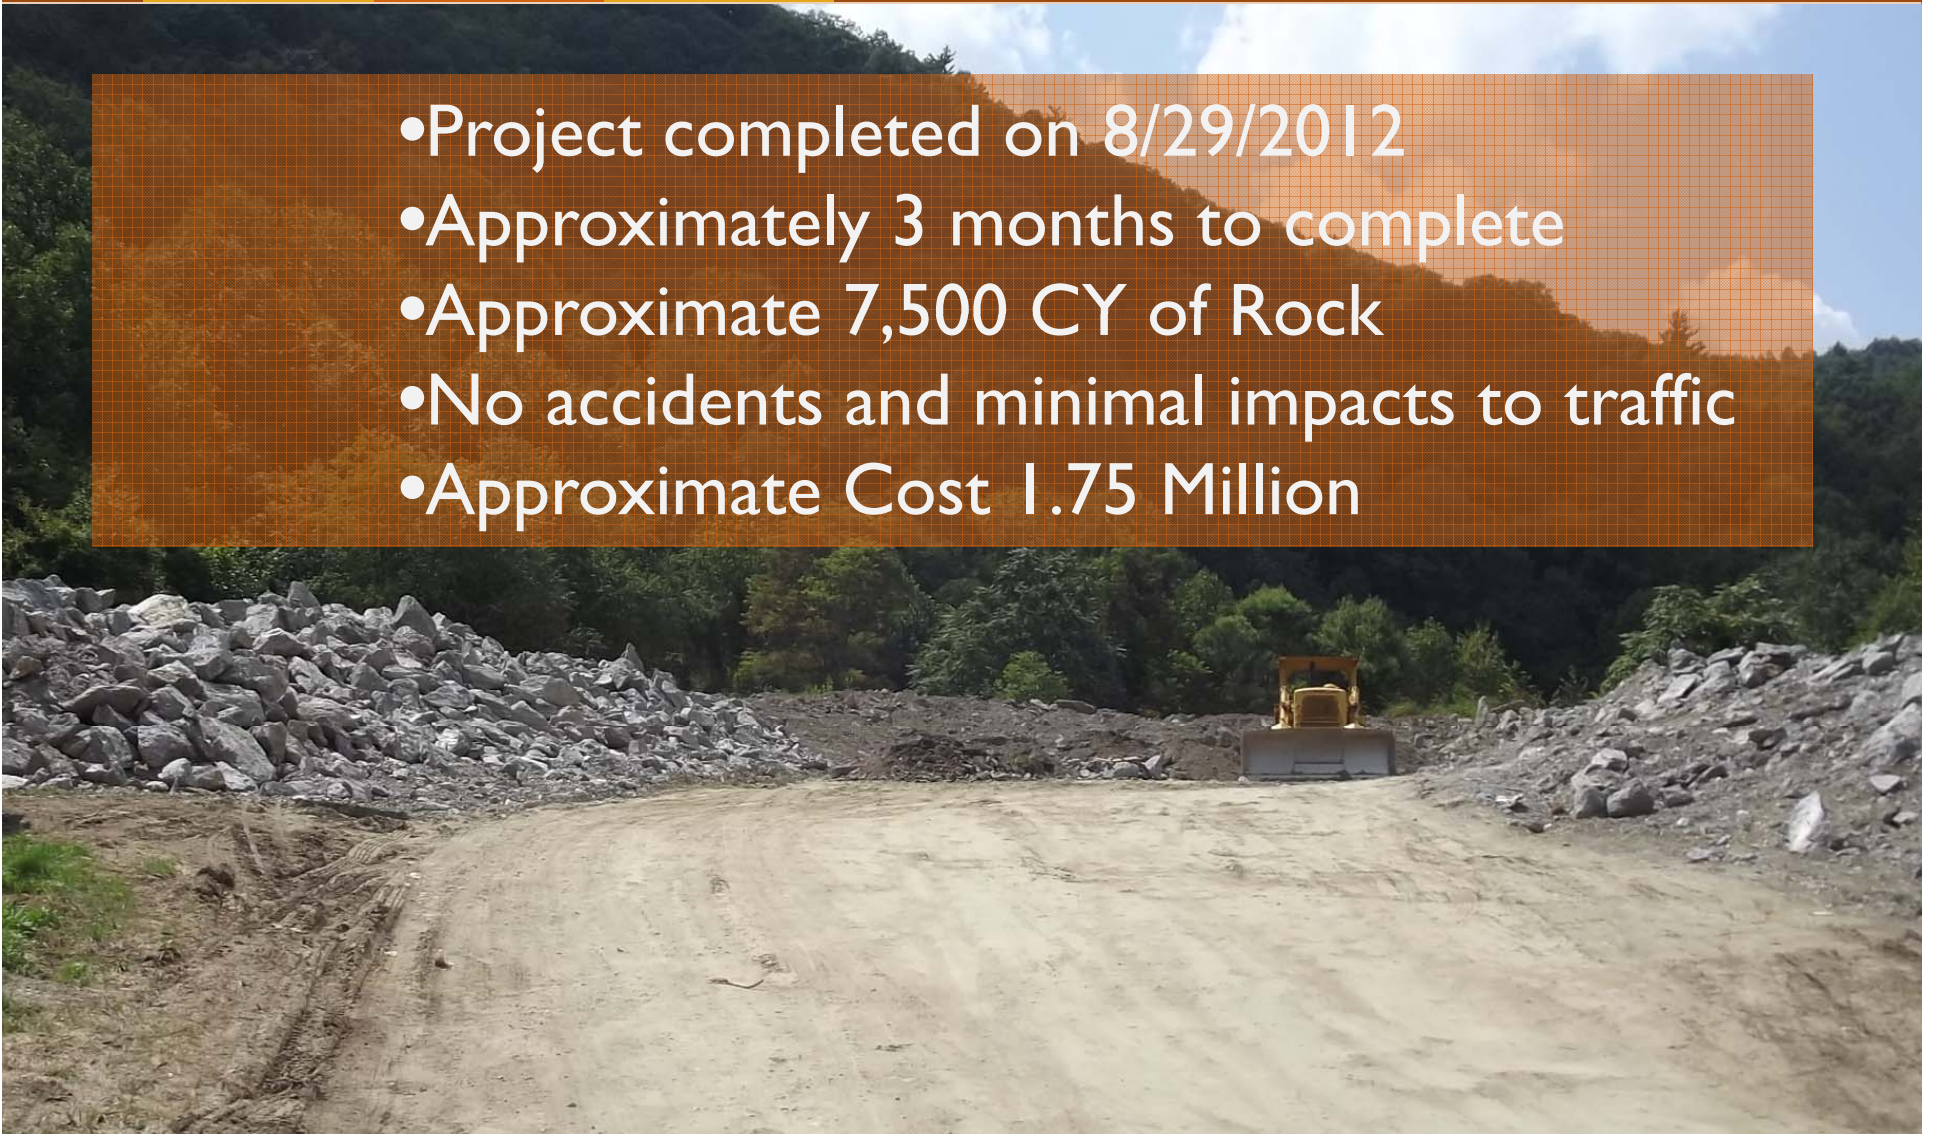
- Project completed on 8/29/2012
- Approximately 3 months to complete
- Approximate 7,500 CY of Rock
- No accidents and minimal impacts to traffic
- Approximate Cost 1.75 Million
